Phase 1 Preliminary Risk Assessment

Land off Hinchley Road, M9 7FG

A REPORT PREPARED FOR AND ON BEHALF OF:
Manchester City Council

Issue Date: 23 February 2023
Revision No: A
Revision Date: 27 March 2023

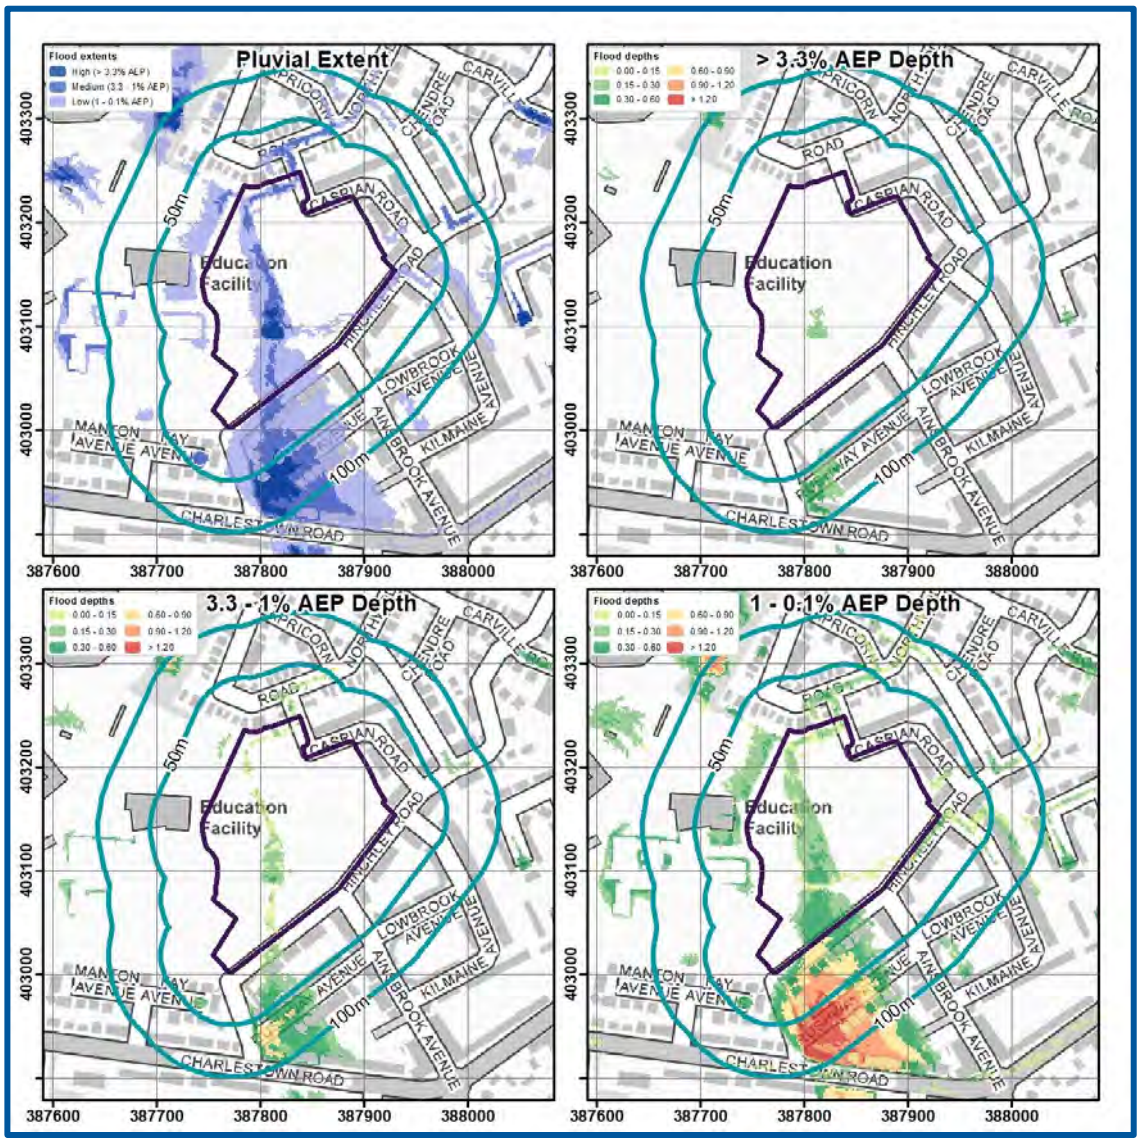
Figure 9. EA surface water flood extent and depth map (EA, 2023)

It is noted that the area anticipated to experience surface water flooding reflects a topographical depression on-Site; ground levels in this area are between 0.3m and 1.3m below average ground elevations on-Site (100.5mAOD).

During this event flood depths of up to 0.6m are anticipated in the south of the Site. It is again noted that the area anticipated to experience flooding reflects a topographical depression on Site.

Site investigation is recommended to confirm the presence of any historic or culverted watercourse on Site, in the location of the identified flood flow route.
