Ceiling Inspection

Sheppard Robson

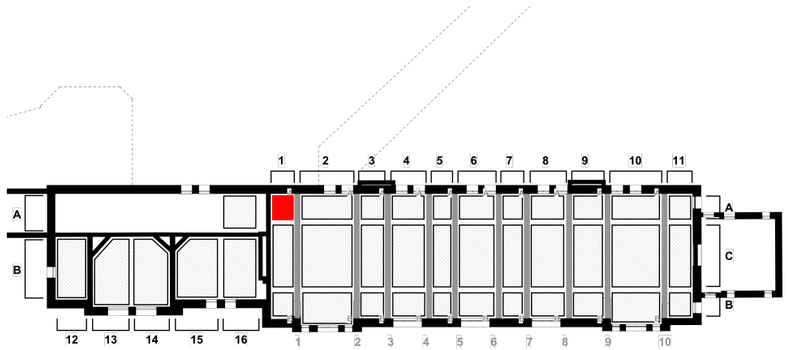
1A

Minor surface damage.

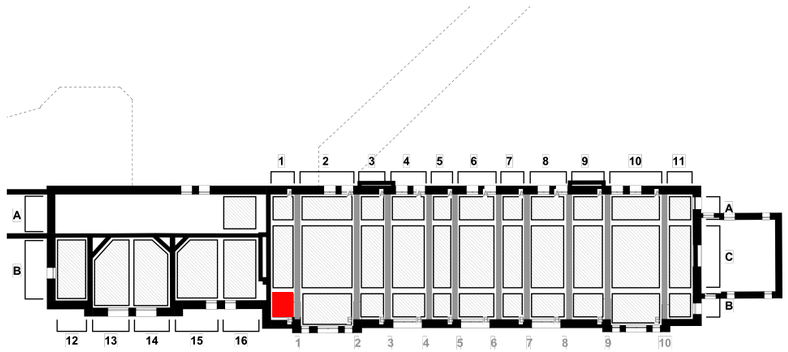
1B

Large area of plaster lost historically.

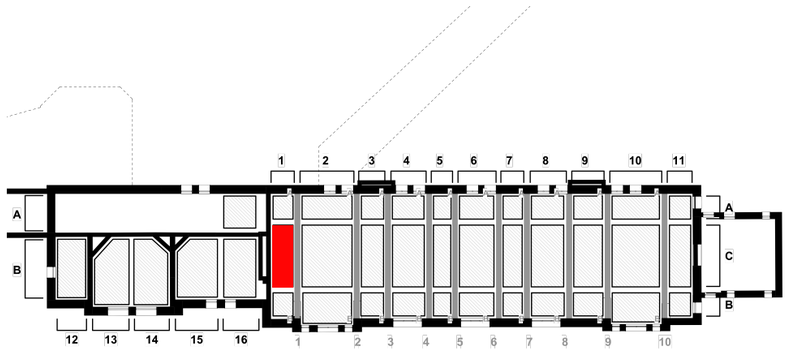
1C

Large area removed, some surface damage.

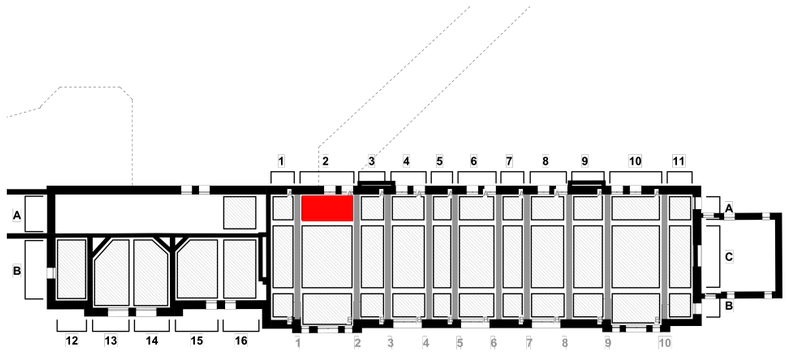
2A

Large area removed, some surface damage.

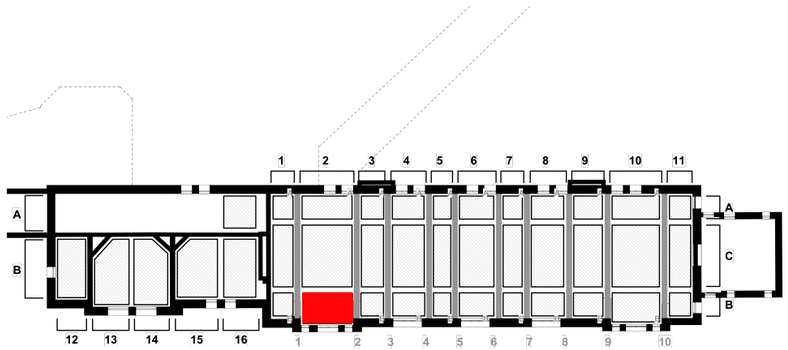
2B

Surface delamination.

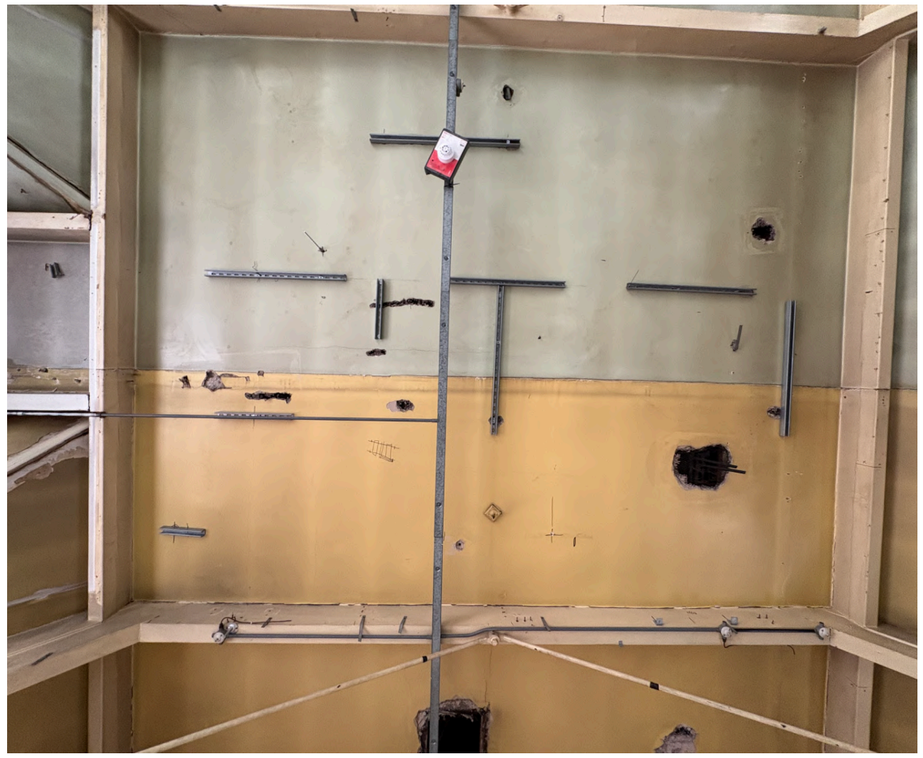
2C

Small holes within plaster, probably related to historic services.

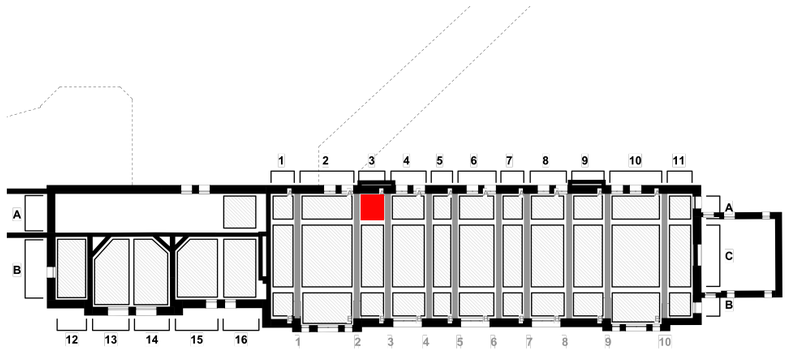
3A

Large area lost, clear signs of historic repairs to rafters and wall plate.

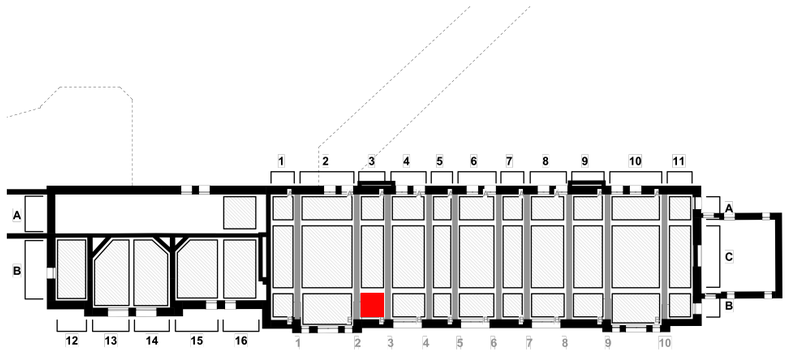
3B

Minor damage due to service penetrations.

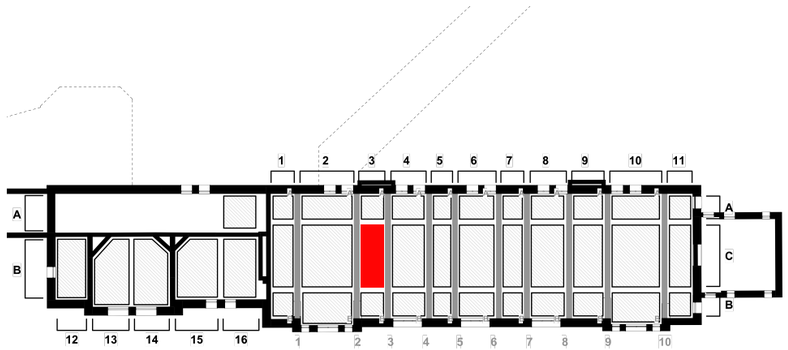
3C

Minor damage due tot service penetrations.

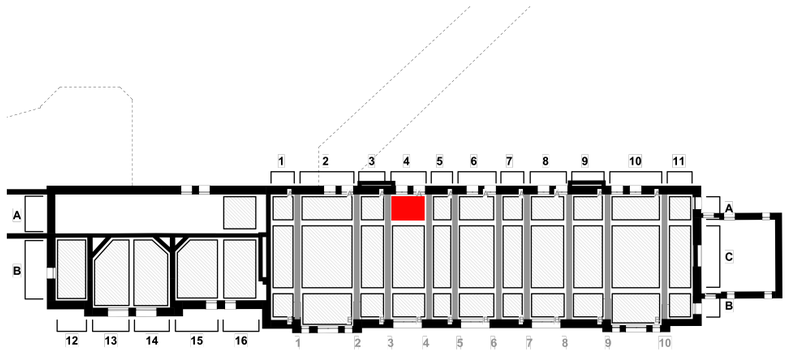
4A

Large area removed, additional surface damage, assume due to rafter repair.

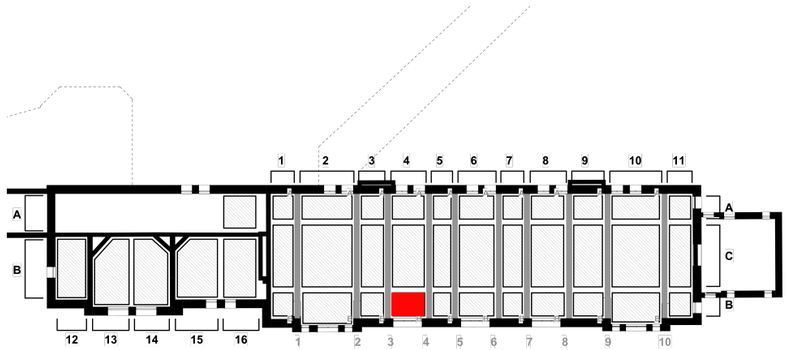
4B

Some surface delamination.

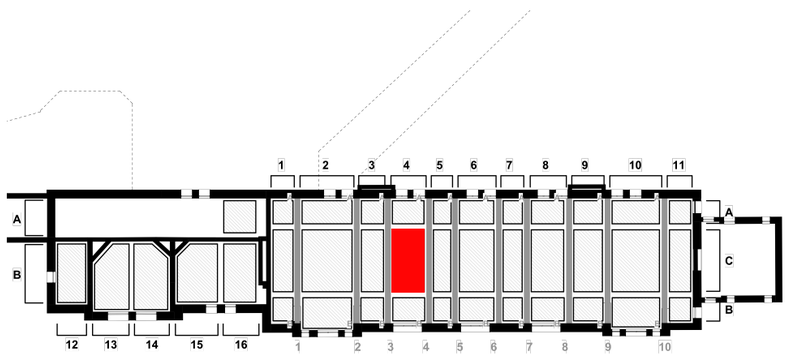
4C

Small holes within surface, some plaster loss with expanded mesh exposed.

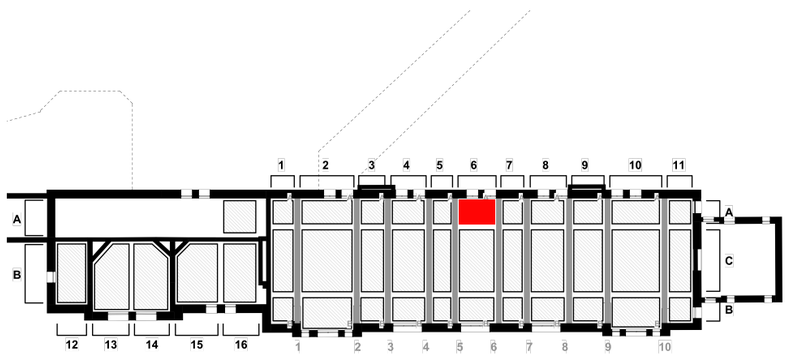
6A

Small loss of fabric to side of truss.

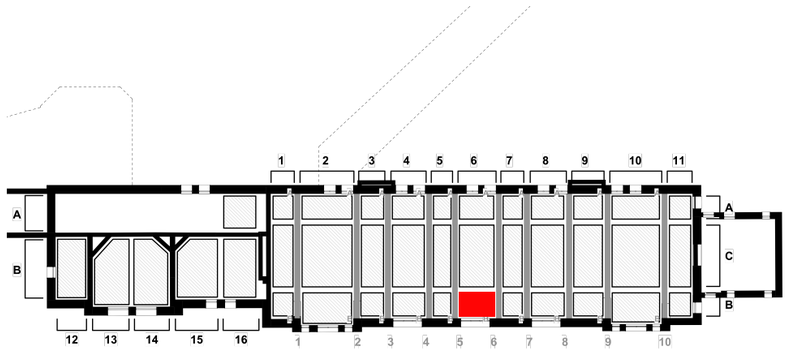
6B

Water damage with some surface declamination. Large area removed with area with plaster lost from lath.

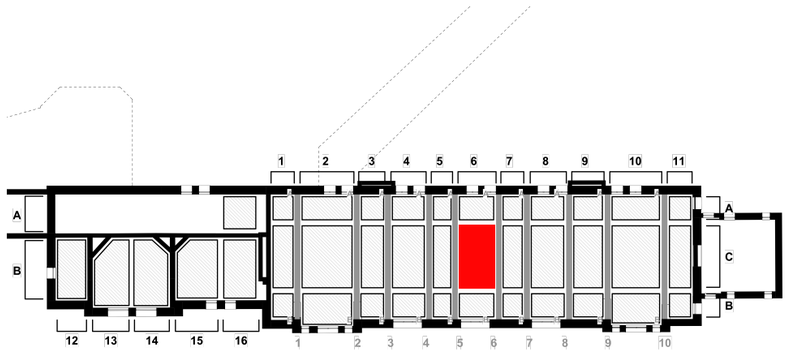
6C

Holes from historic service penetrations.

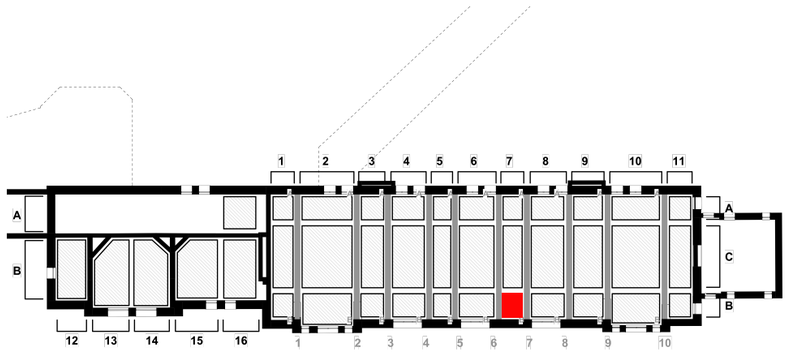
7B

Small opening to truss end.

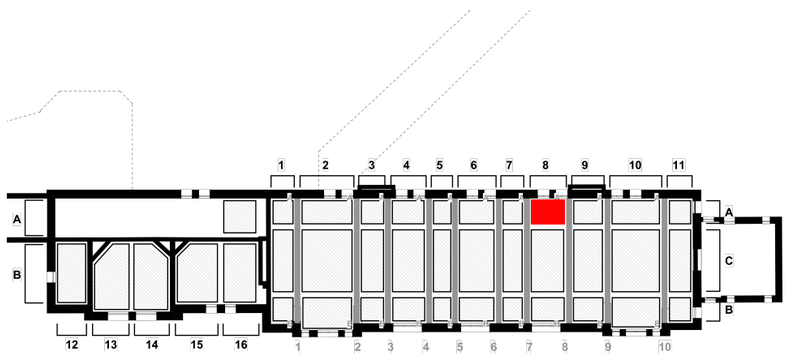
8A

Small hole to truss end.

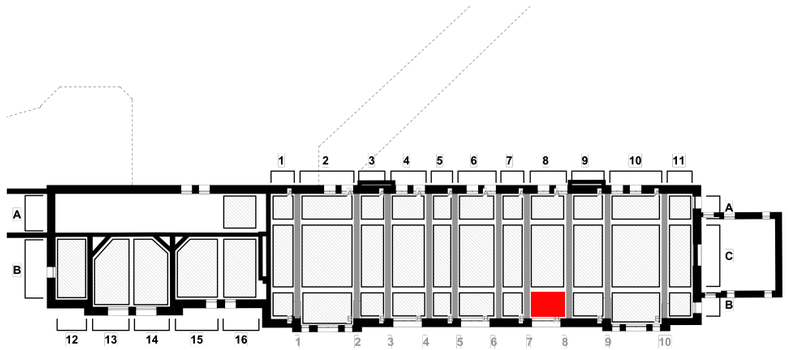
8B

Small water damage evident.

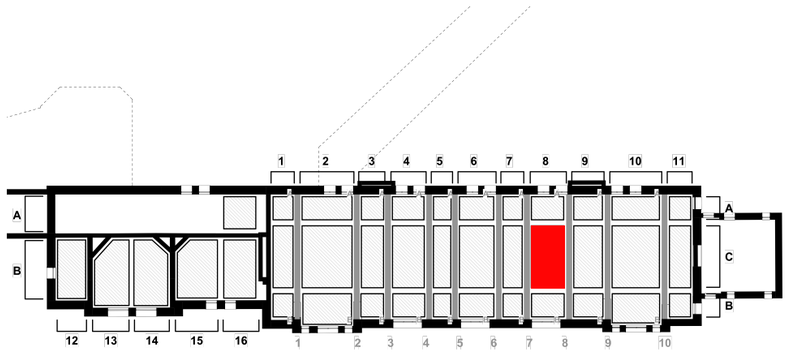
8C

Small service penetrations.

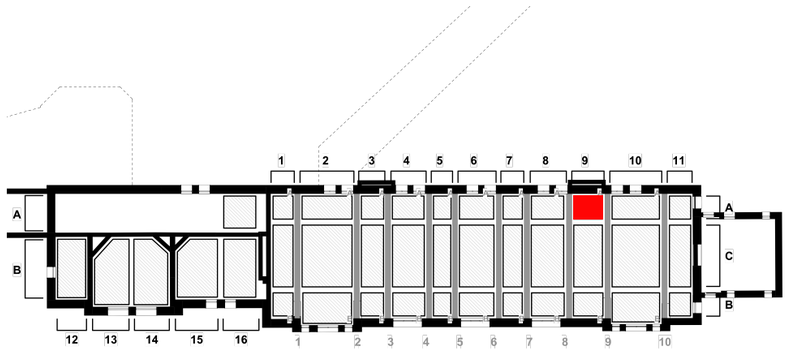
9A

Large area of material loss. Evidence of splice repairs to rafters and wall plate.

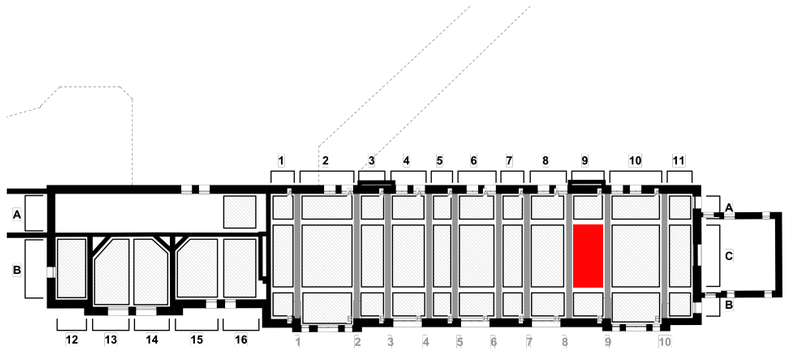
9C

Minor surface damage.

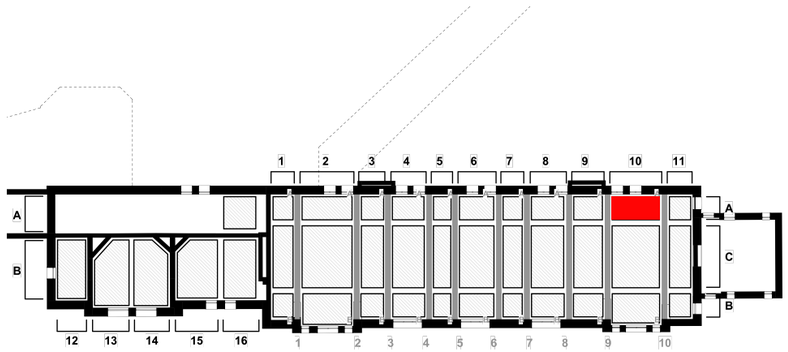
10A

Small areas of loss.

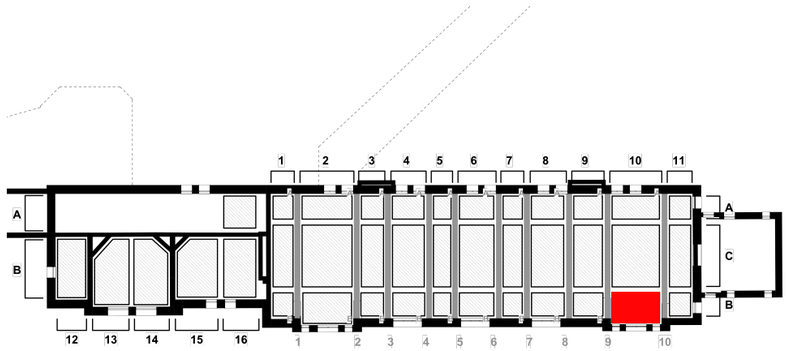
10B

Area of loss to truss foot.

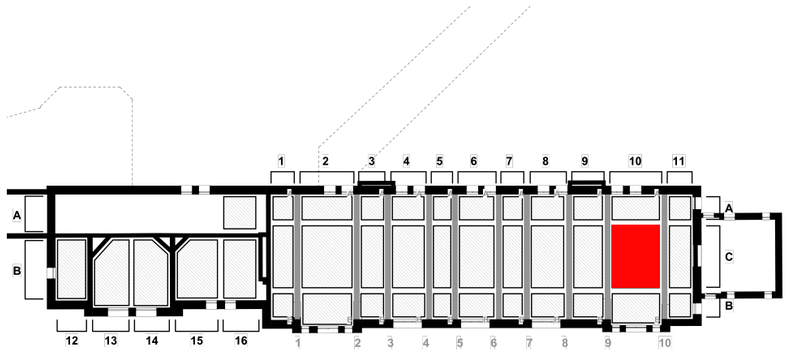
10C

Larger hold created by redundant services.
