4259-05 / JH / A

LAND OFF LATHBURY LANE, HARPURHEY – COVER SYSTEM AND GROUND GAS PROTECTION MEASURES VALIDATION REPORT

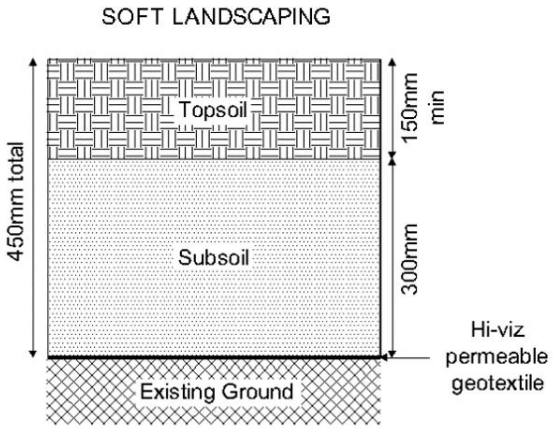
The cover system for the soft landscaping is to be 450mm thick and consist of:

- A minimum of 150mm suitable topsoil, underlain by;
- Suitable subsoil, to a total thickness of 450mm.

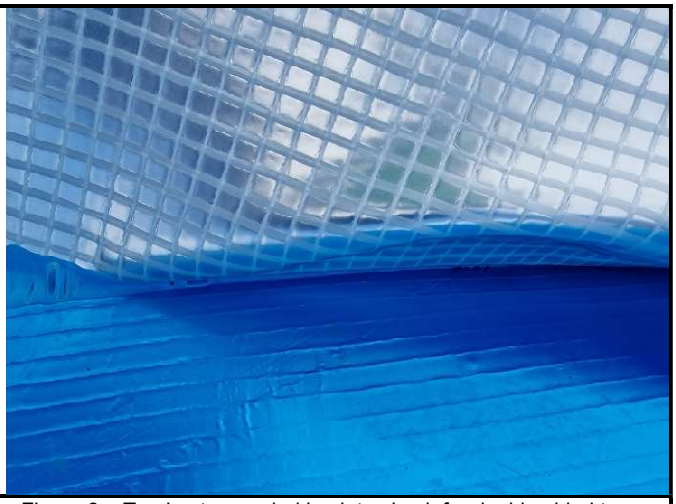
Figure 7 -- Top lap tape ealed back to check for double sided tape.

Figure 8 – Top lap tape ealed back to check for double sided tape

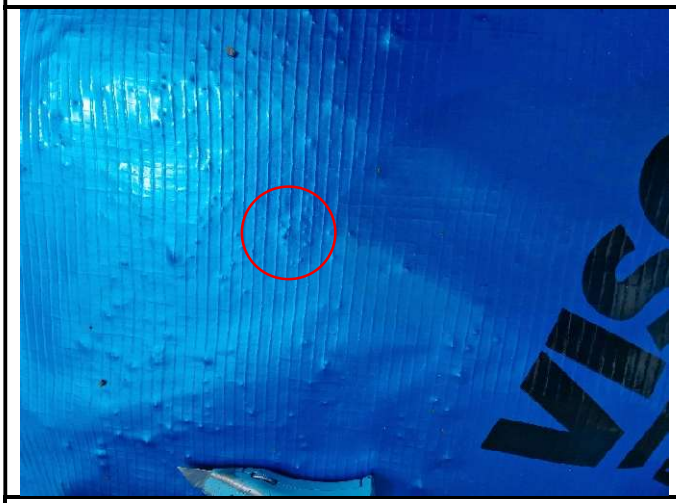
Figure 10 – Nibs and corners sealed with Visqueen Pro Detail Tape

Figure 11 – Small area of damage <2mm

Figure 12 – Repair to damage in Fig 11
