Project
Education North: Undergraduate Building

Address
Manchester Royal Informary University Hospital
Nelson Street, Chorlton-on-Medlock, Manchester

Drawing Title
Fabric Repairs - East Elevation as Existing (Sheet 1 of 2)

Department No:	Drg No.	Revision	Sheet Size
MAN	L(02)202	P01	1 : 50
Aims No. 2025 / 02 / 0015			Drawing Status PLANNING
Drawn By S.Wardle	Checked By C.Latham		Date 21/06/2026 22:23:38

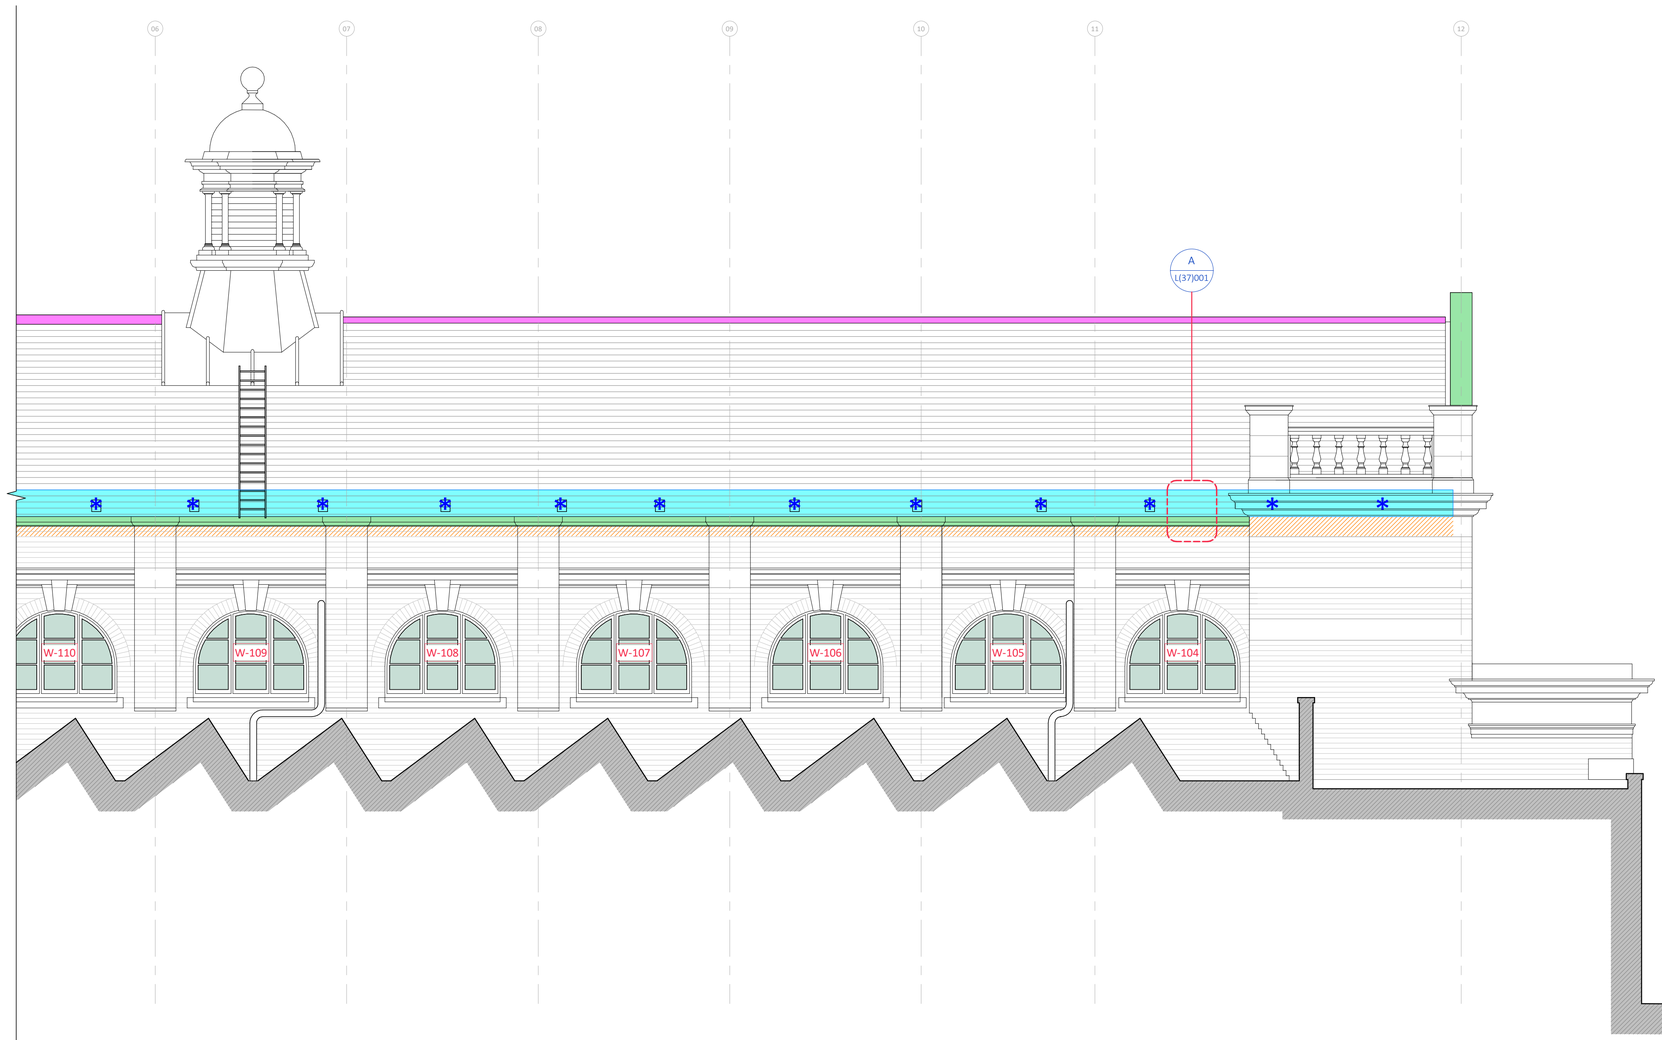
Fabric Repairs_East Elevation (Right)

Slipped/Damaged Slate. Replacement with new blue/grey Welsh slate. 500x300mm, County (7mm) grade thickness.
*- see Restoration Specification **RS11**.*

Carefully remove and replace existing slates. Allowance to replace any broken slates with New blue/grey Welsh slate. 500x300mm, County (7mm) grade thickness.
*- see Restoration Specification **RS11**.*

Code 6 stepped taped lead lined parapet gutter @ 1:80 fall.
*- see Restoration Specification **RS12**.*

Carefully remove existing ashlar coping stone to facilitate the replacement of the parapet gutter. Remove any vegetation and wooded growth between joints. Rebed coping stones on hydraulic lime mortar bed with Code 4 lead soaker.
*- see Restoration Specification **RS4**, **RS5, RS9** and **RS12**.*

Carefully remove and rebed existing Ridge Tile with Hydraulic Mortar.
*- see Restoration Specification **RS4**.*

Existing Loggia roof to be replaced with IKO Permaphalt Asphalt Roofing Systems
*- see Restoration Specification **RS13**.*

* Existing plastic cowel roof vent to be replaced with Just Lead Standard Roof Vent *- see Restoration Specification **RS11.6**.*

Repoint areas of missing pointing in Hydraulic Lime Mortar
*- see Restoration Specification **RS04**.*

W-### Redecorate Window. Undertake timber repairs where necessary upon closer inspection by CA.
*- see Restoration Specification **RS15**.*

Redecorate Rainwater Goods
*- see Restoration Specification **RS14**.*
