Project
Education North: Undergraduate Building

Drawing Title
Fabric Repairs - East Elevation as Existing (Sheet 2 of 2)

Department No:	Drg No.	Revision	Sheet Size
MAN	L(02)203	P01	1 : 50
Aims No. 2025 / 02 / 0015			Drawing Status PLANNING
Drawn By S.Wardle	Checked By C.Latham		Date 21/06/2026 22:23:40

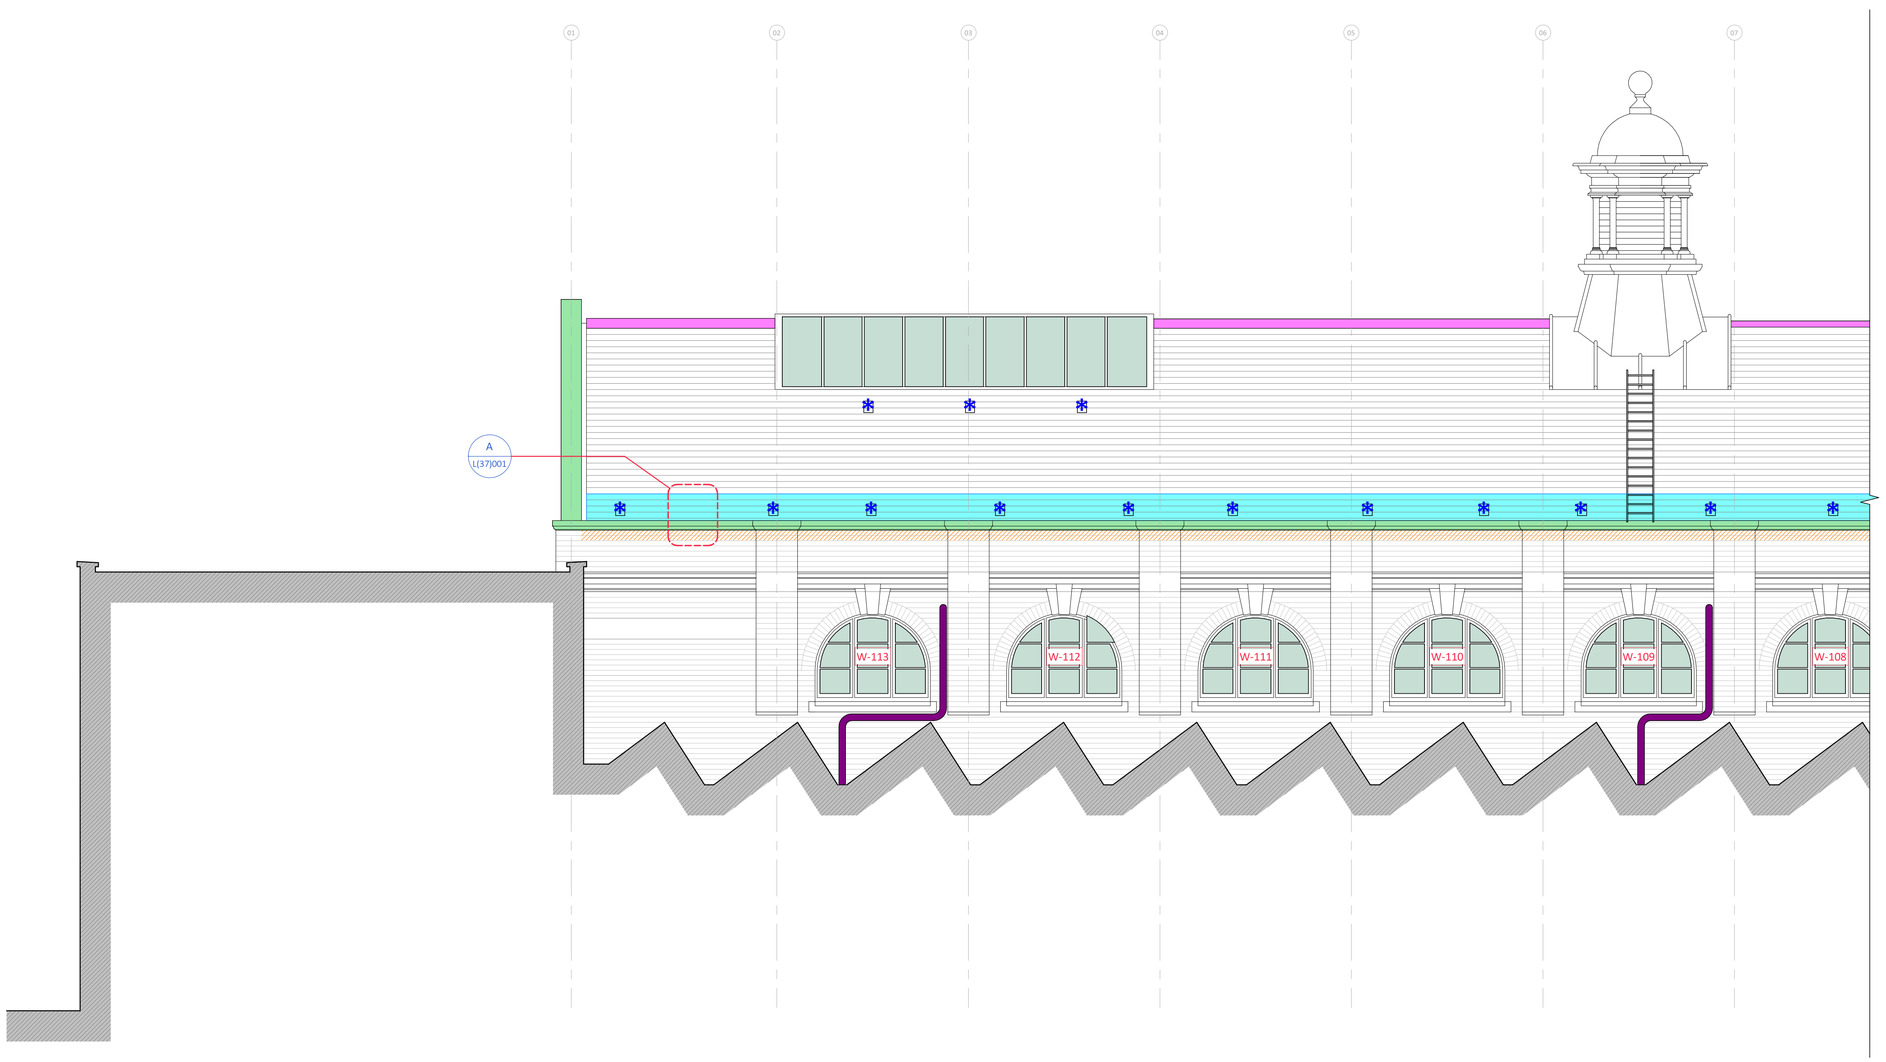
Fabric Repairs_East Elevation (Left) as Existing

Slipped/Damaged Slate. Replacement with new blue/grey Welsh slate. 500x300mm, County (7mm) grade thickness.
- *see Restoration Specification* ***RS11***.

Carefully remove and replace existing slates. Allowance to replace any broken slates with New blue/grey Welsh slate. 500x300mm, County (7mm) grade thickness.
- *see Restoration Specification* ***RS11***.

Code 6 stepped taped lead lined parapet gutter @ 1:80 fall.
- *see Restoration Specification* ***RS12***.

Carefully remove existing ashlar coping stone to facilitate the replacement of the parapet gutter. Remove any vegetation and wooded growth between joints. Rebed coping stones on hydraulic lime mortar bed with Code 4 lead soaker.
- *see Restoration Specification* ***RS4, RS5, RS9 and RS12***.

Carefully remove and rebed existing Ridge Tile with Hydraulic Mortar.
- *see Restoration Specification* ***RS4***.

Existing Loggia roof to be replaced with IKO Permaphalt Asphalt Roofing Systems
- *see Restoration Specification* ***RS13***.

* Existing plastic cowel roof vent to be replaced with Just Lead Standard Roof Vent - *see Restoration Specification* ***RS11.6***.

Repoint areas of missing pointing in Hydraulic Lime Mortar
- *see Restoration Specification* ***RS04***.

W-### Redecorate Window. Undertake timber repairs where necessary upon closer inspection by CA.
- *see Restoration Specification* ***RS15***.

Redecorate Rainwater Goods
- *see Restoration Specification* ***RS14***.
