Project
Education North: Undergraduate Building

Address
Manchester Royal Informary University Hospital
Nelson Street, Chorlton-on-Medlock, Manchester

Drawing Title
Fabric Repairs - West Elevation as Existing (Sheet 1 of 2)

Department No:	Drg No.	Revision	Sheet Size
MAN	L(02)205	P01	1 : 50
Aims No. 2025 / 02 / 0015			Drawing Status PLANNING
Drawn By S.Wardle	Checked By C.Latham		Date 21/06/2026 22:23:44

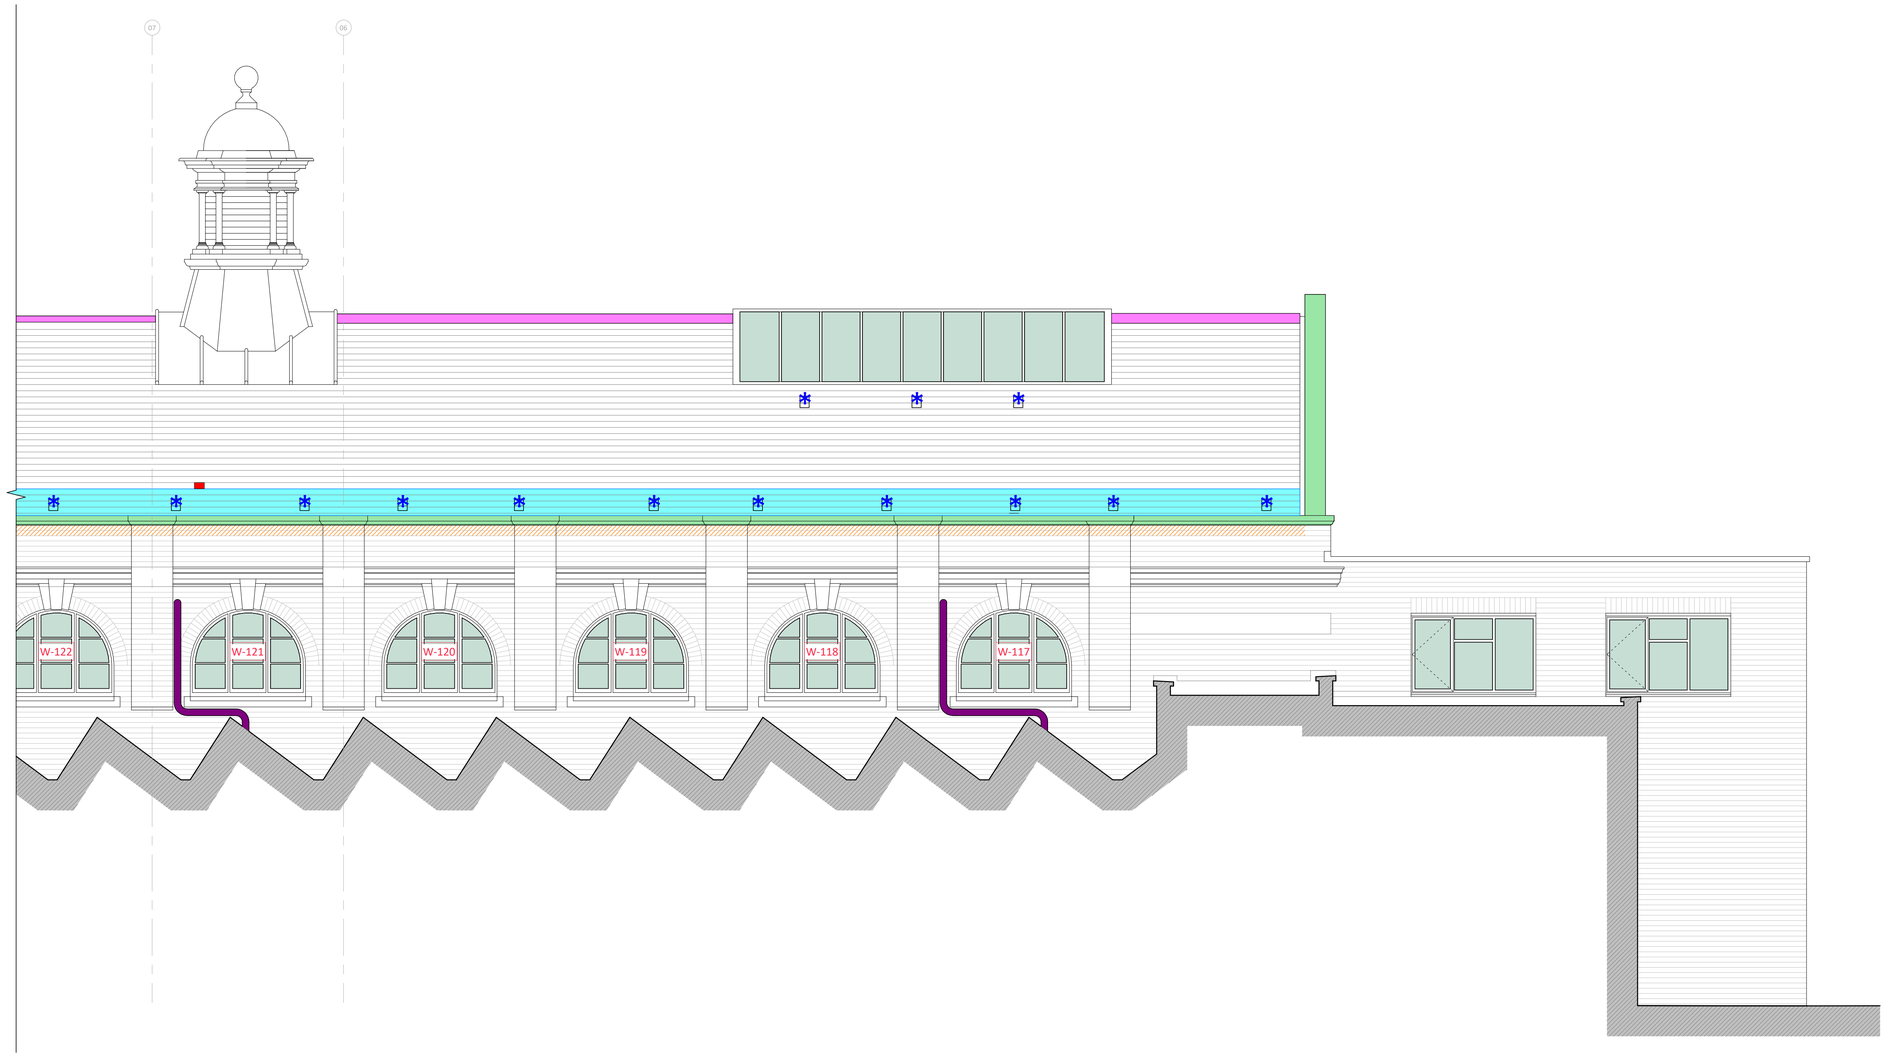
Fabric Repairs_West Elevation (Right) as Existing

- Slipped/Damaged Slate. Replacement with new blue/grey Welsh slate. 500x300mm, County (7mm) grade thickness. *- see Restoration Specification **RS11**.*

- Carefully remove and replace existing slates. Allowance to replace any broken slates with New blue/grey Welsh slate. 500x300mm, County (7mm) grade thickness. *- see Restoration Specification **RS11**.*

- Code 6 stepped taped lead lined parapet gutter @ 1:80 fall. *- see Restoration Specification **RS12**.*
- Carefully remove existing ashlar coping stone to facilitate the replacement of the parapet gutter. Remove any vegetation and wooded growth between joints. Rebed coping stones on hydraulic lime mortar bed with Code 4 lead soaker. *- see Restoration Specification **RS4**, **RS5**, **RS9** and **RS12**.*

- Carefully remove and rebed existing Ridge Tile with Hydraulic Mortar. *- see Restoration Specification **RS4**.*
- Existing Loggia roof to be replaced with IKO Permaphalt Asphalt Roofing Systems *- see Restoration Specification **RS13**.*

- * Existing plastic cowel roof vent to be replaced with Just Lead Standard Roof Vent *- see Restoration Specification **RS11.6**.*
- Existing Lightening Protection *- see Restoration Specification **RS11.5**.*

- Repoint areas of missing pointing in Hydraulic Lime Mortar *- see Restoration Specification **RS04**.*
- W-### Redecorate Window. Undertake timber repairs where necessary upon closer inspection by CA. *- see Restoration Specification **RS15**.*

- Redecorate Rainwater Goods *- see Restoration Specification **RS14**.*
