Fabric Repairs_West Elevation (Left) as Existing

Project
Education North: Undergraduate Building

Drawing Title
Fabric Repairs - West Elevation as Existing (Sheet 2 of 2)

Department No:	Drg No.	Revision	Sheet Size
MAN	L(02)206	P01	1 : 50
Aims No. 2025 / 02 / 0015			Drawing Status PLANNING
Drawn By S.Wardle	Checked By C.Latham		Date 21/06/2026 22:23:47

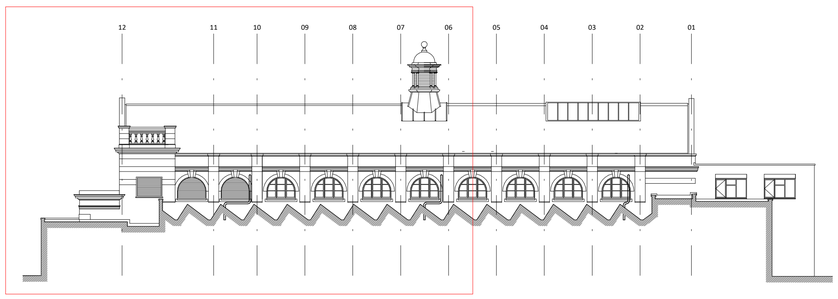
- Slipped/Damaged Slate. Replacement with new blue/grey Welsh slate. 500x300mm, County (7mm) grade thickness. *- see Restoration Specification **RS11**.*

- Carefully remove and replace existing slates. Allowance to replace any broken slates with New blue/grey Welsh slate. 500x300mm, County (7mm) grade thickness. *- see Restoration Specification **RS11**.*

- Code 6 stepped taped lead lined parapet gutter @ 1:80 fall. *- see Restoration Specification **RS12**.*
- Carefully remove existing ashlar coping stone to facilitate the replacement of the parapet gutter. Remove any vegetation and wooded growth between joints. Rebed coping stones on hydraulic lime mortar bed with Code 4 lead soaker. *- see Restoration Specification **RS4**, **RS5**, **RS9** and **RS12**.*

- Carefully remove and rebed existing Ridge Tile with Hydraulic Mortar. *- see Restoration Specification **RS4**.*
- Existing Loggia roof to be replaced with IKO Permaphalt Asphalt Roofing Systems *- see Restoration Specification **RS13**.*

- * Existing plastic cowel roof vent to be replaced with Just Lead Standard Roof Vent *- see Restoration Specification **RS11.6**.*
- Existing Lightening Protection *- see Restoration Specification **RS11.5**.*

- Repoint areas of missing pointing in Hydraulic Lime Mortar *- see Restoration Specification **RS04**.*
- W-### Redecorate Window. Undertake timber repairs where necessary upon closer inspection by CA. *- see Restoration Specification **RS15**.*

- Redecorate Rainwater Goods *- see Restoration Specification **RS14**.*
