Jersey Wharf, Ancoats

Remediation Verification Report

Curtins Ref: 077879-CUR-XX-XX-T-GE-00005

Client Name: John Sisk & Son Ltd

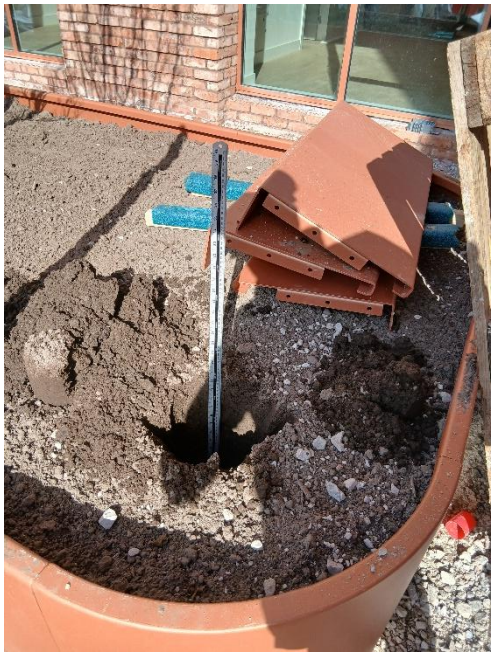
Hole: TP103

Photographic Record: Capping Layer Depth Validation

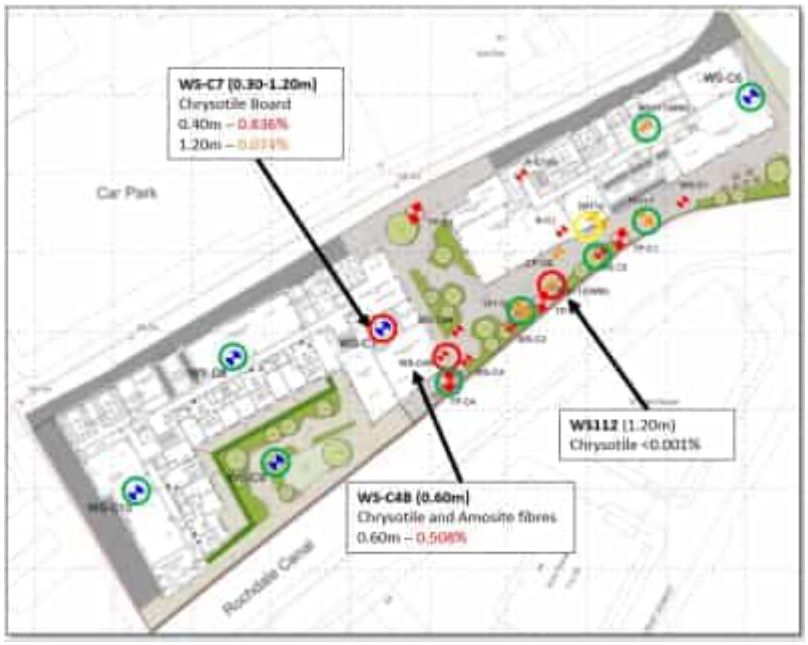
Figure 1 – Asbestos Distribution

The laboratory testing results are shown on Drawing DBR-JW-AMP-001 (see Figure 1). Three areas have been defined where asbestos is anticipated in greater concentrations and permit to dig/RAMS will be required prior to intrusive works in these areas.

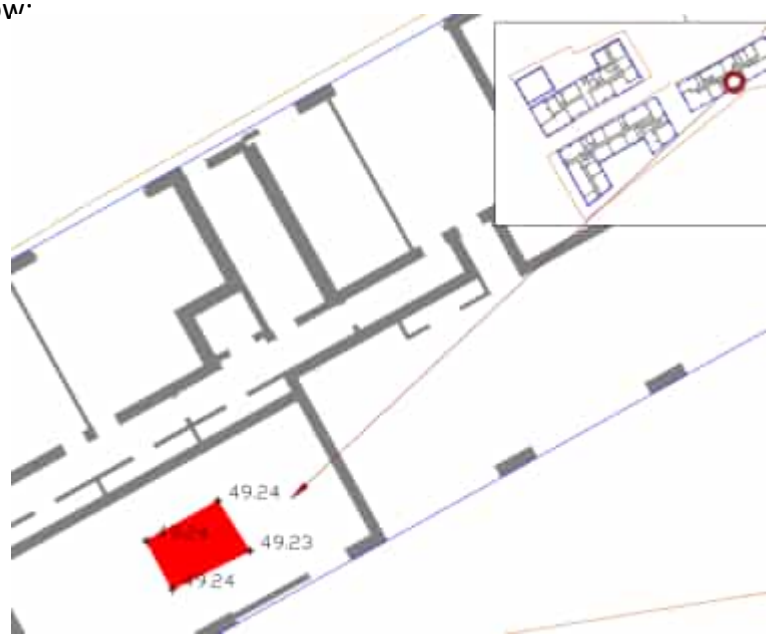
DB Remediation provided a validation report which stated that during groundworks at Jersey Wharf, an in-ground concrete structure was encountered, and upon breaking the concrete a steel underground storage tank (UST) was encased within the concrete. The tank was exposed and was found to contain fuel oil. DB Remediation produced a discovery strategy for unknown contamination, the safe decommissioning and validation of the tank. Validation was completed and a hotspot record was produced, contained within *Appendix E*.

The location of the UST and the subsequent validated excavation is shown on the screenshot of the DBR survey below:

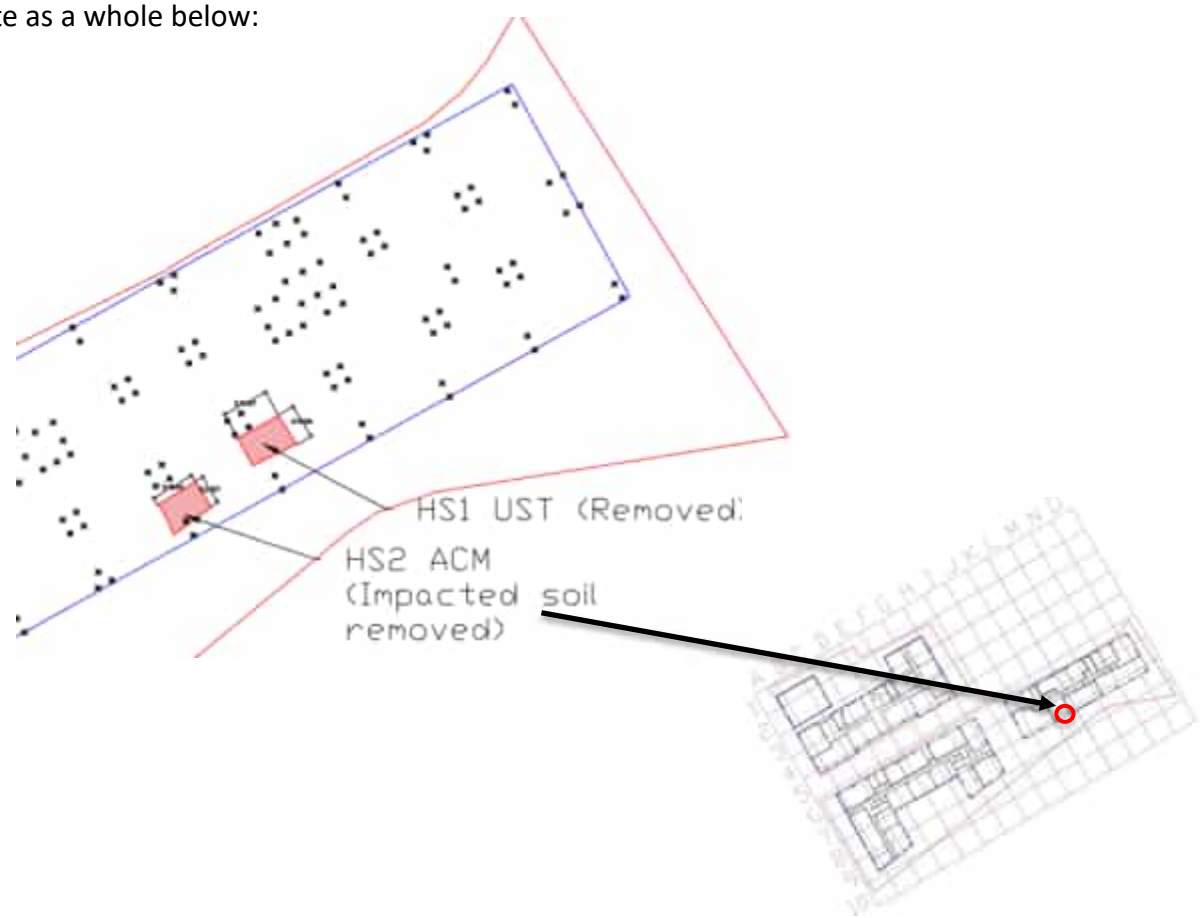
The location of HS2 is shown on the screenshot of the DBR produced Relic Survey Drawing relative to the site as a whole below:

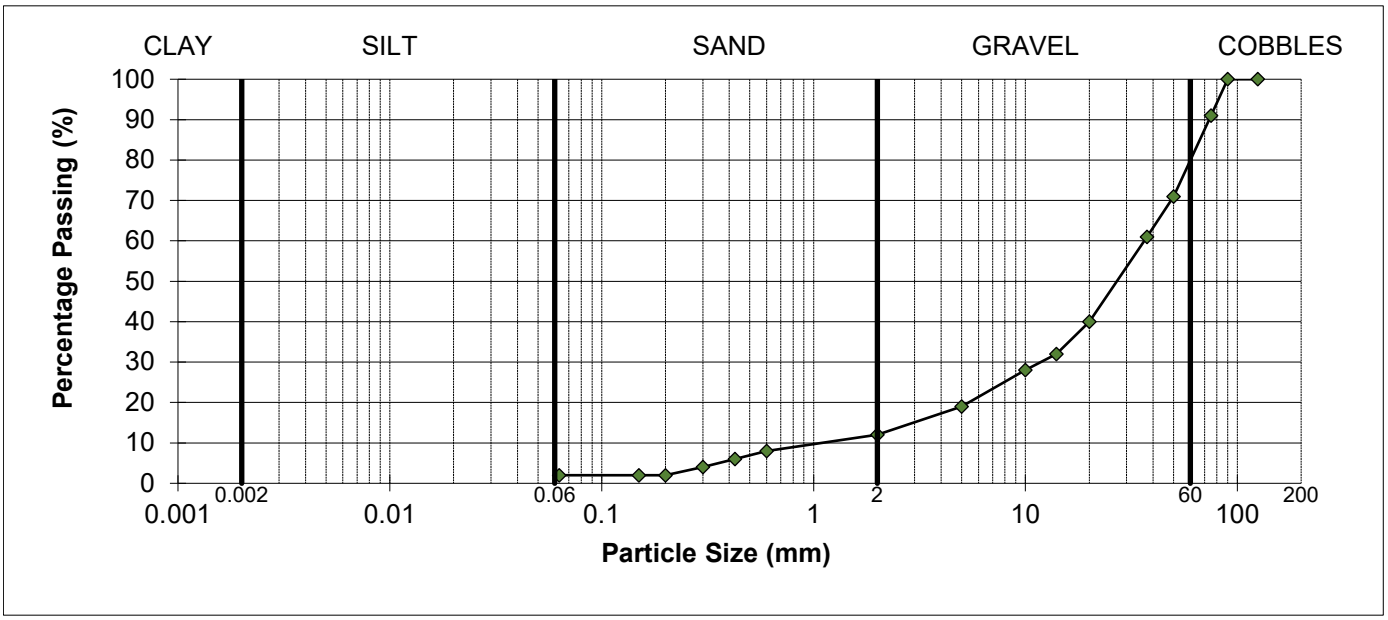
REMARKS
Sample complies with the advised grading specification for a 6F2 material (SHW 2016)
As received water content = 9.4%

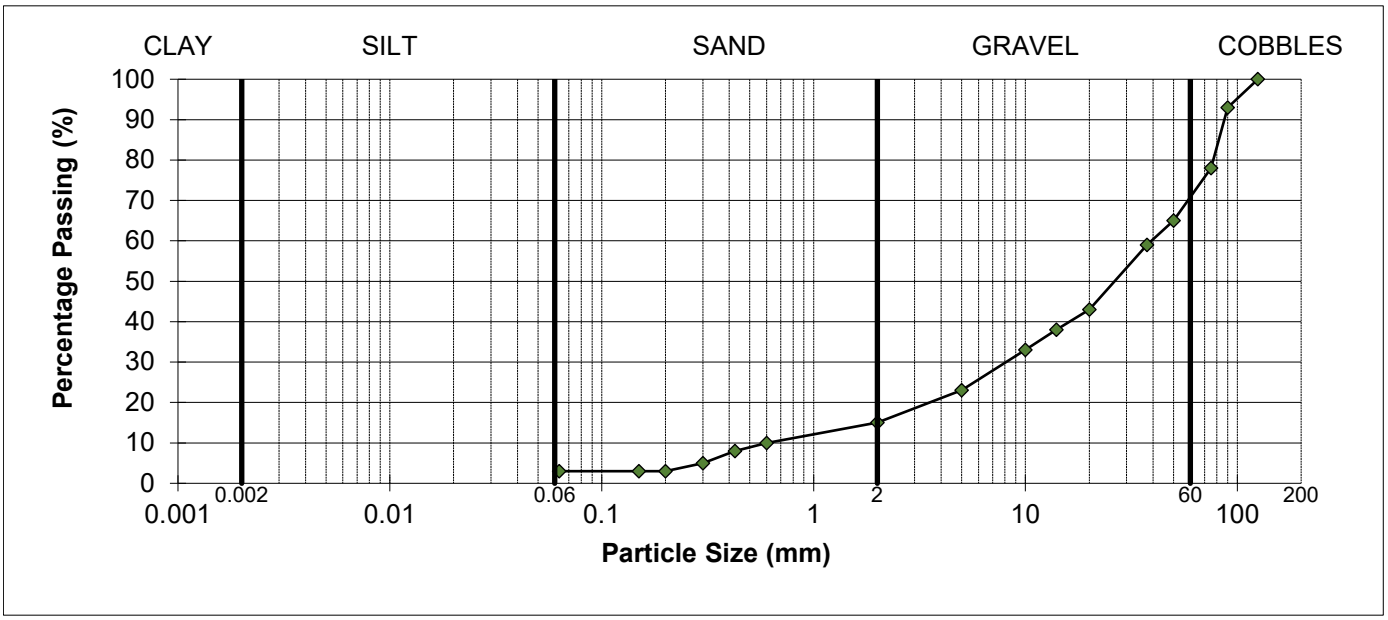
REMARKS
Sample complies with the advised grading specification for a 6F2 material (SHW 2016)
As received water content = 10.9%

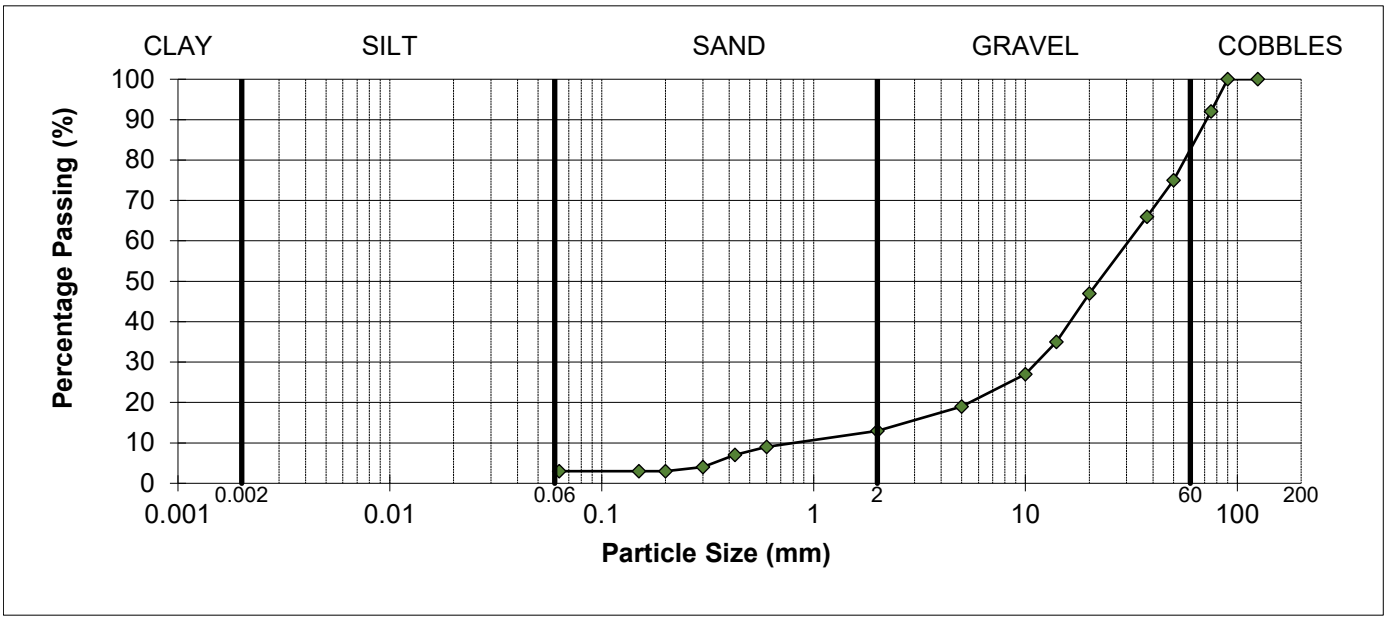
REMARKS
Sample complies with the advised grading specification for a 6F2 material (SHW 2016)
As received water content = 10.0%

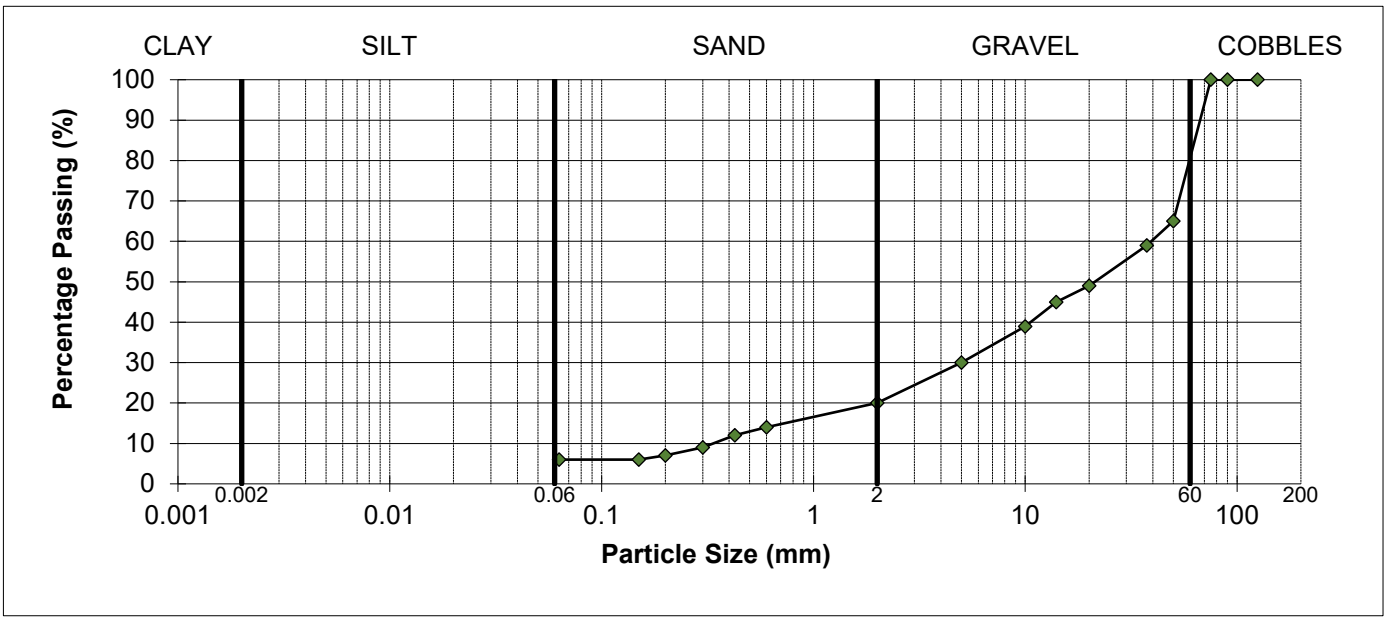
REMARKS
Sample complies with the advised grading specification for a 6F2 material (SHW 2016)
As received water content = 13.4%

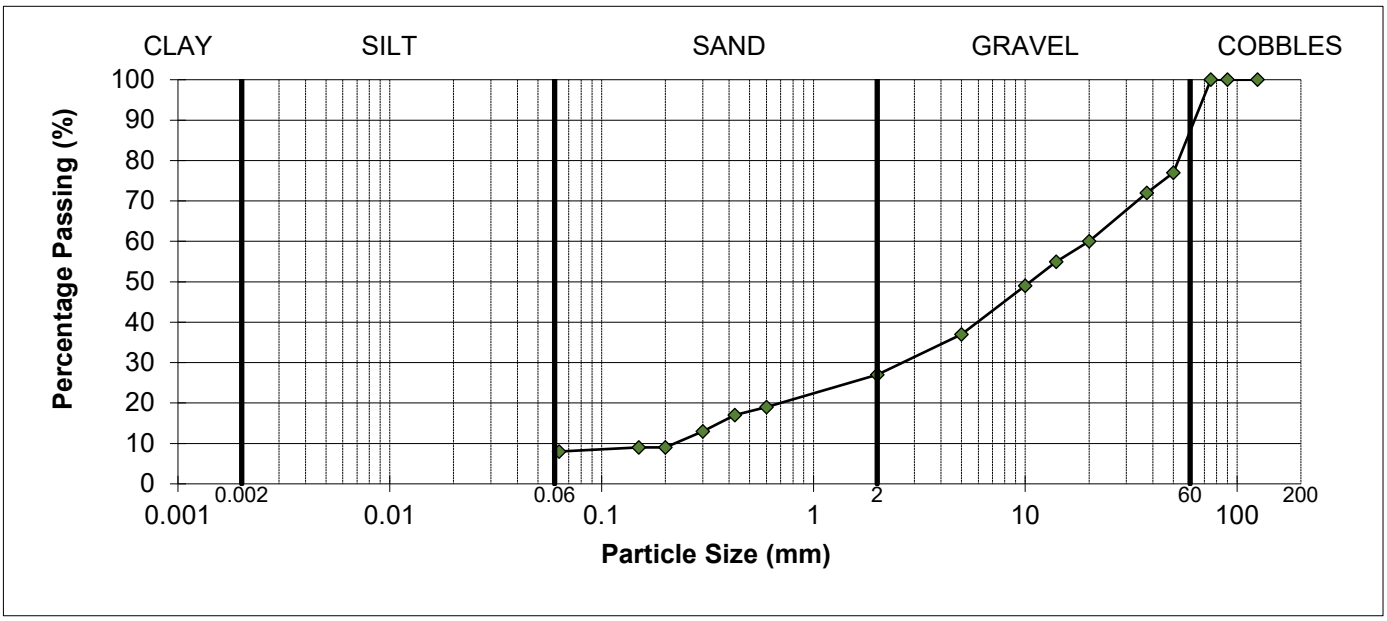
REMARKS
Sample complies with the advised grading specification for a 6F2 material (SHW 2016)
As received water content = 15.2%

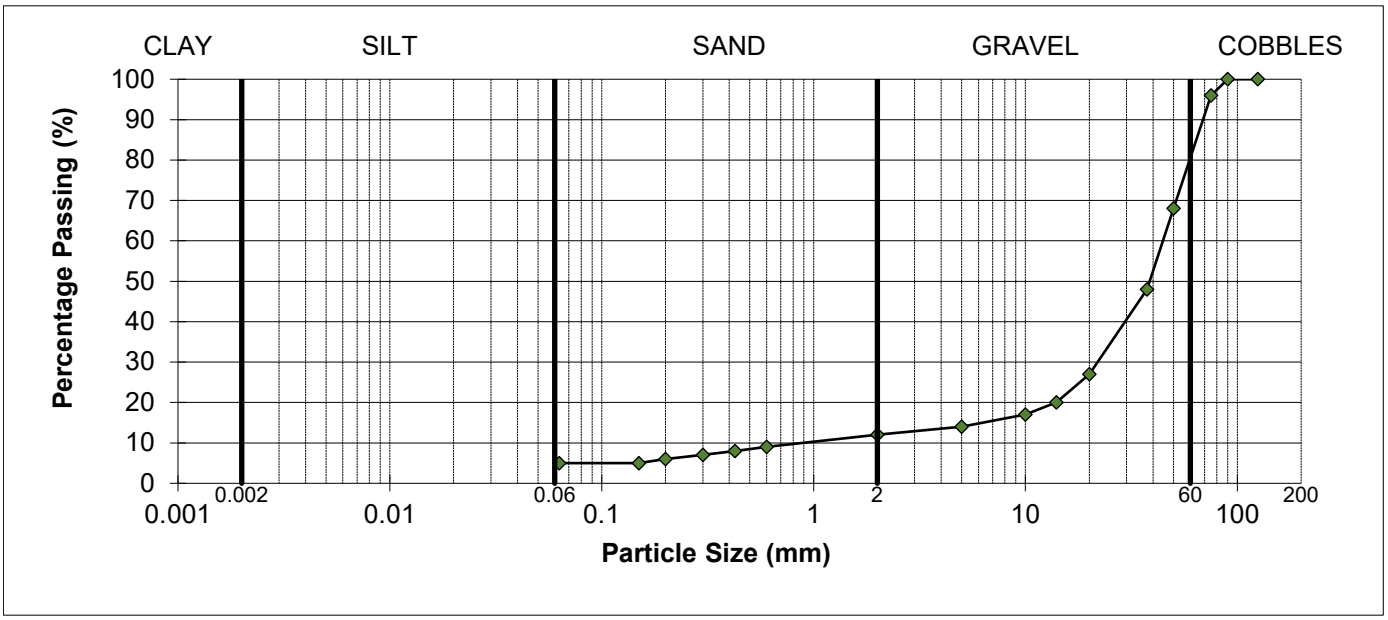
REMARKS
Sample complies with the advised grading specification for a 6F2 material (SHW 2016)

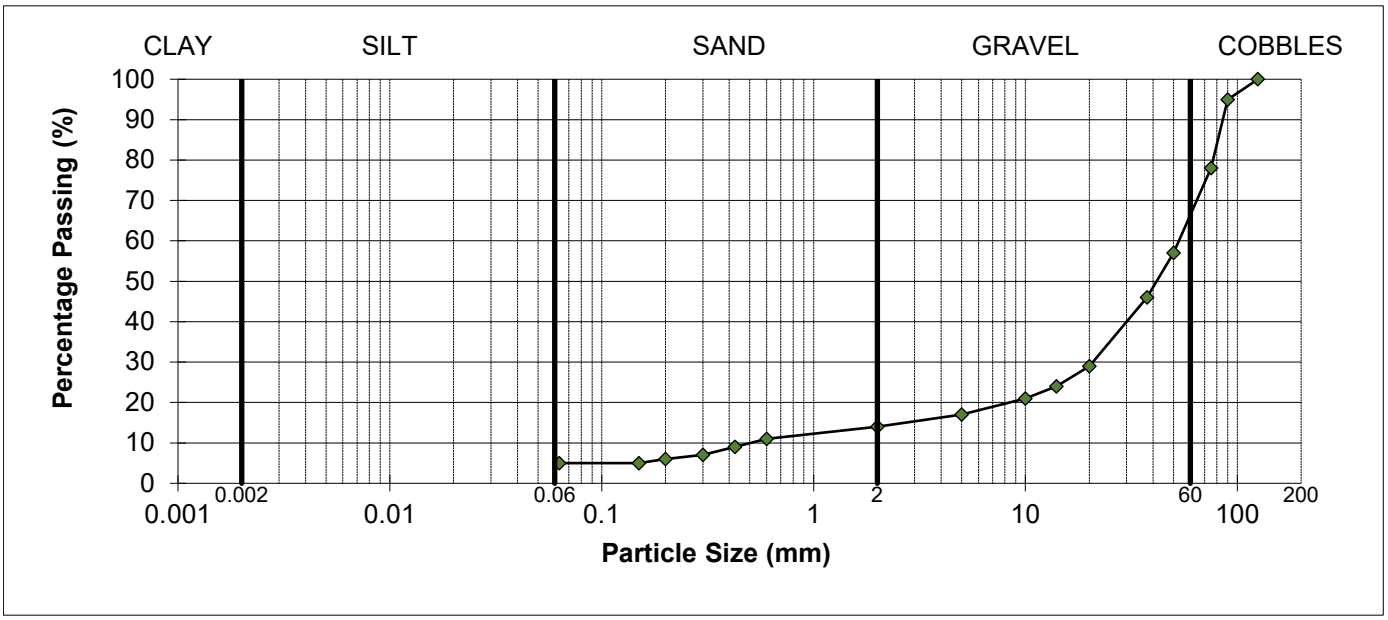
REMARKS
Sample complies with the advised grading specification for a 6F2 material (SHW 2016)

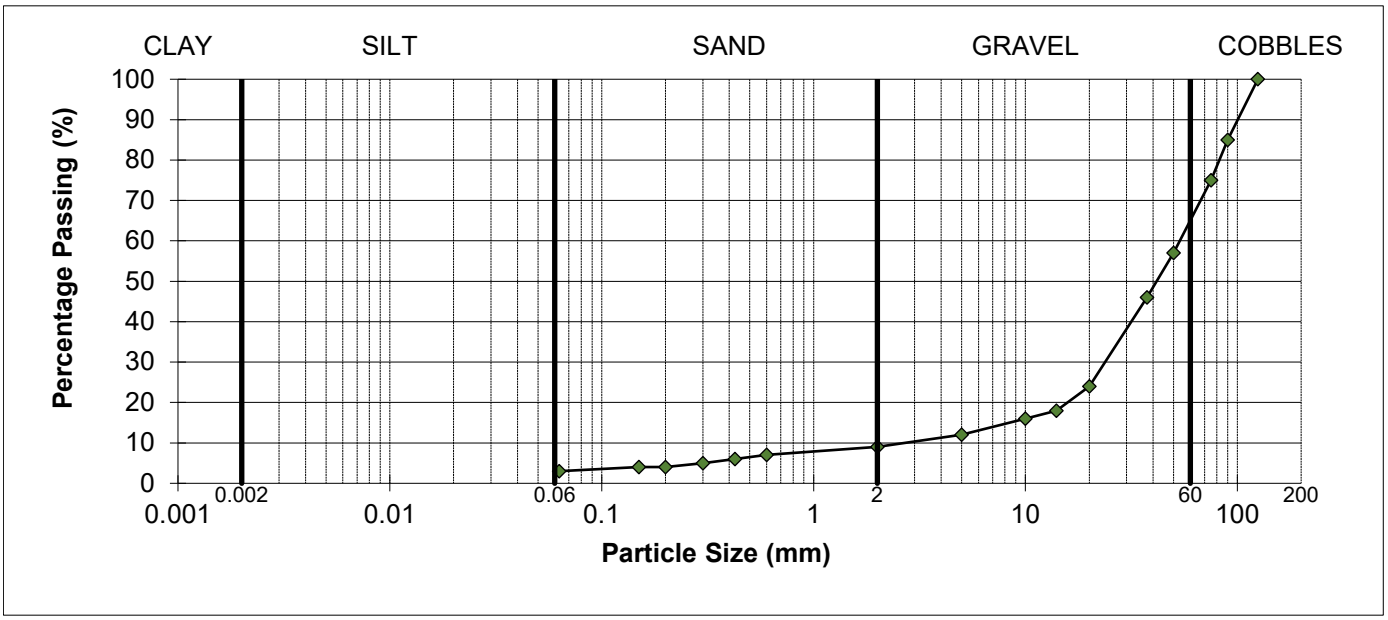
REMARKS
Sample complies with the advised grading specification for a 6F2 material (SHW 2016)
