Land off Crabtree Lane, Manchester

VALIDATION REPORT FOR DEMOLITION, SITE PREPARATION & EARTHWORKS

Project no: BSH2258

Date: 25th March 2026

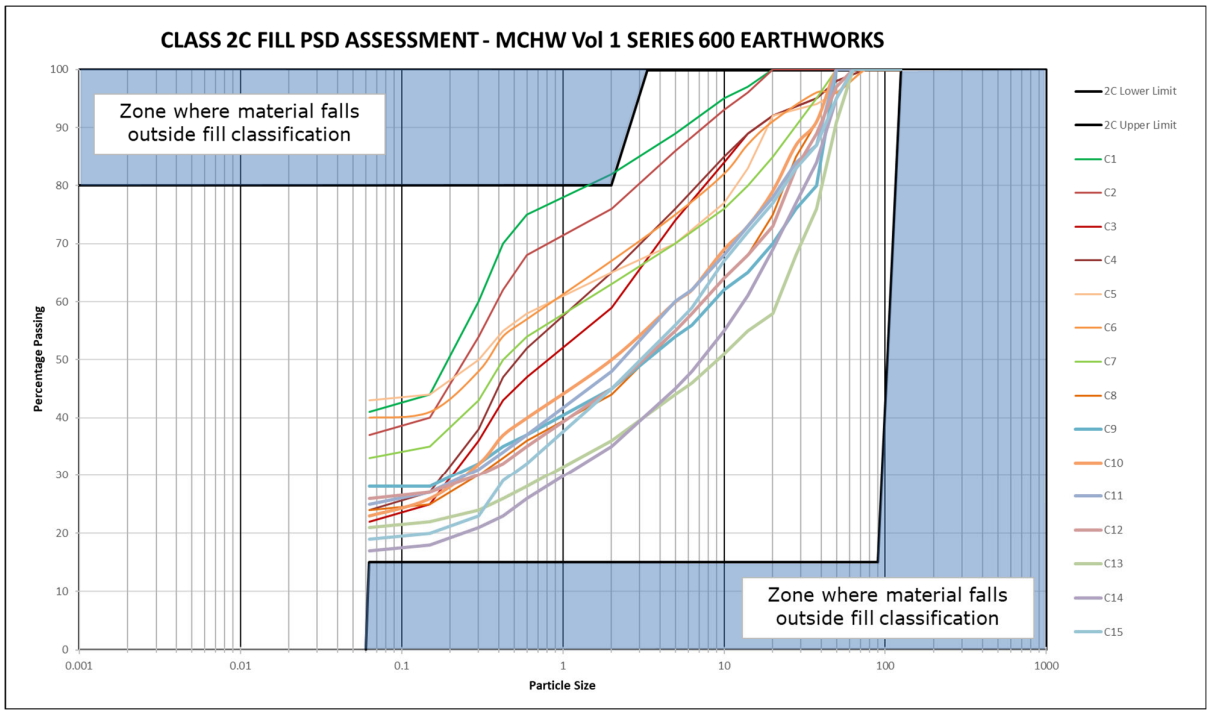
Figure 4.1 PSD Assessment – Class 2C Fill (Made Ground)

PSD tests carried out on samples of the made ground indicate it generally comprises greyish brown slightly gravelly slightly sandy clay with varying degrees of ceramic, brick and made ground. No deleterious materials were noted during the earthworks.

All the soils re-engineered on site are made ground soils. Comparison of the PSD results to the grading requirements presented in Table 6/2 of the 600 Series Earthworks Specification for Highway Works is provided in Figure 4.1.

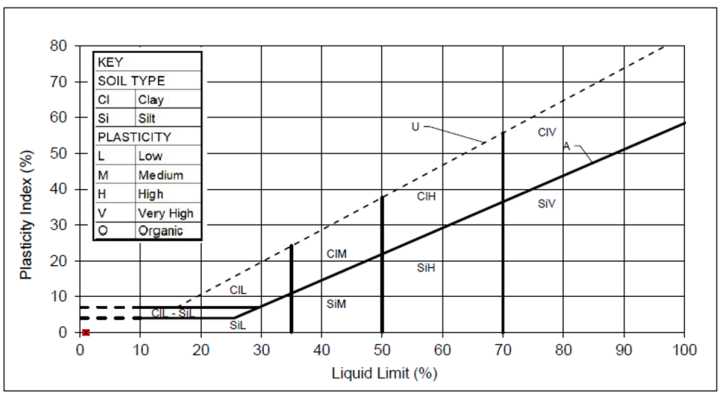
The majority of the made ground tested on site were found to be non-plastic.

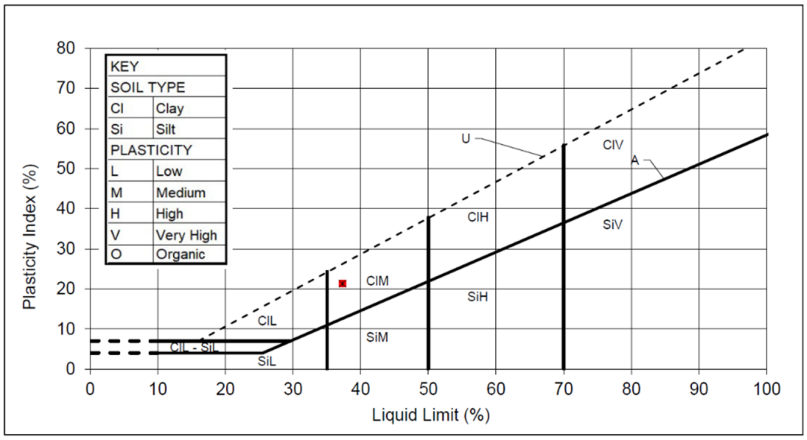
Dependent on the clay content of the made ground at various locations across the site, the made ground was recorded as being medium plasticity.

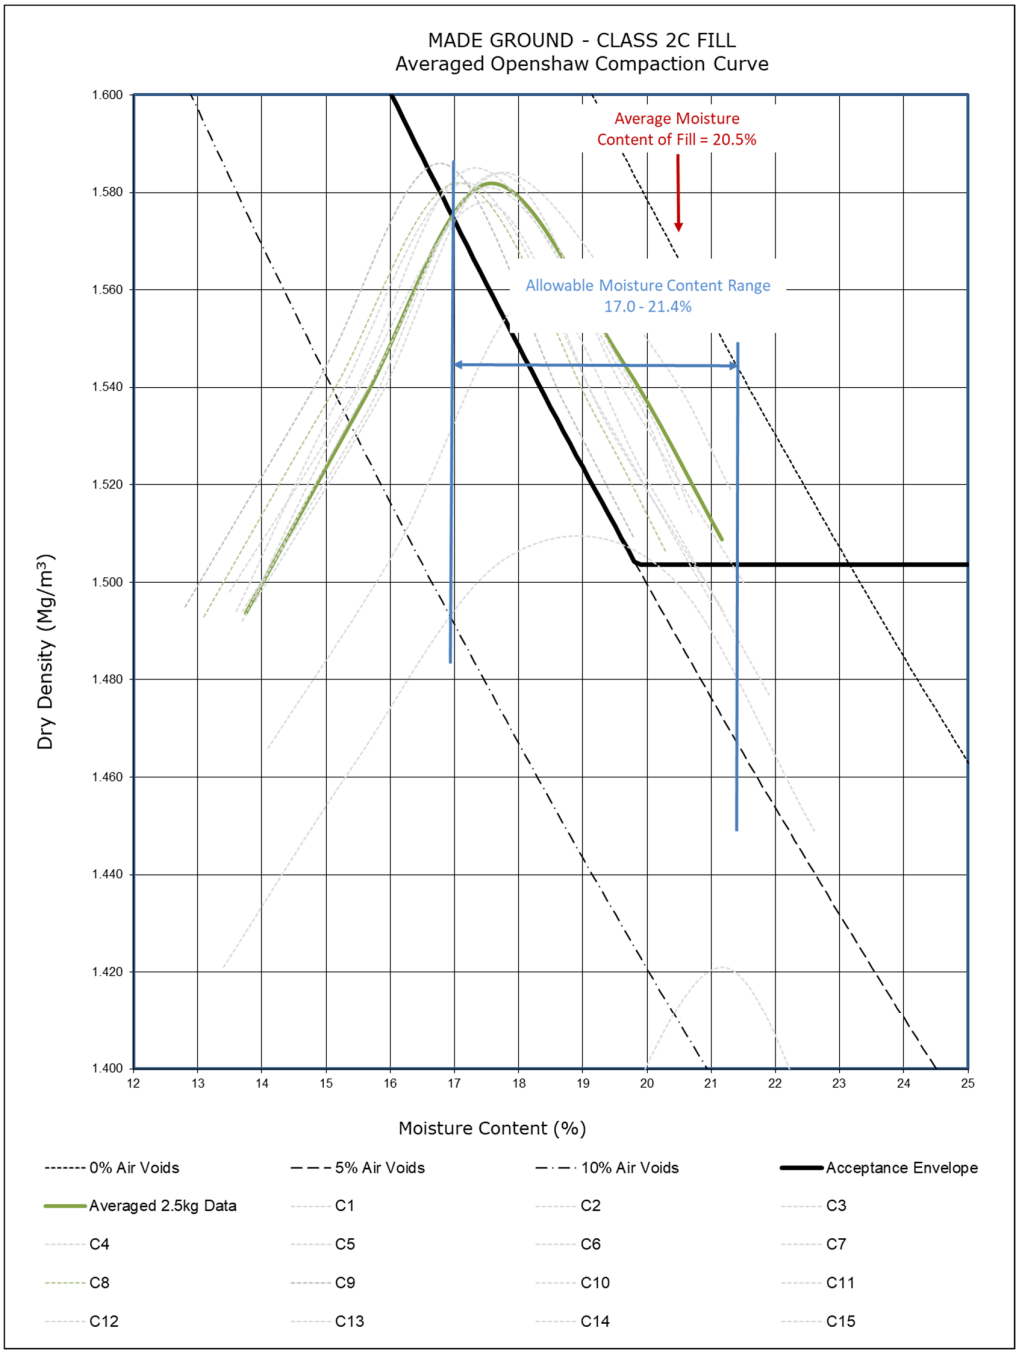
Figure 4.2 Average Compaction Curves

The averaged compaction curve of the made ground is presented in Figure 4.2. *(Note: The compaction curves for each individual sample are presented in light grey to show the potential spread of data relative to the average curve)*.

Comparison of the in-situ moisture contents of the samples to the allowable average moisture content range (AMCR) indicates the made ground was generally slightly wet of the optimum moisture content (OMC).

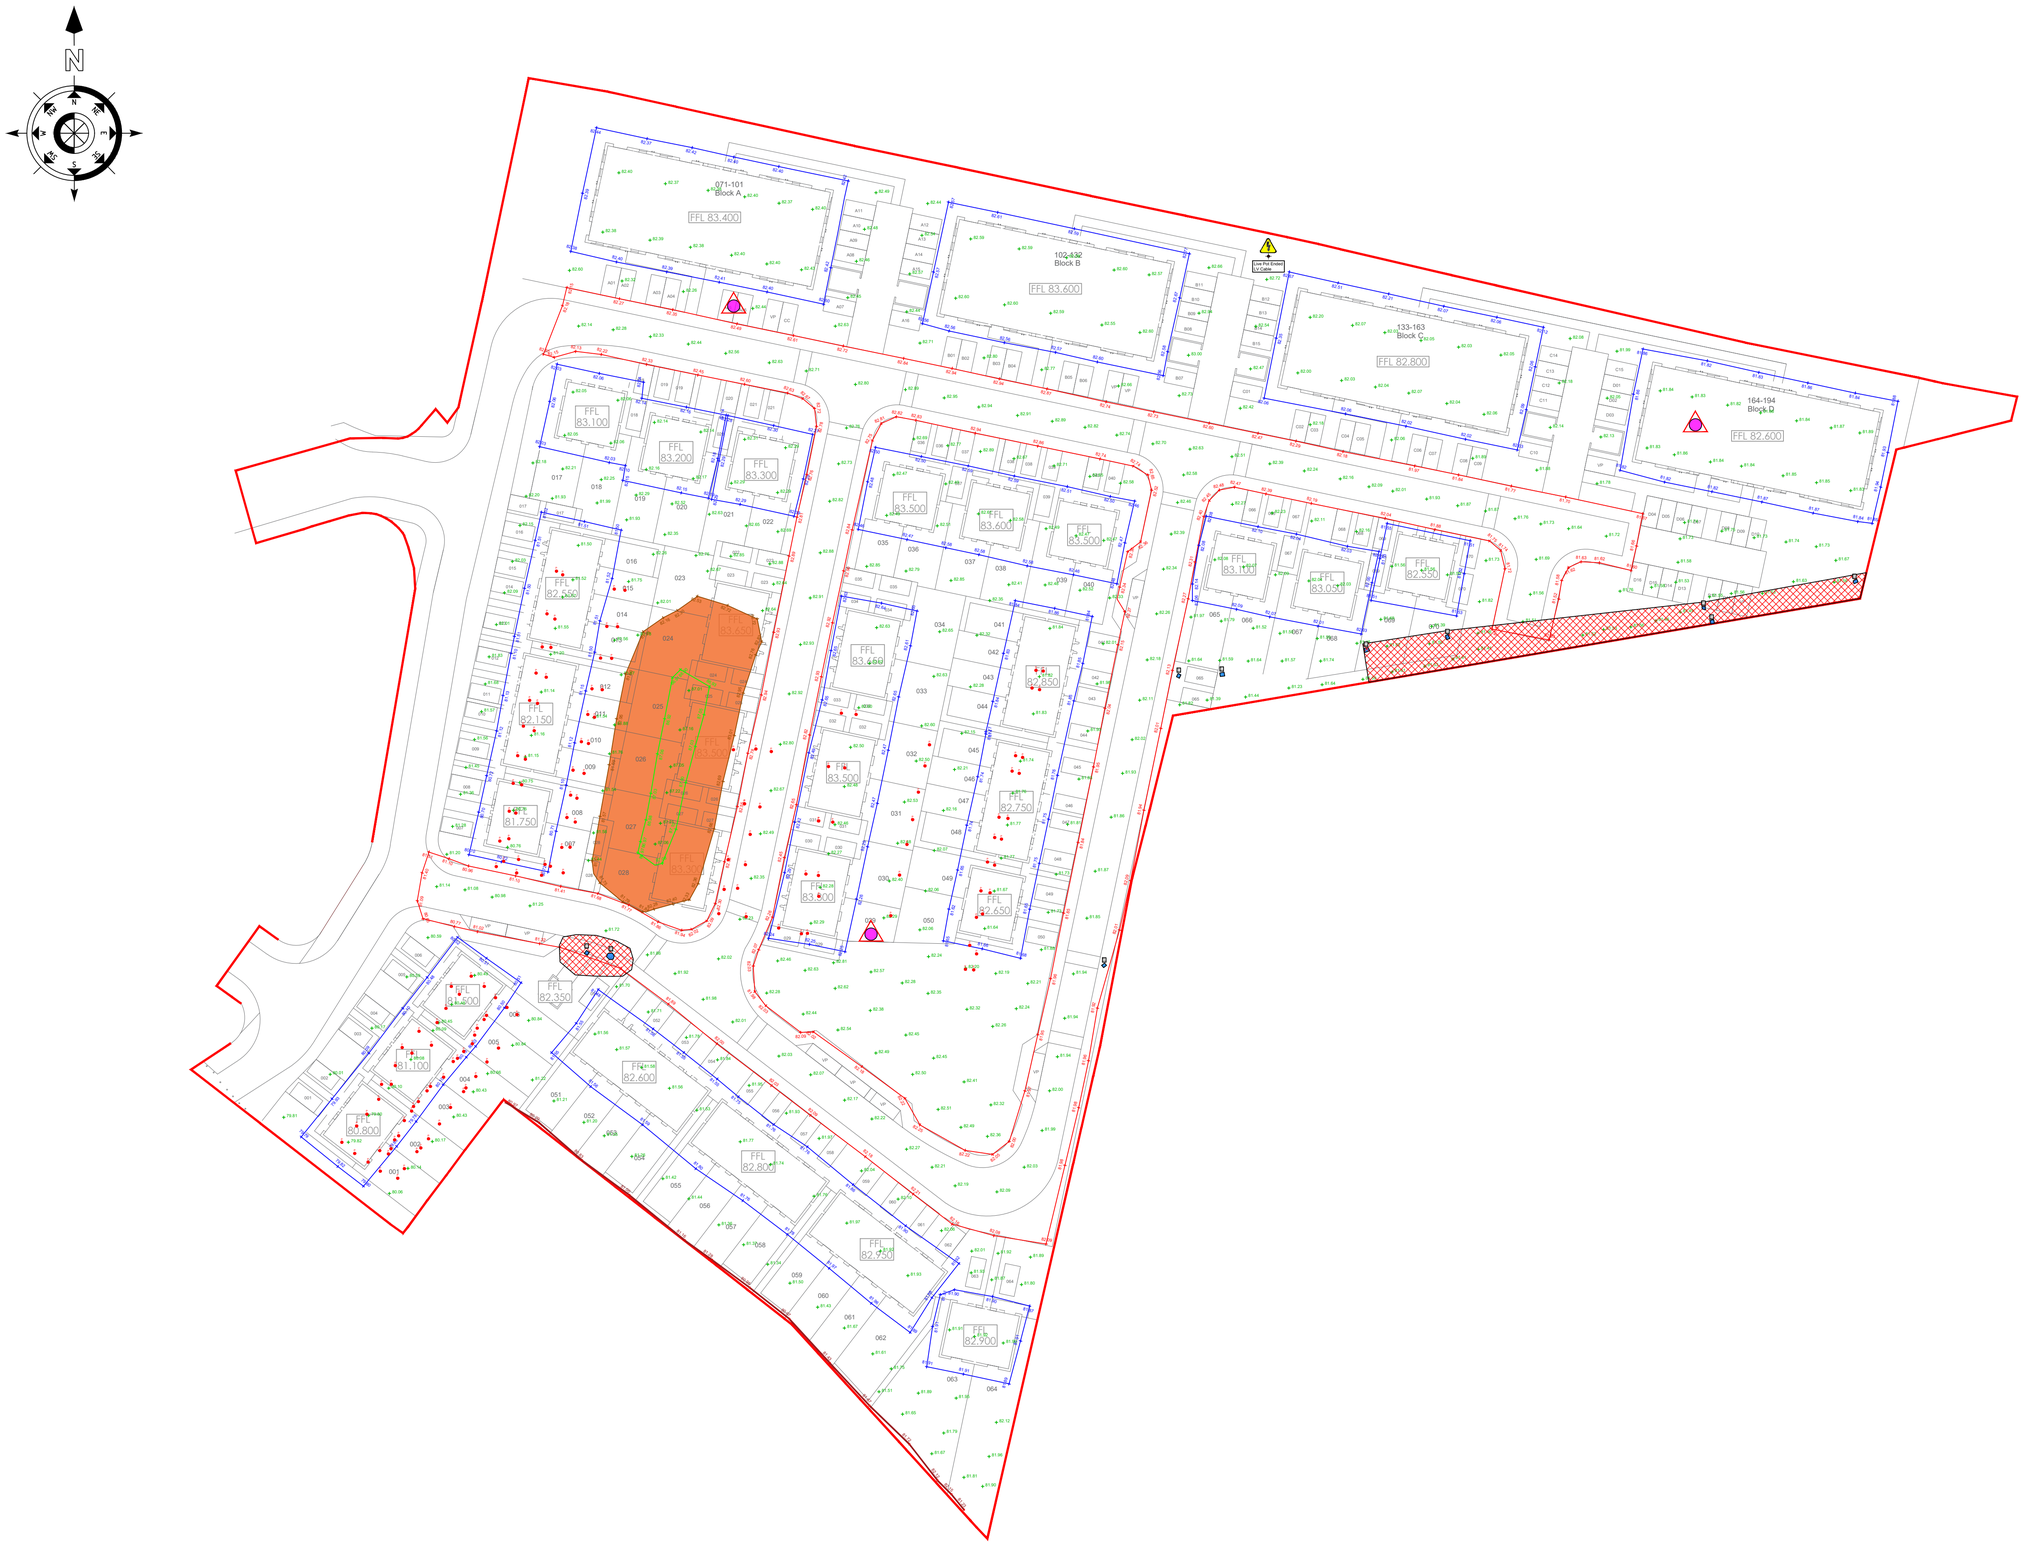
Base of Excavation/Made Ground Survey

During the earthwork's operations building slabs, in-ground obstructions (relic foundations etc.) were encountered and have been removed in their entirety and crushed to produce a 6f2 recycled aggregate for use in the construction phase of the project. The full depth of made ground (base of made ground / top of natural) has been surveyed and shown on Drawing No. BSH2258-009 within Appendix A.

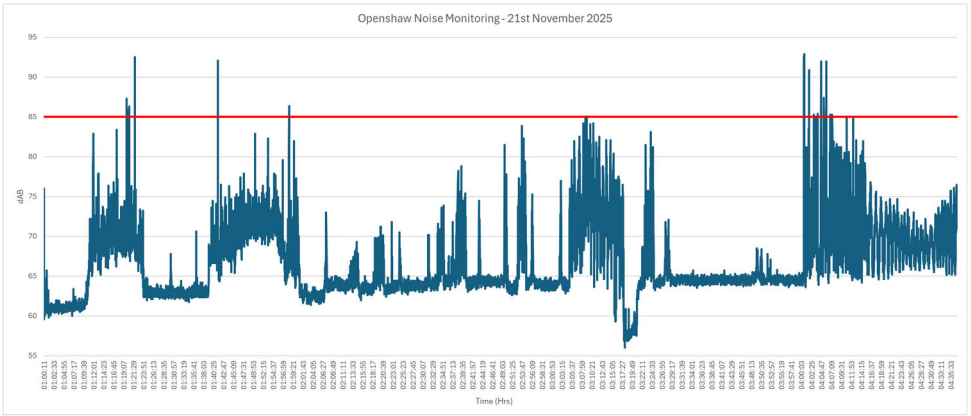
Noise monitoring – site boundary

Average: 66.6 dBA

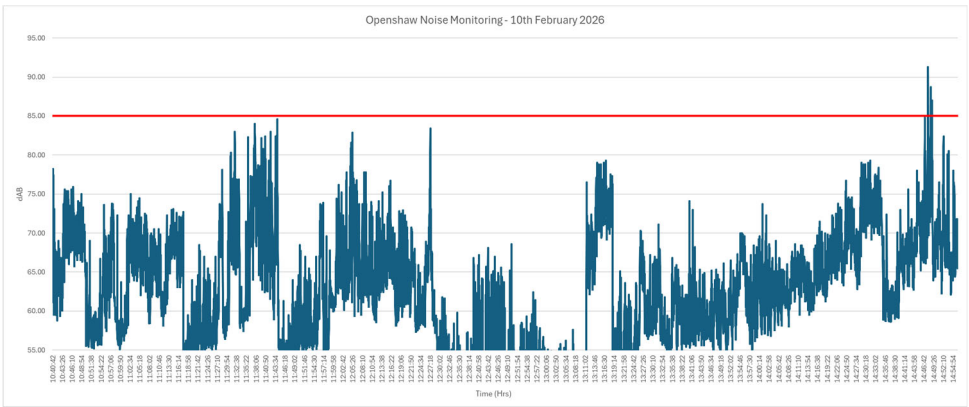
10th February 2026
Crushing in western portion of the site

Average noise level 62.44dBA

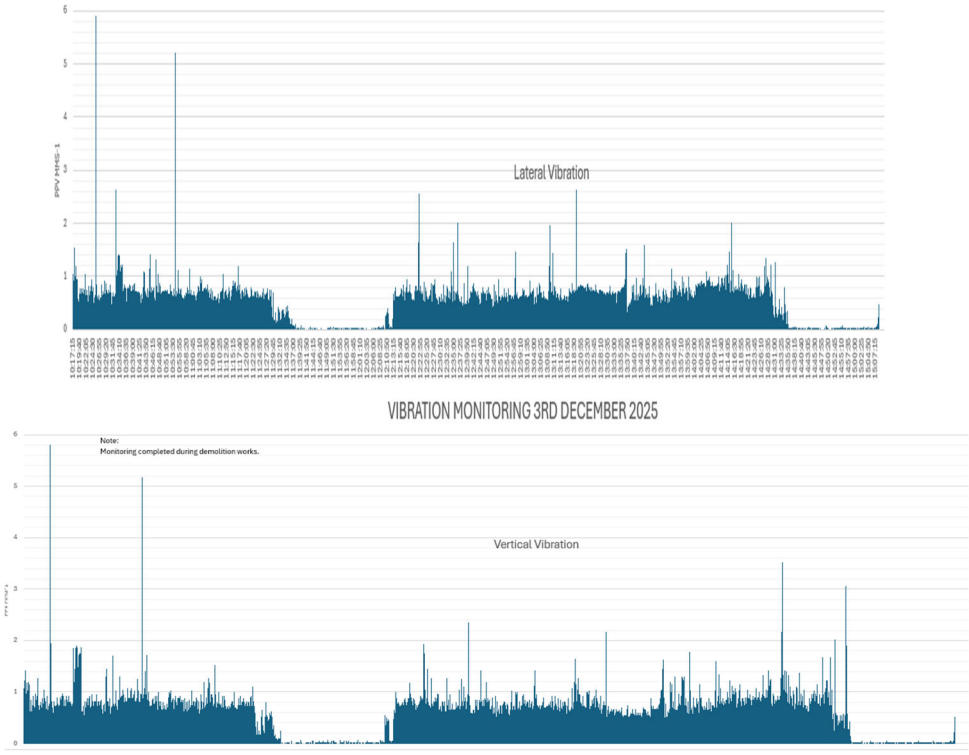
Project	Crabtree Lane, Openshaw	**Project No.**	BSH2258
3rd December 2025 Vibration monitoring undertaken near crushing operations			
3rd December 2025 Vibration Monitoring Data	 Maximum recorded vibration 3.525mm/s

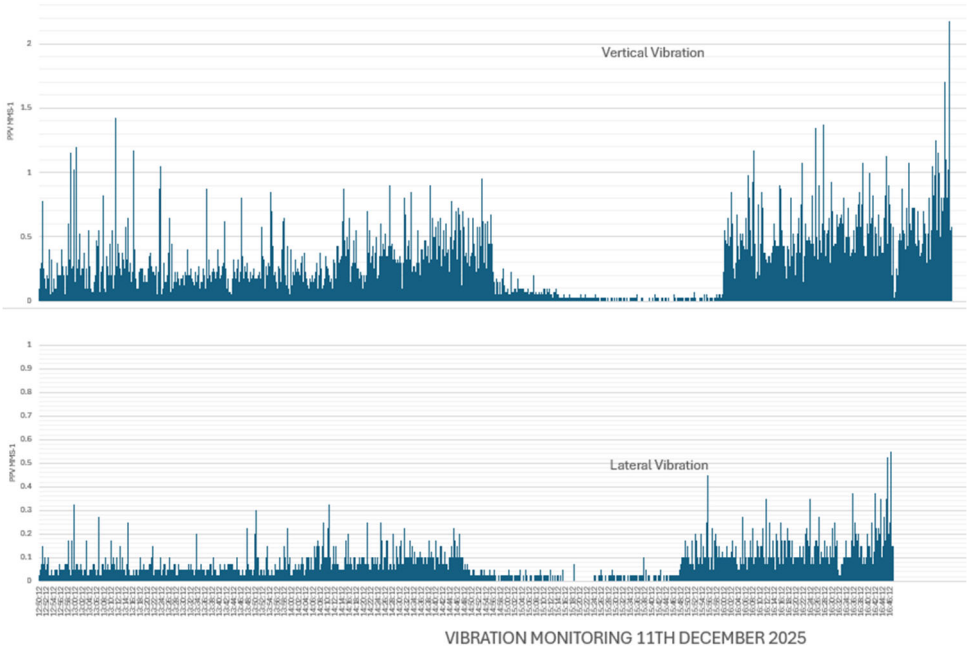
Project	Crabtree Lane, Openshaw	**Project No.**	BSH2258
11th December 2025 Vibration monitoring undertaken near demolition activities			
11th December 2025 Vibration Monitoring Data	 Maximum recorded vibration 2.175mm/s

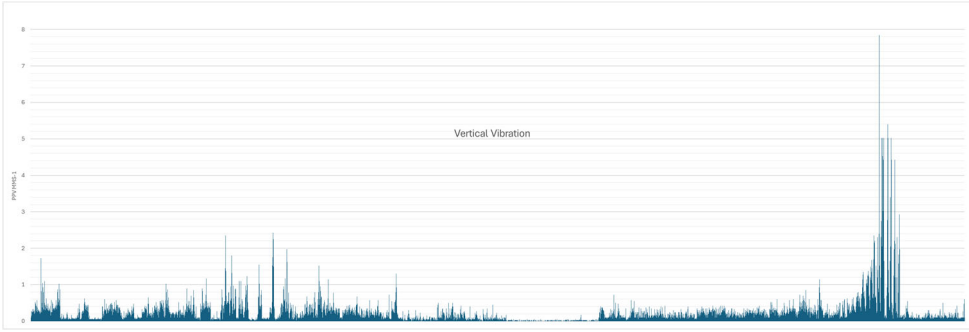
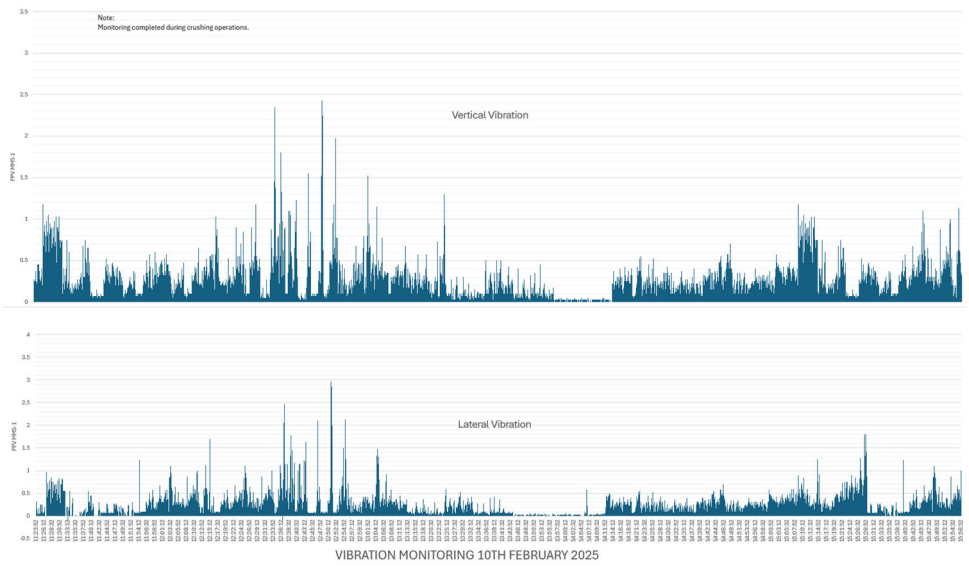
Project	Crabtree Lane, Openshaw	**Project No.**	BSH2258
22nd January 2026 Vibration monitoring adjacent to canal earthworks in north western portion of the site.	 Maximum recorded vibration 7.85mm/s		
10th February 2026 Vibration monitoring during crushing operations.	 Maximum recorded vibration 2.975mm/s

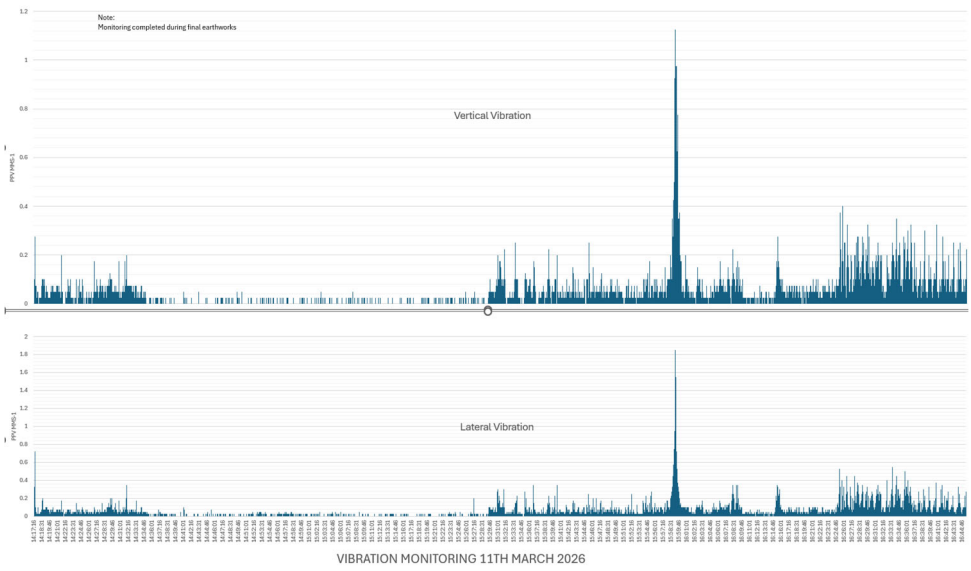
Project	Crabtree Lane, Openshaw	Project No.	BSH2258
11th March 2026 Final earthworks / crushing plot footprints	 Maximum recorded vibration 1.750mm/s		
11th March 2026

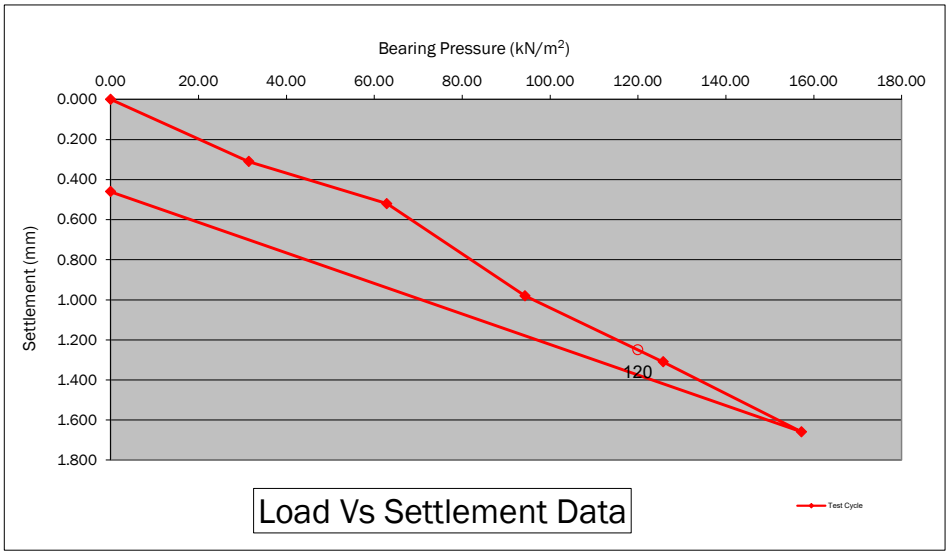
Material Description:	Class 6F2	Date Tested:	**17/12/2025**
Test Location:	**CBR P-1**	Supplier/Source:	Ex-Site
Weather	Wet

Test Cycle	
Bearing Pressure (See Notes below)	*Settlement*
kN/m²	*mm*
31.44	0.31
62.88	0.52
94.31	0.98
125.75	1.31
157.19	1.66
0.00	0.46
Recovery %	72

Depth of Test	Surface		
Distance from edge of plate to wall of excavation	N/A	mm	
Reaction Load	19T Roller		
Plate Correction Factor	0.62		
Maximum Applied Pressure	157.2	kN/m²	
Maximum Settlement	1.66	mm	
Test Cycle Values			
Bearing Pressure @ 1.25mm Settlement	120.0	kN/m²	
Modulus of Subgrade Reaction K762	59.8	kN/m²/mm

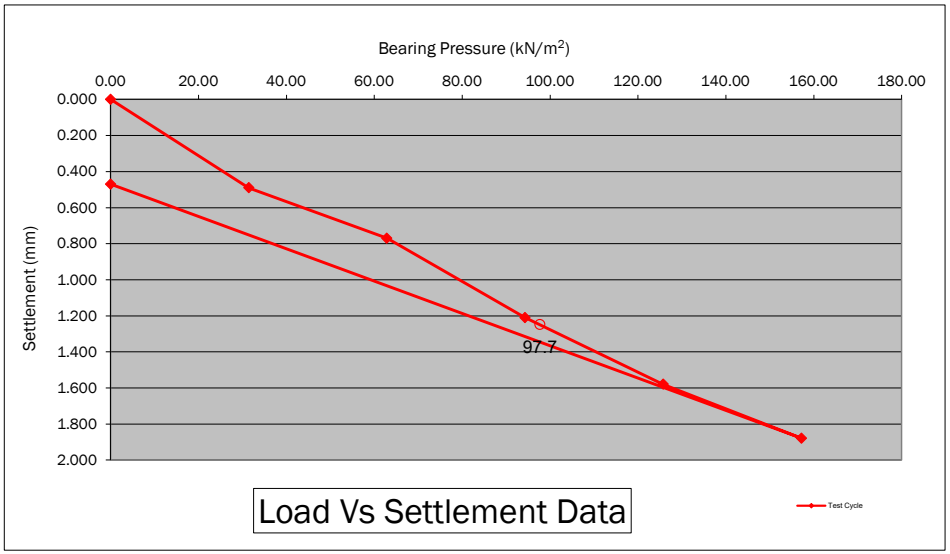
Material Description:	Class 6F2	Date Tested:	**17/12/2025**
Test Location:	**CBR P-2**	Supplier/Source:	Ex-Site
Weather	Wet

Test Cycle	
Bearing Pressure (See Notes below)	*Settlement*
kN/m²	*mm*
31.44	0.49
62.88	0.77
94.31	1.21
125.75	1.58
157.19	1.88
0.00	0.47
Recovery %	75

Depth of Test	Surface		Plate Diameter	450mm
Distance from edge of plate to wall of excavation	N/A	mm	Moisture Content*	Not Taken
Reaction Load	19T Roller		*Carried out in accordance with BS1377: Part 2: 1990.	
Plate Correction Factor	0.62		**Equivalent CBR Value (%)**	
Maximum Applied Pressure	157.2	kN/m²		
Maximum Settlement	1.88	mm	**8.1**	
Test Cycle Values				
Bearing Pressure @ 1.25mm Settlement	97.7	kN/m²		
Modulus of Subgrade Reaction K762	48.7	kN/m²/mm

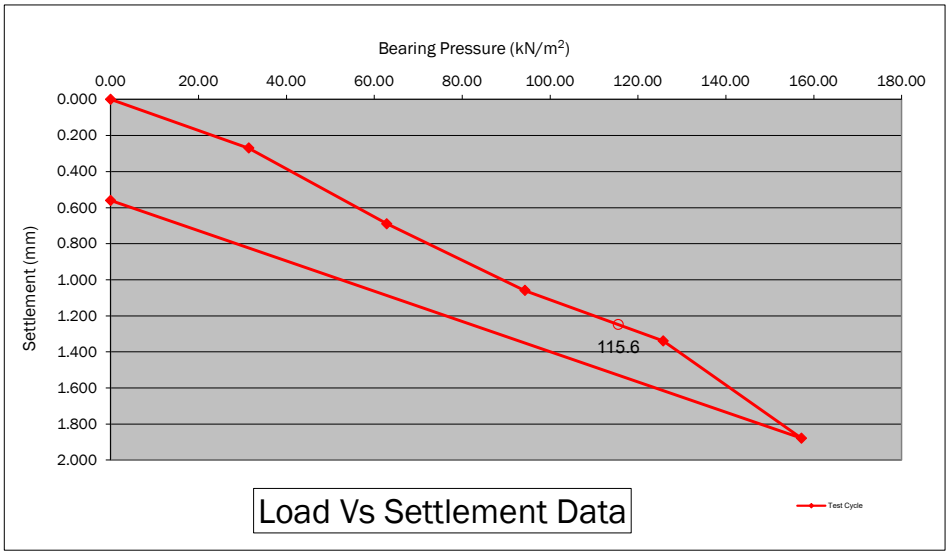
Material Description:	Class 6F2	Date Tested:	**17/12/2025**
Test Location:	**CBR P-3**	Supplier/Source:	Ex-Site
Weather	Wet

Test Cycle	
Bearing Pressure (See Notes below)	*Settlement*
kN/m²	*mm*
31.44	0.27
62.88	0.69
94.31	1.06
125.75	1.34
157.19	1.88
0.00	0.56
Recovery %	70

Depth of Test	Surface		
Distance from edge of plate to wall of excavation	N/A	mm	
Reaction Load	19T Roller		
Plate Correction Factor	0.62		
Maximum Applied Pressure	157.2	kN/m²	
Maximum Settlement	1.88	mm	
Test Cycle Values			
Bearing Pressure @ 1.25mm Settlement	115.6	kN/m²	
Modulus of Subgrade Reaction K762	57.6	kN/m²/mm

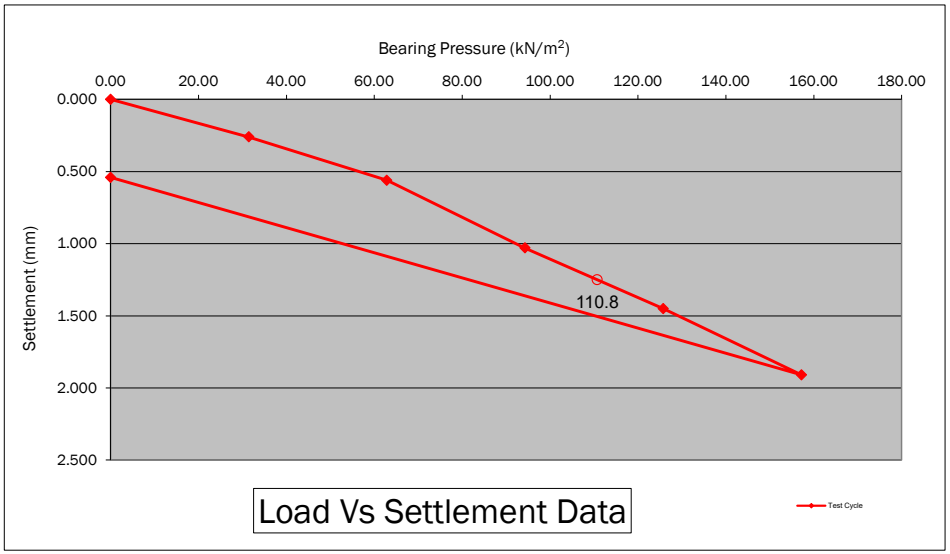
Material Description:	Class 6F2	Date Tested:	**17/12/2025**
Test Location:	**CBR P-4**	Supplier/Source:	Ex-Site
Weather	Wet

Test Cycle	
Bearing Pressure (See Notes below)	*Settlement*
kN/m²	*mm*
31.44	0.26
62.88	0.56
94.31	1.03
125.75	1.45
157.19	1.91
0.00	0.54
Recovery %	72

Depth of Test	Surface		
Distance from edge of plate to wall of excavation	N/A	mm	
Reaction Load	19T Roller		
Plate Correction Factor	0.62		
Maximum Applied Pressure	157.2	kN/m²	
Maximum Settlement	1.91	mm	
Test Cycle Values			
Bearing Pressure @ 1.25mm Settlement	110.8	kN/m²	
Modulus of Subgrade Reaction K762	55.2	kN/m²/mm

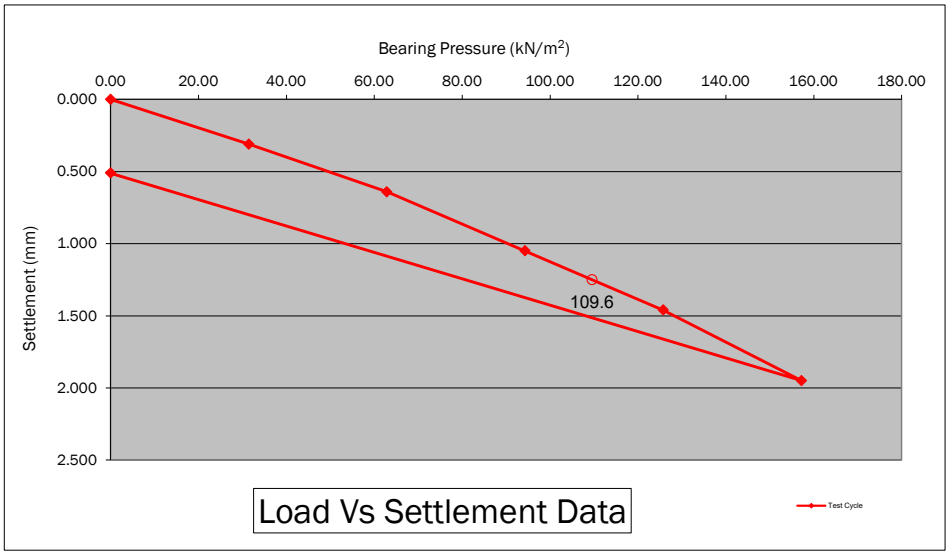
Material Description:	Class 6F2	Date Tested:	**17/12/2025**
Test Location:	**CBR P-5**	Supplier/Source:	Ex-Site
Weather	Wet

Test Cycle	
Bearing Pressure (See Notes below)	*Settlement*
kN/m²	*mm*
31.44	0.31
62.88	0.64
94.31	1.05
125.75	1.46
157.19	1.95
0.00	0.51
Recovery %	74

Depth of Test	Surface	
Distance from edge of plate to wall of excavation	N/A	mm
Reaction Load	19T Roller	
Plate Correction Factor	0.62	
Maximum Applied Pressure	157.2	kN/m²
Maximum Settlement	1.95	mm
Test Cycle Values		
Bearing Pressure @ 1.25mm Settlement	109.6	kN/m²
Modulus of Subgrade Reaction K762	54.6	kN/m²/mm

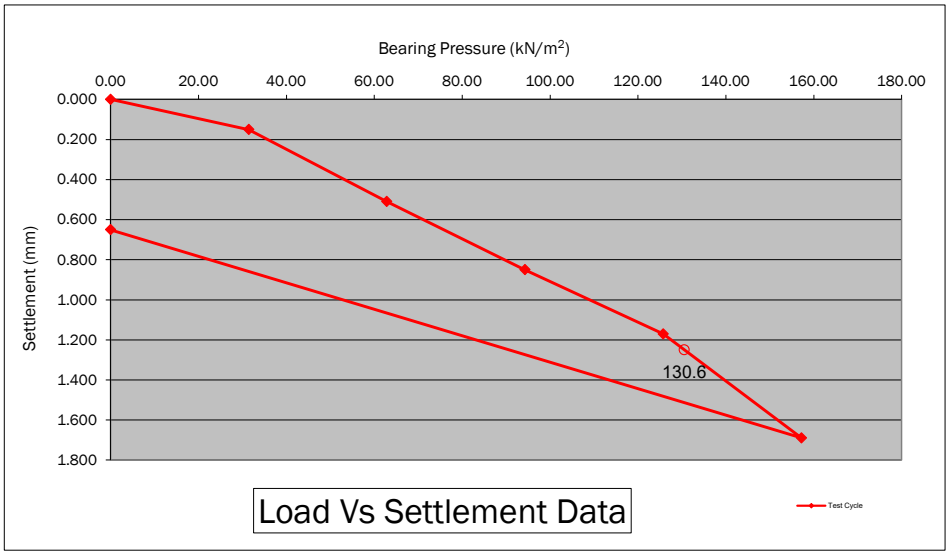
Material Description:	Crush Stone	Date Tested:	**20/01/2026**
Test Location:	**CBR - P6**	Supplier/Source:	Not Stated
Weather	Overcast

Test Cycle	
Bearing Pressure (See Notes below)	*Settlement*
kN/m²	*mm*
31.44	0.15
62.88	0.51
94.31	0.85
125.75	1.17
157.19	1.69
0.00	0.65
Recovery %	62

Depth of Test	Surface		Plate Diameter	**450mm**
Distance from edge of plate to wall of excavation	N/A	mm	Moisture Content*	**Not Taken**
Reaction Load	13T		*Carried out in accordance with BS1377: Part 2: 1990.	
Plate Correction Factor	0.62		**Equivalent CBR Value (%)**	
Maximum Applied Pressure	157.2	kN/m²	**13.4**	
Maximum Settlement	1.69	mm		
Test Cycle Values				
Bearing Pressure @ 1.25mm Settlement	130.6	kN/m²		
Modulus of Subgrade Reaction K762	65.1	kN/m²/mm

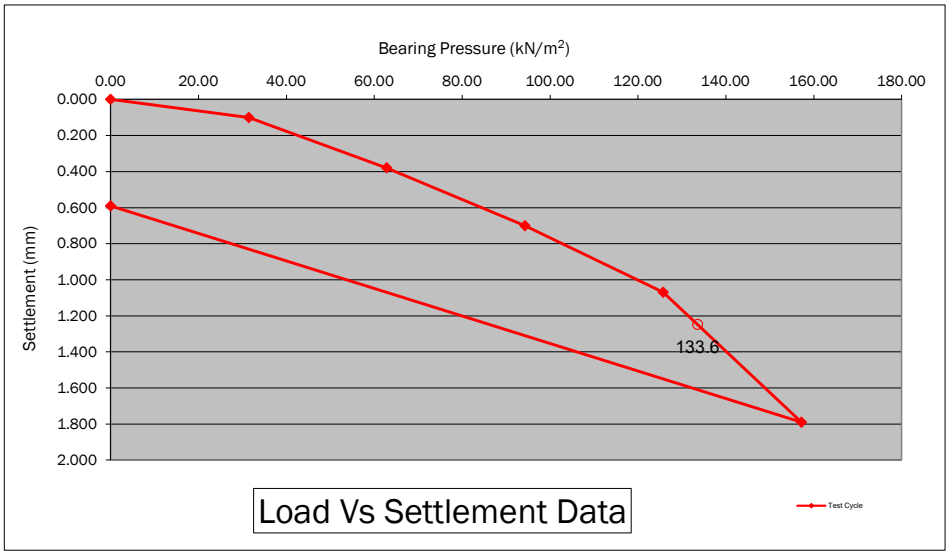
Material Description:	Crush Stone	Date Tested:	**20/01/2026**
Test Location:	**CBR - P7**	Supplier/Source:	Not Stated
Weather	Overcast

Test Cycle	
Bearing Pressure (See Notes below)	*Settlement*
kN/m²	*mm*
31.44	0.10
62.88	0.38
94.31	0.70
125.75	1.07
157.19	1.79
0.00	0.59
Recovery %	67

Depth of Test	**Surface**		Plate Diameter	**450mm**
Distance from edge of plate to wall of excavation	**N/A**	mm	Moisture Content*	**Not Taken**
Reaction Load	**13T**		*Carried out in accordance with BS1377: Part 2: 1990.	
Plate Correction Factor	**0.62**		**Equivalent CBR Value (%)**	
Maximum Applied Pressure	**157.2**	kN/m²	**13.9**	
Maximum Settlement	**1.79**	mm		
Test Cycle Values				
Bearing Pressure @ 1.25mm Settlement	**133.6**	kN/m²		
Modulus of Subgrade Reaction K762	**66.6**	kN/m²/mm

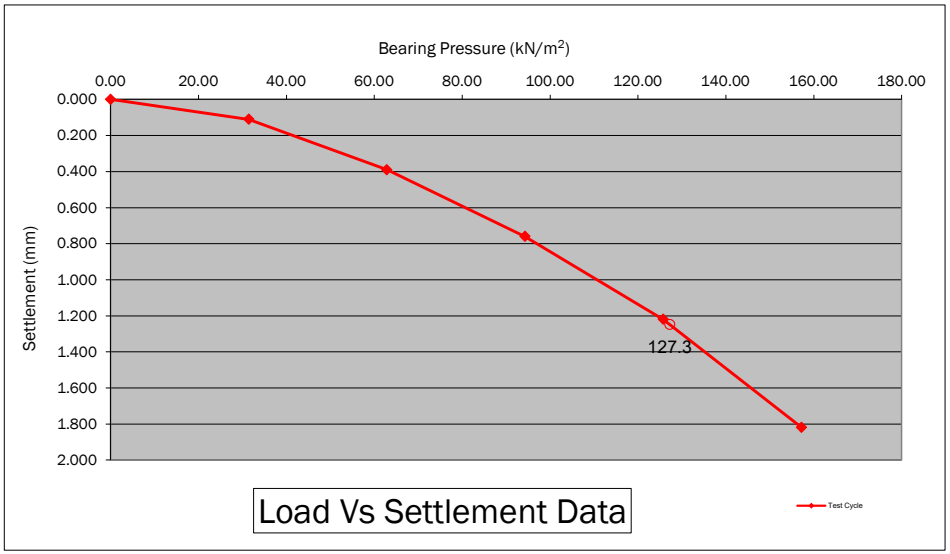
Material Description:	Crush Stone	Date Tested:	**20/01/2026**
Test Location:	**CBR - P8**	Supplier/Source:	Not Stated
Weather	Overcast

Test Cycle	
Bearing Pressure (See Notes below)	*Settlement*
kN/m²	*mm*
31.44	0.11
62.88	0.39
94.31	0.76
125.75	1.22
157.19	1.82
Recovery %	100

Depth of Test	Surface		Plate Diameter	450mm
Distance from edge of plate to wall of excavation	N/A	mm	Moisture Content*	Not Taken
Reaction Load	13T		*Carried out in accordance with BS1377: Part 2: 1990.	
Plate Correction Factor	0.62		**Equivalent CBR Value (%)**	
Maximum Applied Pressure	157.2	kN/m²	**12.8**	
Maximum Settlement	1.82	mm		
Test Cycle Values				
Bearing Pressure @ 1.25mm Settlement	127.3	kN/m²		
Modulus of Subgrade Reaction K762	63.5	kN/m²/mm

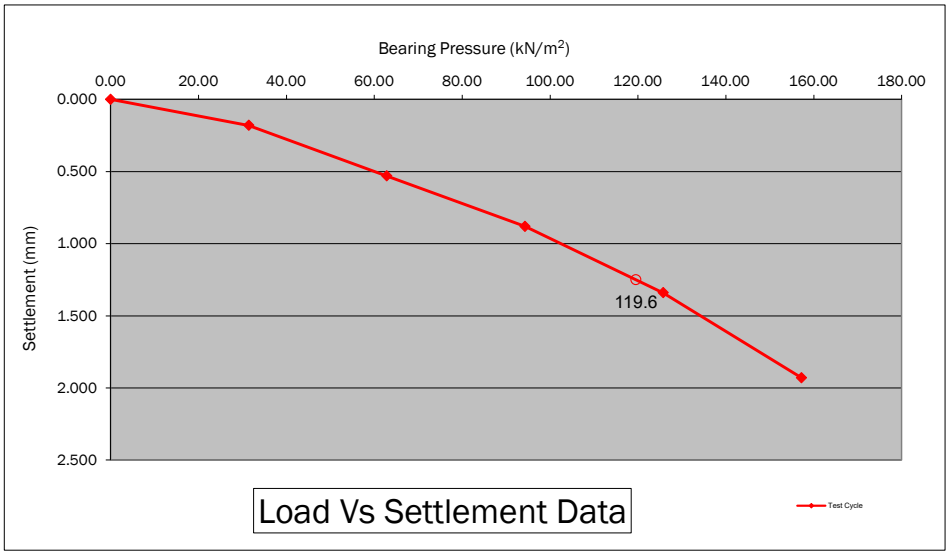
Material Description:	Crush Stone	Date Tested:	**20/01/2026**
Test Location:	**CBR - P9**	Supplier/Source:	Not Stated
Weather	Overcast

Test Cycle	
Bearing Pressure (See Notes below)	*Settlement*
kN/m²	*mm*
31.44	0.18
62.88	0.53
94.31	0.88
125.75	1.34
157.19	1.93
Recovery %	100

Depth of Test	Surface		Plate Diameter	450mm
Distance from edge of plate to wall of excavation	N/A	mm	Moisture Content*	Not Taken
Reaction Load	13T		*Carried out in accordance with BS1377: Part 2: 1990.	
Plate Correction Factor	0.62		**Equivalent CBR Value (%)**	
Maximum Applied Pressure	157.2	kN/m²	**11.5**	
Maximum Settlement	1.93	mm		
Test Cycle Values				
Bearing Pressure @ 1.25mm Settlement	119.6	kN/m²		
Modulus of Subgrade Reaction K762	59.6	kN/m²/mm

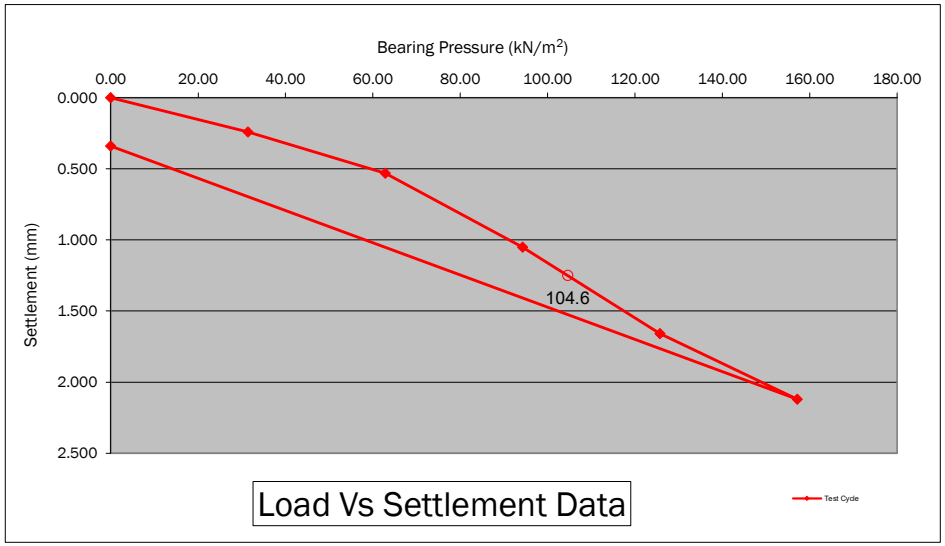
Material Description:	6F2	Date Tested:	**03/03/2026**
Test Location:	**CBR No. P-10**	Supplier/Source:	Not Stated
Weather	Overcast

Test Cycle	
Bearing Pressure (See Notes below)	*Settlement*
kN/m²	*mm*
31.44	0.24
62.88	0.53
94.31	1.05
125.75	1.66
157.19	2.12
0.00	0.34
Recovery %	84

Depth of Test	Surface		
Distance from edge of plate to wall of excavation	N/A	mm	
Reaction Load	14T Roller		
Plate Correction Factor	0.62		
Maximum Applied Pressure	157.2	kN/m²	
Maximum Settlement	2.12	mm	
Test Cycle Values			
Bearing Pressure @ 1.25mm Settlement	104.6	kN/m²	
Modulus of Subgrade Reaction K762	52.1	kN/m²/mm

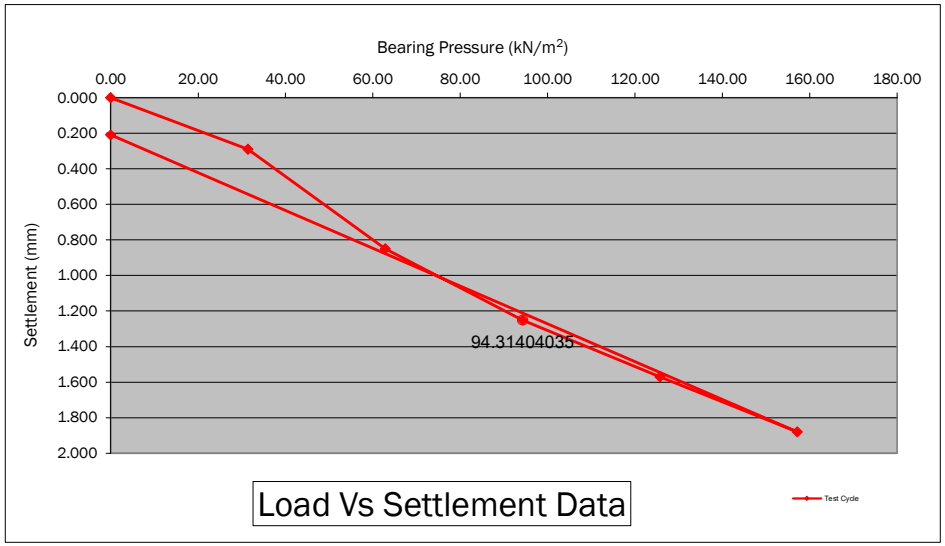
Material Description:	6F2	Date Tested:	**03/03/2026**
Test Location:	**CBR No. P-11**	Supplier/Source:	Not Stated
Weather	Overcast

Test Cycle	
Bearing Pressure (See Notes below)	*Settlement*
kN/m²	*mm*
31.44	0.29
62.88	0.85
94.31	1.25
125.75	1.57
157.19	1.88
0.00	0.21
Recovery %	89

Depth of Test	Surface		
Distance from edge of plate to wall of excavation	N/A	mm	
Reaction Load	14T Roller		
Plate Correction Factor	0.62		
Maximum Applied Pressure	157.2	kN/m²	
Maximum Settlement	1.88	mm	
Test Cycle Values			
Bearing Pressure @ 1.25mm Settlement	94.3	kN/m²	
Modulus of Subgrade Reaction K762	47.0	kN/m²/mm
