**37437 – Victoria Bath's Listed Building Application – Photo Schedule**

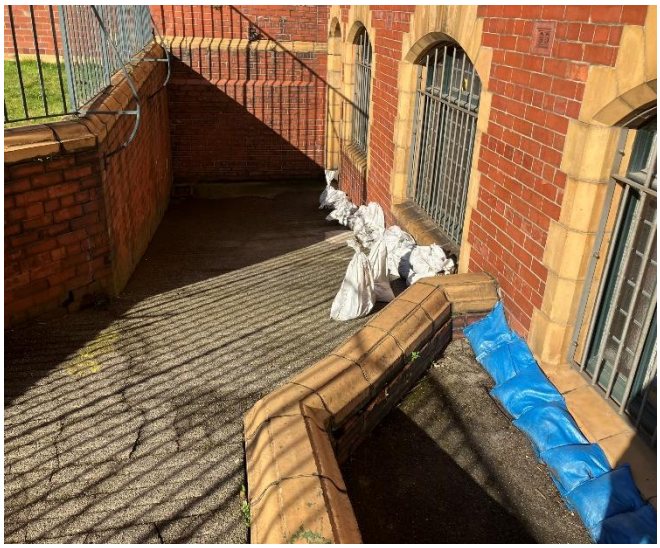
**Photo 1: Overview of area of proposed works.**

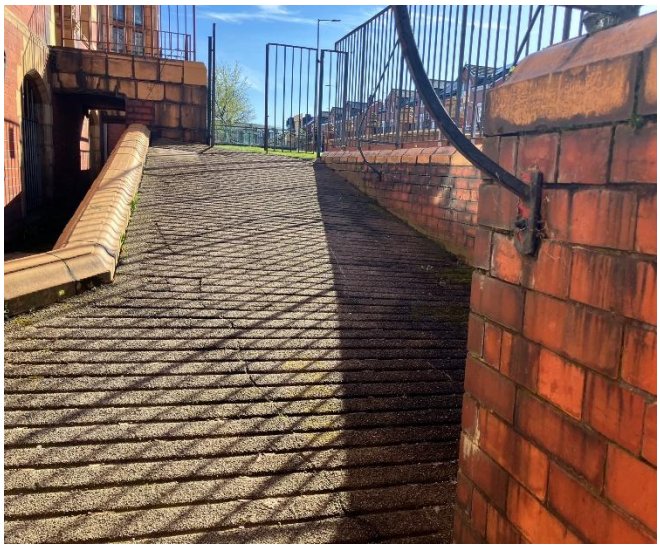
**Photo 2: View from the bottom of the ramp looking up.**

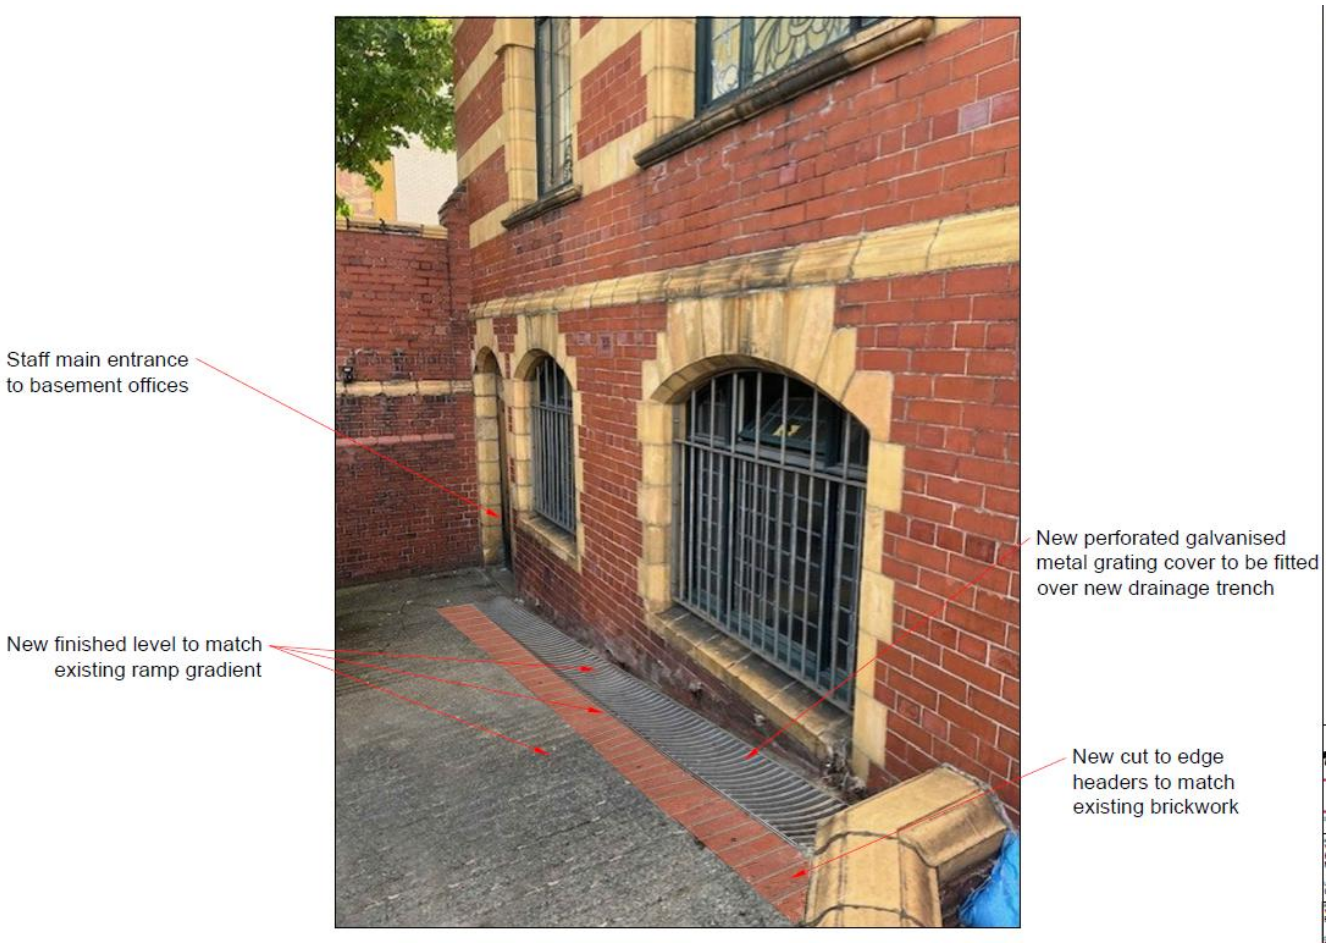
**Photo 7: An impression showing what area 1 will look like following the works, including the installation of the retaining wall capped with headers, galvanised metal grating to cover retained area behind wall and prevent trips and a new connection to the existing drainage.**
