Technical Note – Manchester Metrolink Site Survey Report

Date: 12.02.2025

Client Name: Transport For Greater Manchester

Document Reference: 18436104-WAT-XX-XX-RP-H800001-C03

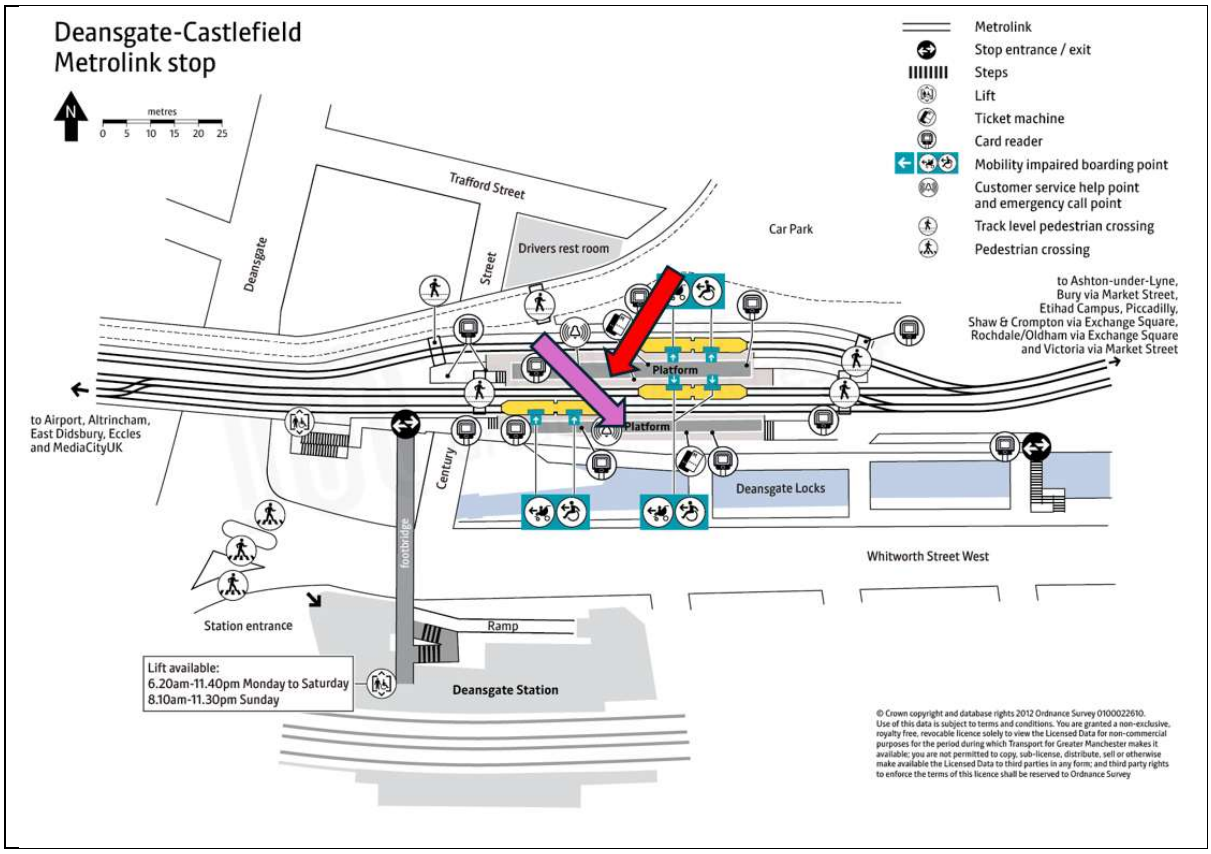
A3: Screen Location

Alignment: Is track, straight or curved? Are screens to be located on approach to junction?	The Platform is of a straight alignment, although on the approach from the east the track is curved	Yes
Any Visibility or sightline Issues for any users?	There are no Visibility Issues	Yes
Existing Digital Adverts: Is there existing digital signage in the area of the proposed location which currently do not cause issues? Are the existing digital signs brighter than the proposed?	There are Currently No digital Signs within the vicinity of Deansgate Castlefield stop.	Yes
Maintenance / Installation: Can screen be serviced safely (cleaning, repair etc)? Is there a safe place for a vehicle to stop and service the site?	The screens can be serviced safely however vehicles would have to park on Whitworth Street below the viaduct and come up the steps to access the screens	Yes

Based on the above analysis, should the proposed Digital screen location be permitted? If not, why not?
Although there are currently no digital screens located within the vicinity of the stop, 2x 6 screen advertising board digitalisation should be permitted on this stop due to there being no visibility issues around the track for drivers.
Do you recommend that a safety audit is carried out? No
If the assessor is of the opinion that the screen location should not be permitted, are there changes that could be made to the proposal that would address the above concerns?

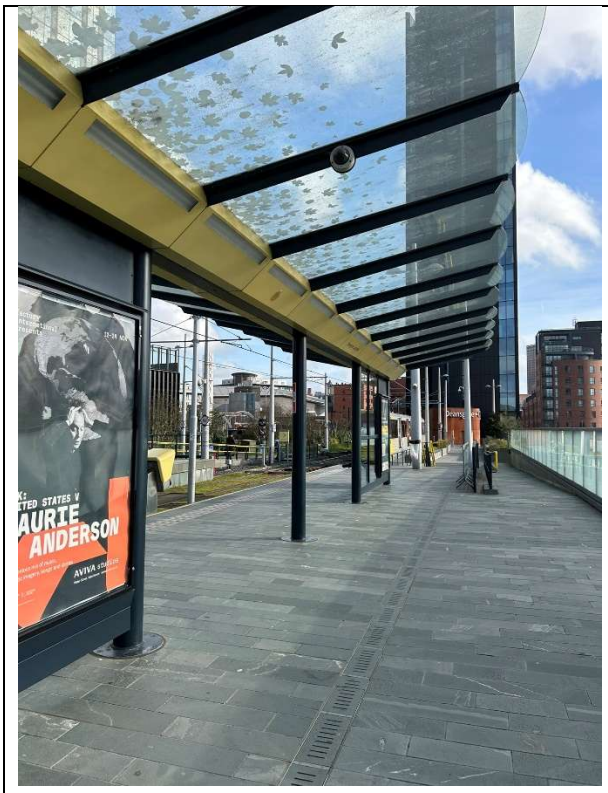
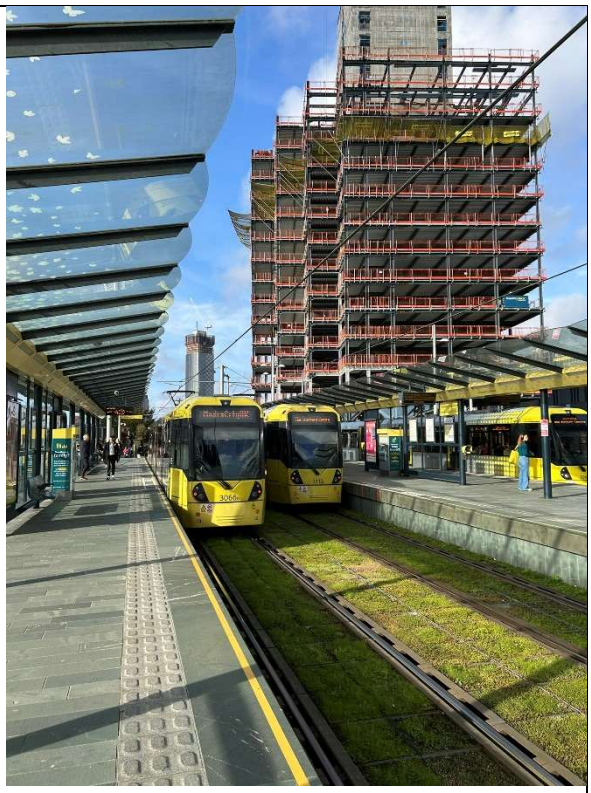
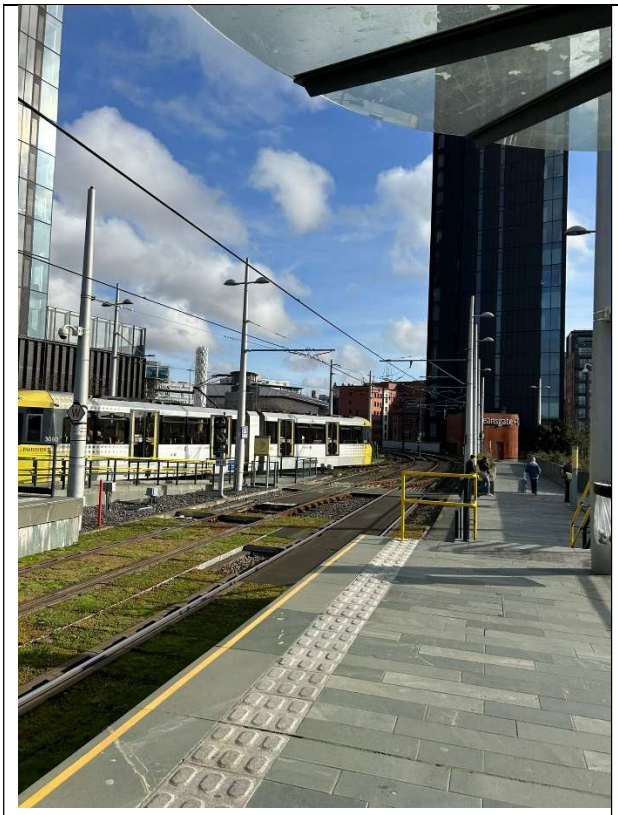
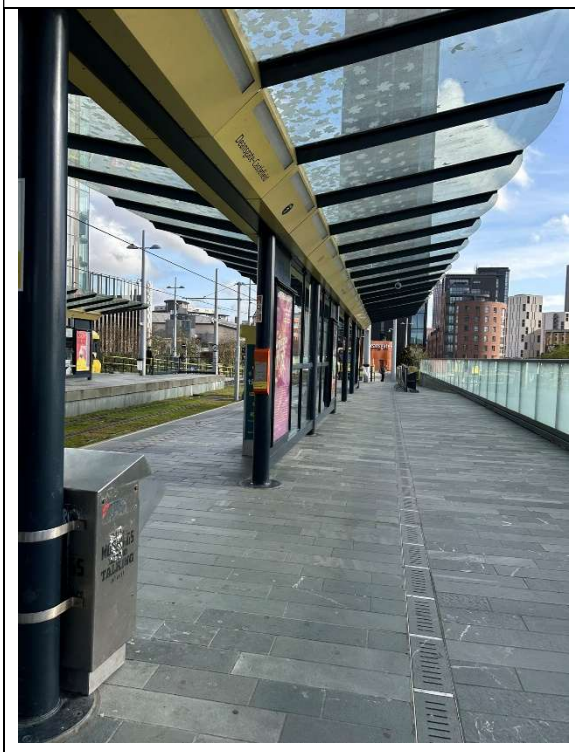
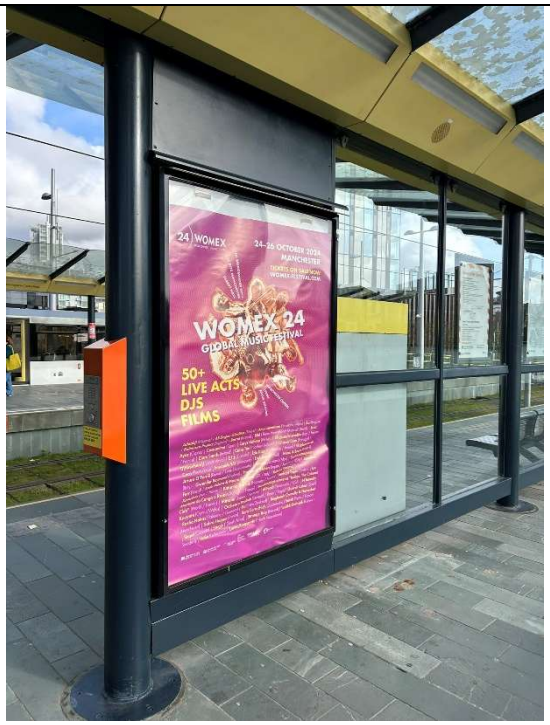
B3 Site Photos

Does the stop have history of crowding in normal operation or events/disruption?	Yes, due to it being a key changeover point between the various Metrolink lines.	Yes
Any other comments?	No	Yes

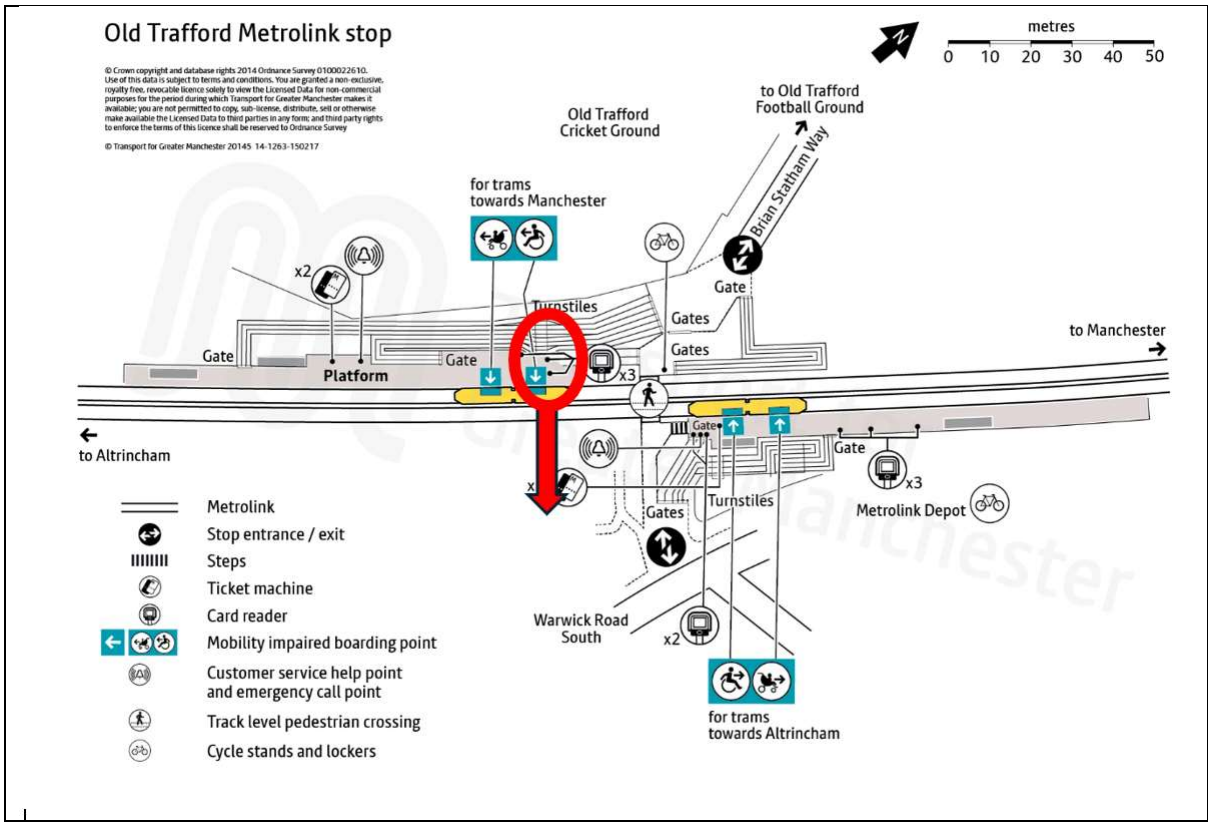
A3: Screen Location

Alignment: Is track, straight or curved? Are screens to be located on approach to junction?	The Platform is of a straight alignment.	Yes
Any Visibility or sightline Issues for any users?	There are no Visibility Issues	Yes
Existing Digital Adverts: Is there existing digital signage in the area of the proposed location which currently do not cause issues? Are the existing digital signs brighter than the proposed?	There are Currently No digital Signs within the vicinity of the Old Trafford stop.	Yes
Maintenance / Installation: Can screen be serviced safely (cleaning, repair etc)? Is there a safe place for a vehicle to stop and service the site?	The screens can be serviced safely by vehicles pulling up on the side closest to Old Trafford Cricket Stadium	Yes

Based on the above analysis, should the proposed Digital screen location be permitted? If not, why not?
Although there are currently no digital screens located within the vicinity of the stop, 1x 6 sheet digitalisation should be permitted on this stop due to there being no visibility issues around the track for drivers and it also being a dedicated tramway.
Do you recommend that a safety audit is carried out? No
If the assessor is of the opinion that the screen location should not be permitted, are there changes that could be made to the proposal that would address the above concerns?

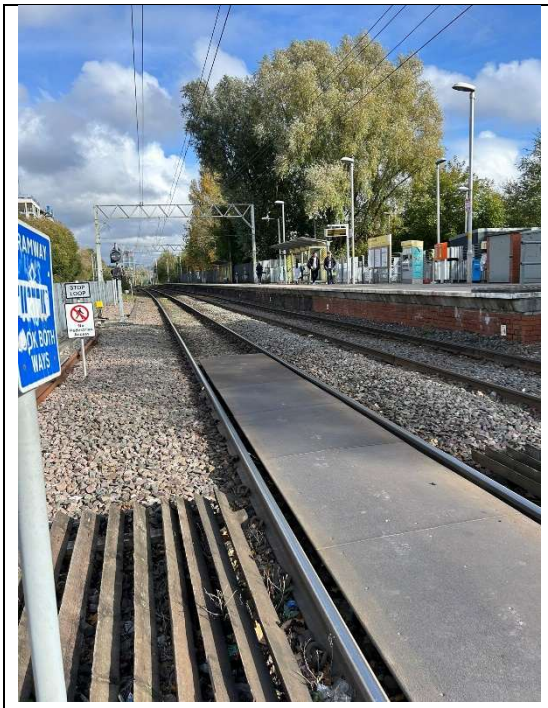
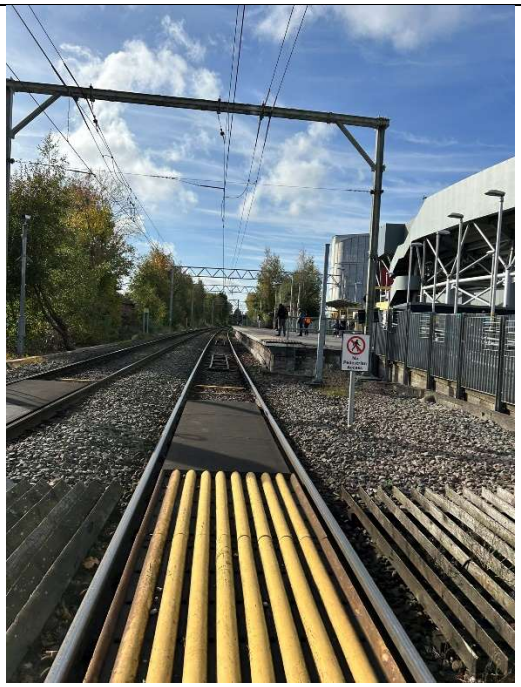
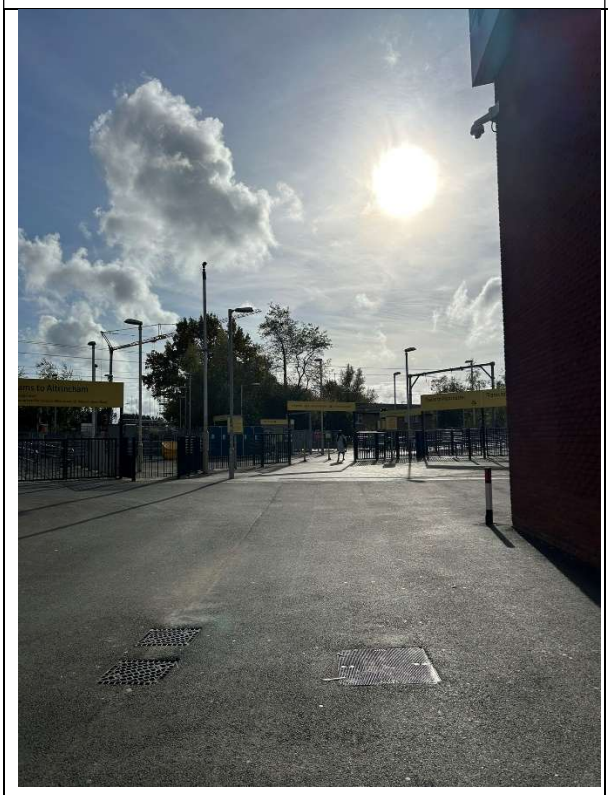
B3 Site Photos

Does the stop have history of crowding in normal operation or events/disruption?	Yes, due to it being located close to both Old Trafford Cricket Ground and Manchester United's Stadium	Yes
Any other comments?	There is a crossing located on the tramway for pedestrians to access the Altrincham bound platform.	Yes

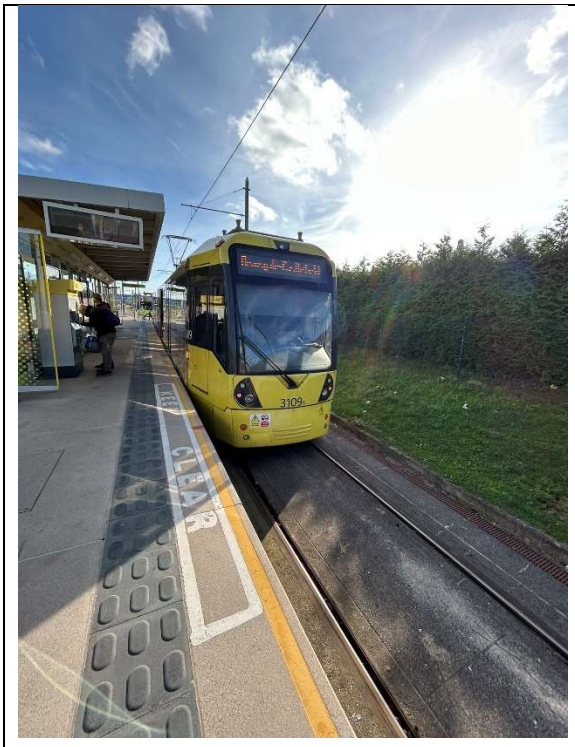
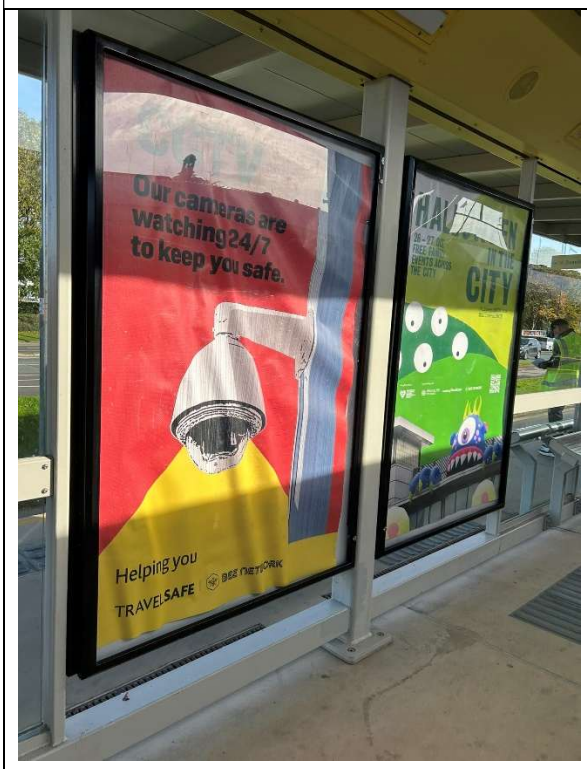
B3 Site Photos

Alignment: Is track, straight or curved? Are screens to be located on approach to junction?	The Platform is of a straight alignment.	Yes
Any Visibility or sightline Issues for any users?	There are no Visibility Issues	Yes
Existing Digital Adverts: Is there existing digital signage in the area of the proposed location which currently do not cause issues? Are the existing digital signs brighter than the proposed?	There is currently a large digital sign within the vicinity of The Trafford Centre stop.	Yes
Maintenance / Installation: Can screen be serviced safely (cleaning, repair etc)? Is there a safe place for a vehicle to stop and service the site?	The screens can be serviced safely by vehicles pulling up on the street or within the Trafford Centre Car Park	Yes

Does the stop have history of crowding in normal operation or events/disruption?	Yes, due to it being located close to the Trafford centre	Yes
Any other comments?	No	Yes

Based on the above analysis, should the proposed Digital screen location be permitted? If not, why not?
The 1x digital screen should be permitted on this platform due to there being a large digital screen directly within the drivers eyeline for trams exiting the Trafford Centre Stop, so therefore the safety risk is deemed to be low. Furthermore, due to the large footfall a digital screen would be beneficial for increasing revenue.
Do you recommend that a safety audit is carried out? No
If the assessor is of the opinion that the screen location should not be permitted, are there changes that could be made to the proposal that would address the above concerns?

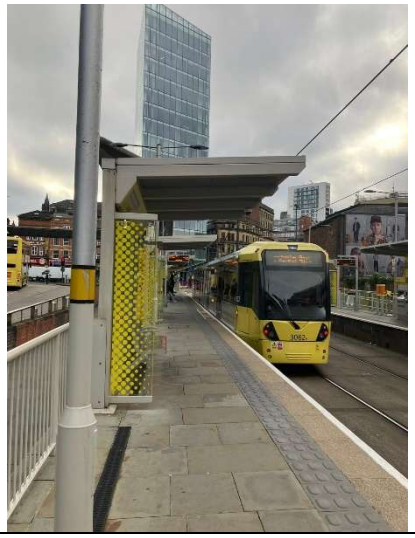
B3 Site Photos

Alignment: Is track, straight or curved? Are screens to be located on approach to junction?	The alignment is straight. No screens on approach to junction.	Yes
Any Visibility or sightline Issues for any users?	There are no Visibility issues	Yes
Existing Digital Adverts: Is there existing digital signage in the area of the proposed location which currently do not cause issues? Are the existing digital signs brighter than the proposed?	Yes, on the Tenpin bowling alley. The existing digital signs are unlikely to be brighter than the proposed.	Yes
Maintenance / Installation: Can screen be serviced safely (cleaning, repair etc)? Is there a safe place for a vehicle to stop and service the site?	Yes, the screen could be serviced easily. A service vehicle would need to come through Shudehill Interchange	Yes
Does the stop have history of crowding in normal operation or events/disruption?	The station could get busy with interchange between buses and trams	Yes

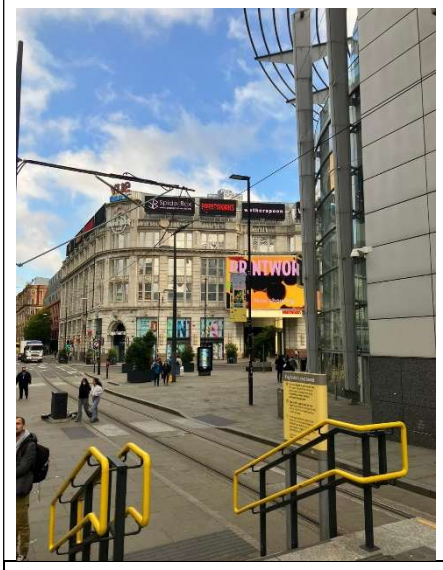
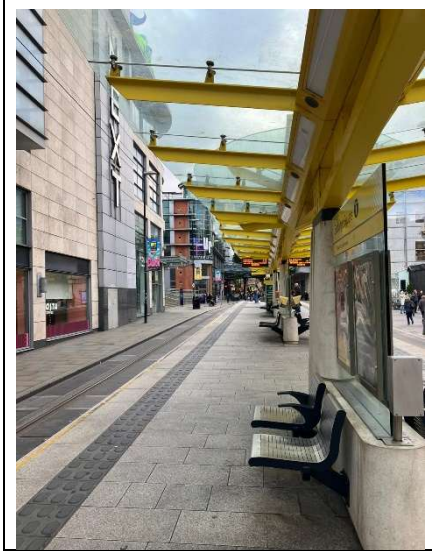
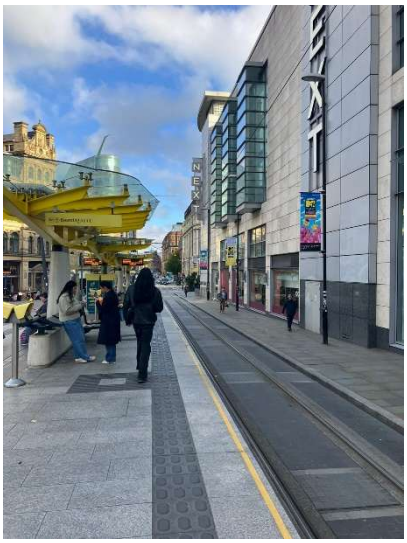
B3 Site Photos

Alignment: Is track, straight or curved? Are screens to be located on approach to junction?	The alignment is straight. No screens on approach to junction.	Yes
Any Visibility or sightline Issues for any users?	There are no Visibility issues	Yes
Existing Digital Adverts: Is there existing digital signage in the area of the proposed location which currently do not cause issues? Are the existing digital signs brighter than the proposed?	Yes, there is digital signage on the Printworks entrance. Yes, and there are also moving images	Yes
Maintenance / Installation: Can screen be serviced safely (cleaning, repair etc)? Is there a safe place for a vehicle to stop and service the site?	Yes, the screen could be serviced easily. A service vehicle would need service from near the Next store.	Yes

Does the stop have history of crowding in normal operation or events/disruption?	Yes, as it is a major stop for shopping – access / egress	Yes
Any other comments?	No	Yes

Based on the above analysis, should the proposed Digital screen location be permitted? If not, why not?
Yes, no safety issues or visibility issues. Digital screens are present nearby at the Printworks which provide no distraction to drivers.
Do you recommend that a safety audit is carried out? No
If the assessor is of the opinion that the screen location should not be permitted, are there changes that could be made to the proposal that would address the above concerns?

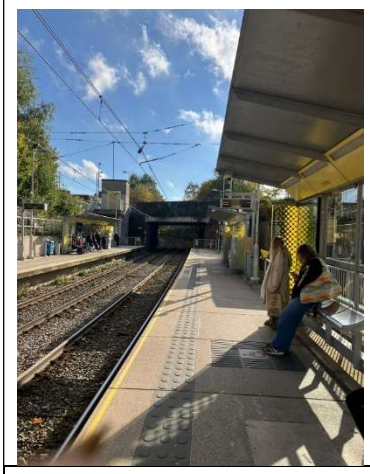
B3 Site Photos

Any Visibility or sightline Issues for any users?	There are no Visibility issues	
Existing Digital Adverts: Is there existing digital signage in the area of the proposed location which currently do not cause issues? Are the existing digital signs brighter than the proposed?	No existing Digital Adverts	
Maintenance / Installation: Can screen be serviced safely (cleaning, repair etc)? Is there a safe place for a vehicle to stop and service the site?	Yes, the screens can be serviced safely. No – the tram stop is located in a cutting away from the road	
Does the stop have history of crowding in normal operation or events/disruption?	No

Based on the above analysis, should the proposed Digital screen location be permitted? If not, why not?
Yes – no safety issues or visibility issues present and adequate space is available.
Do you recommend that a safety audit is carried out? No
If the assessor is of the opinion that the screen location should not be permitted, are there changes that could be made to the proposal that would address the above concerns?
