Technical Note – Manchester Metrolink Site Survey Report

Date: 12.02.2025

Client Name: Transport For Greater Manchester

Document Reference: 18436104-WAT-XX-XX-RP-H800001-C03

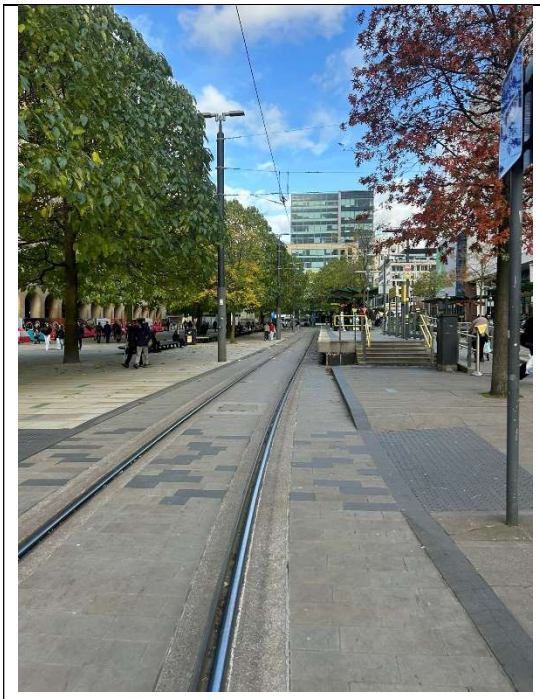
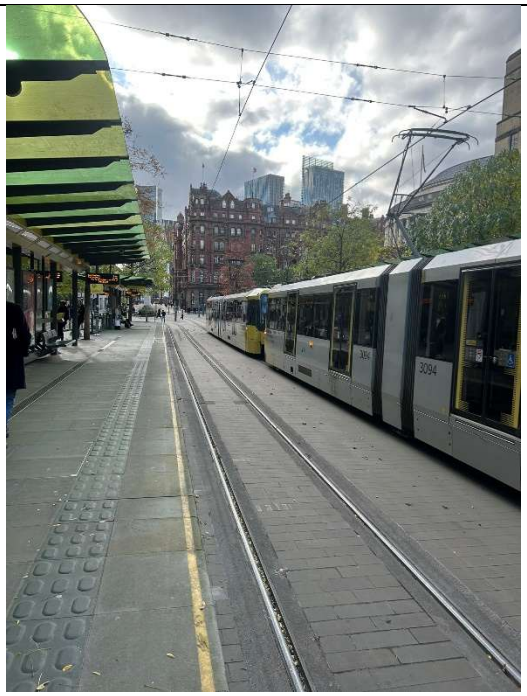
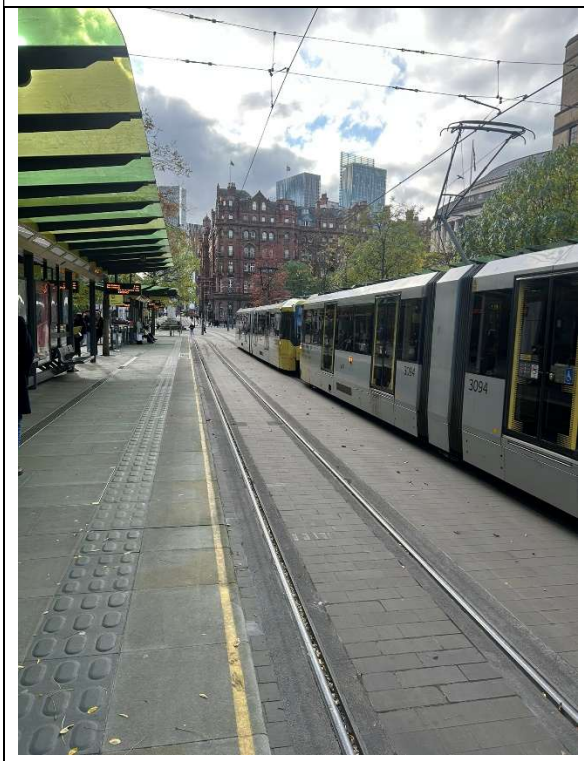
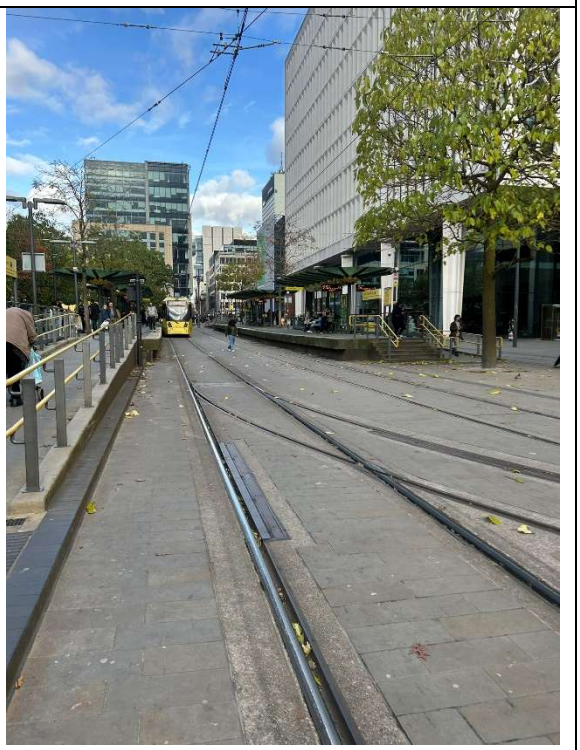
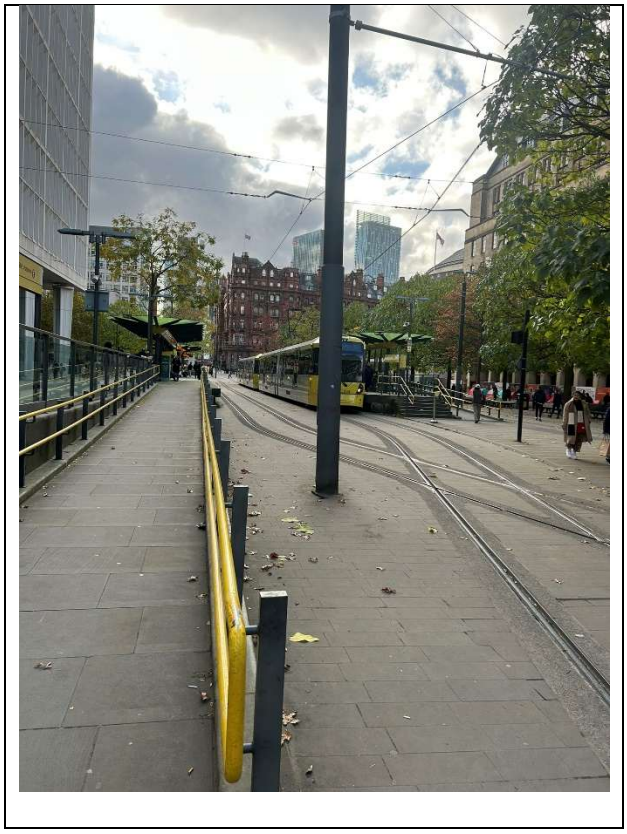
B3 Site Photos

Alignment: Is track, straight or curved? Are screens to be located on approach to junction?	The track is of a straight alignment and located around 40m away from a junction for services travelling North East	Yes
Any Visibility or sightline Issues for any users?	There is No Visibility Issues	Yes
Existing Digital Adverts: Is there existing digital signage in the area of the proposed location which currently do not cause issues?	There are Currently No digital Signs within the vicinity of St Peters Square stop.	Yes

Are the existing digital signs brighter than the proposed?		
Maintenance / Installation: Can screen be serviced safely (cleaning, repair etc)? Is there a safe place for a vehicle to stop and service the site?	There is a safe place for the signs to be serviced which is located adjacent to Platform D.	Yes
Does the stop have history of crowding in normal operation or events/disruption?	Yes, the site is fairly busy and has regular use across all 4 platforms.	Yes
Any other comments?	No	Yes

Based on the above analysis, should the proposed Digital screen location be permitted? If not, why not?
Although there are currently no digital screens located within the vicinity of the stop, Digital Screens should be permitted on this stop due to there being no visibility issues around the track for drivers and it also being a dedicated tramway. The preferred option will be to replace the existing 6 sheet advertising boards with digital screens and not install the freestanding screen on platforms C/D, this is to help reduce the number of digital screens within the drivers eyeline.
Do you recommend that a safety audit is carried out? No
If the assessor is of the opinion that the screen location should not be permitted, are there changes that could be made to the proposal that would address the above concerns?
The 3 existing 6 sheet advertising boards, on platforms B,C, & D are deemed acceptable to be converted to digital screens. And in this particular location the freestanding screen would not be a viable option.
