BRWRY, Manchester

Remediation Validation Report

JEM/C5313/12304 Rev G

May 2026

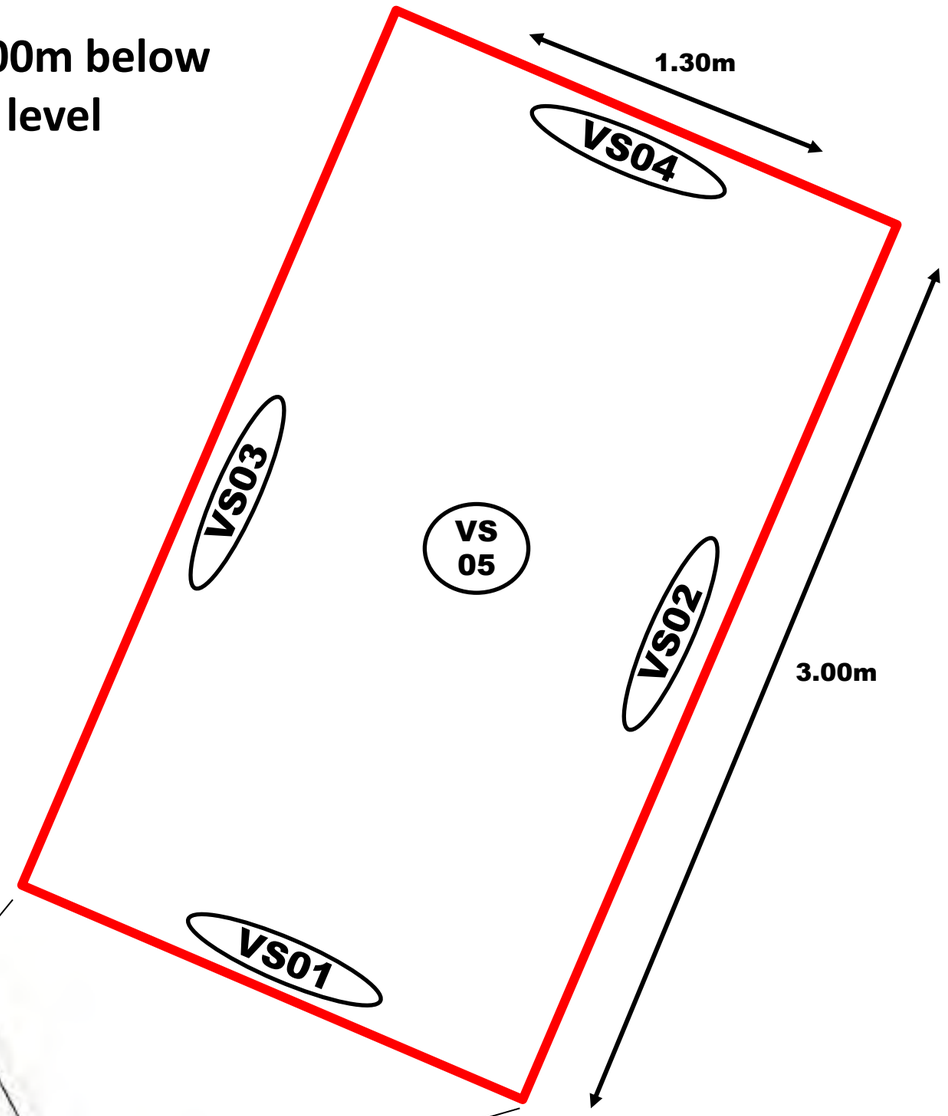
Top of tank found 2.00m below original ground level
