Peacock Centre, Manchester

Phase 2 Geo-Environmental Investigation Report

For: Shepherd Gilmour (SGI) Consulting Engineers

Job Number:	**4396**
Report Reference:	**4396-03D**
Issue Status / Revision:	**Rev D** – Updated proposed development plans
Date:	**July 2026**
Written By:	[redacted]
Checked By:	[redacted]
Authorised By:	[redacted]
Previous Revisions and Date:	**1st Issue -** June 2025 **Rev A -** Updated ground gas monitoring results – August 2025 **Rev B -** Updated Section 3.7.1 – January 2026 **Rev C -** Updated proposed development plans – June 2026

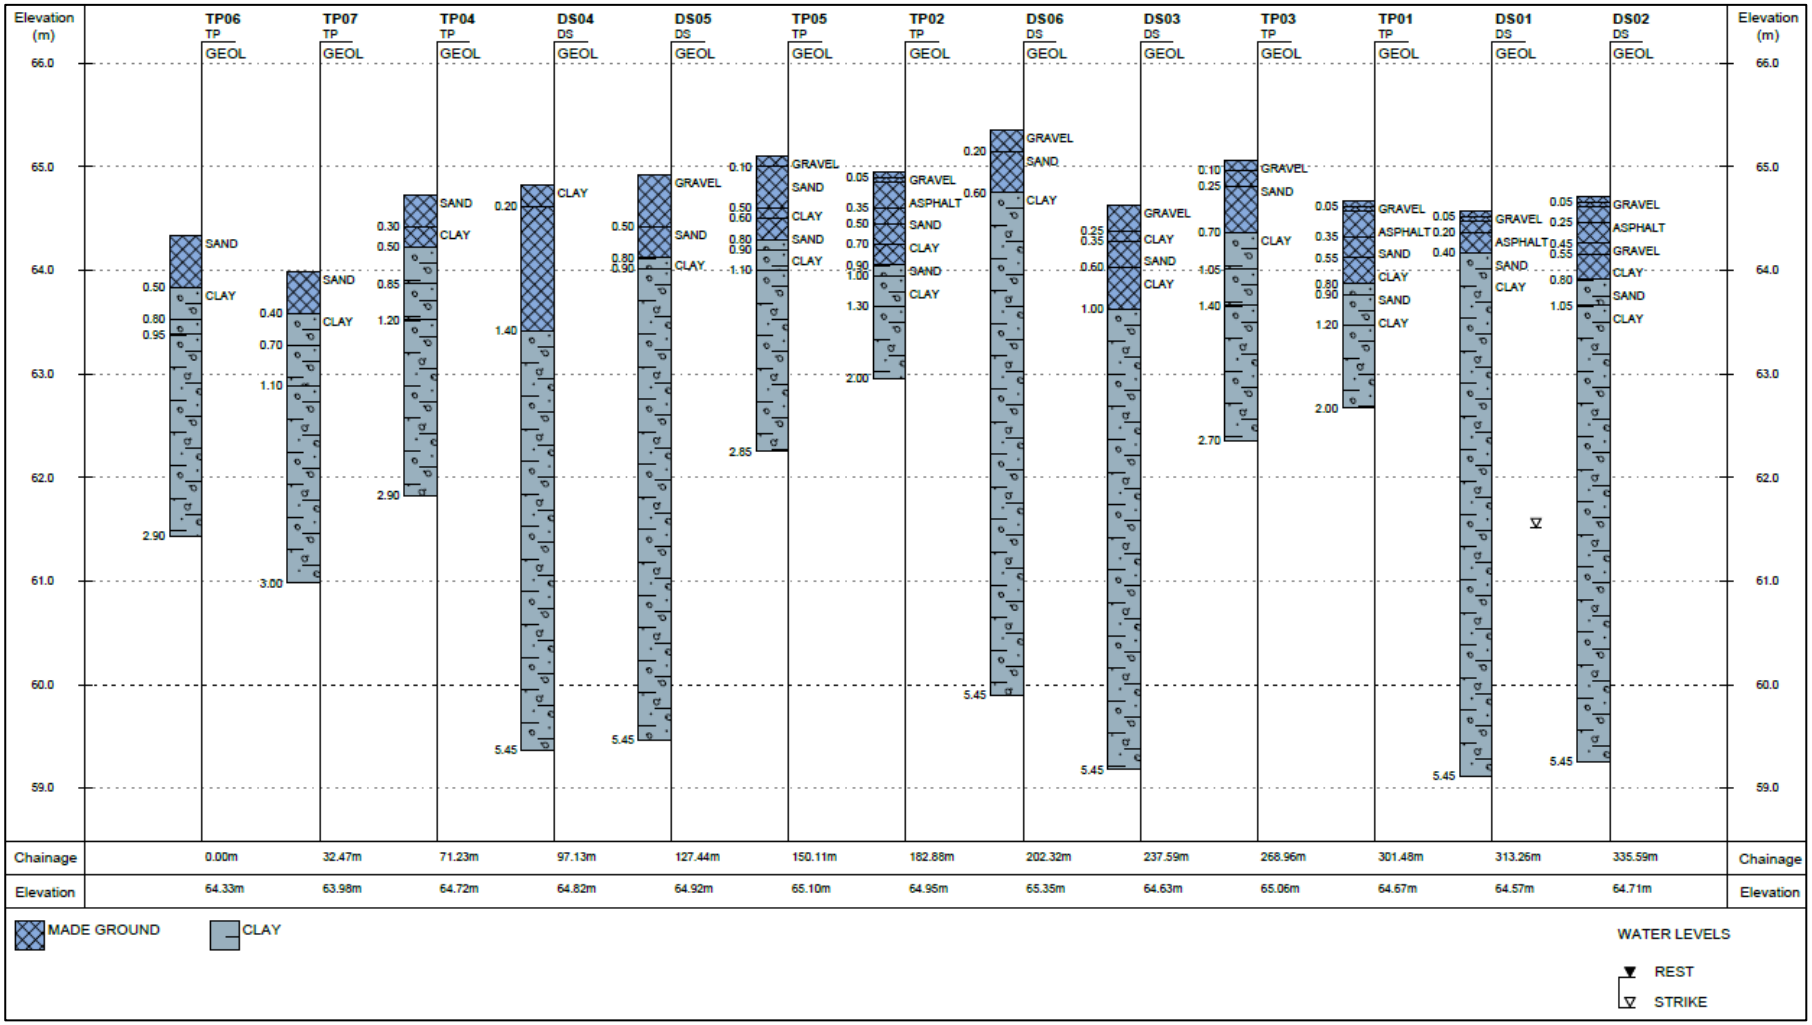
Figure 9: Indicative Cross Section of Parcel A from southwest to northeast. Blue is Made Ground. Grey is Glacial Till.

The cross section presented in Figure 9, below, highlights the recorded depths of Made Ground across the site from southwest to northeast. It should be noted that the base of the Glacial Till was not established in any of the exploratory holes. A detailed cross section is included in Appendix 2.

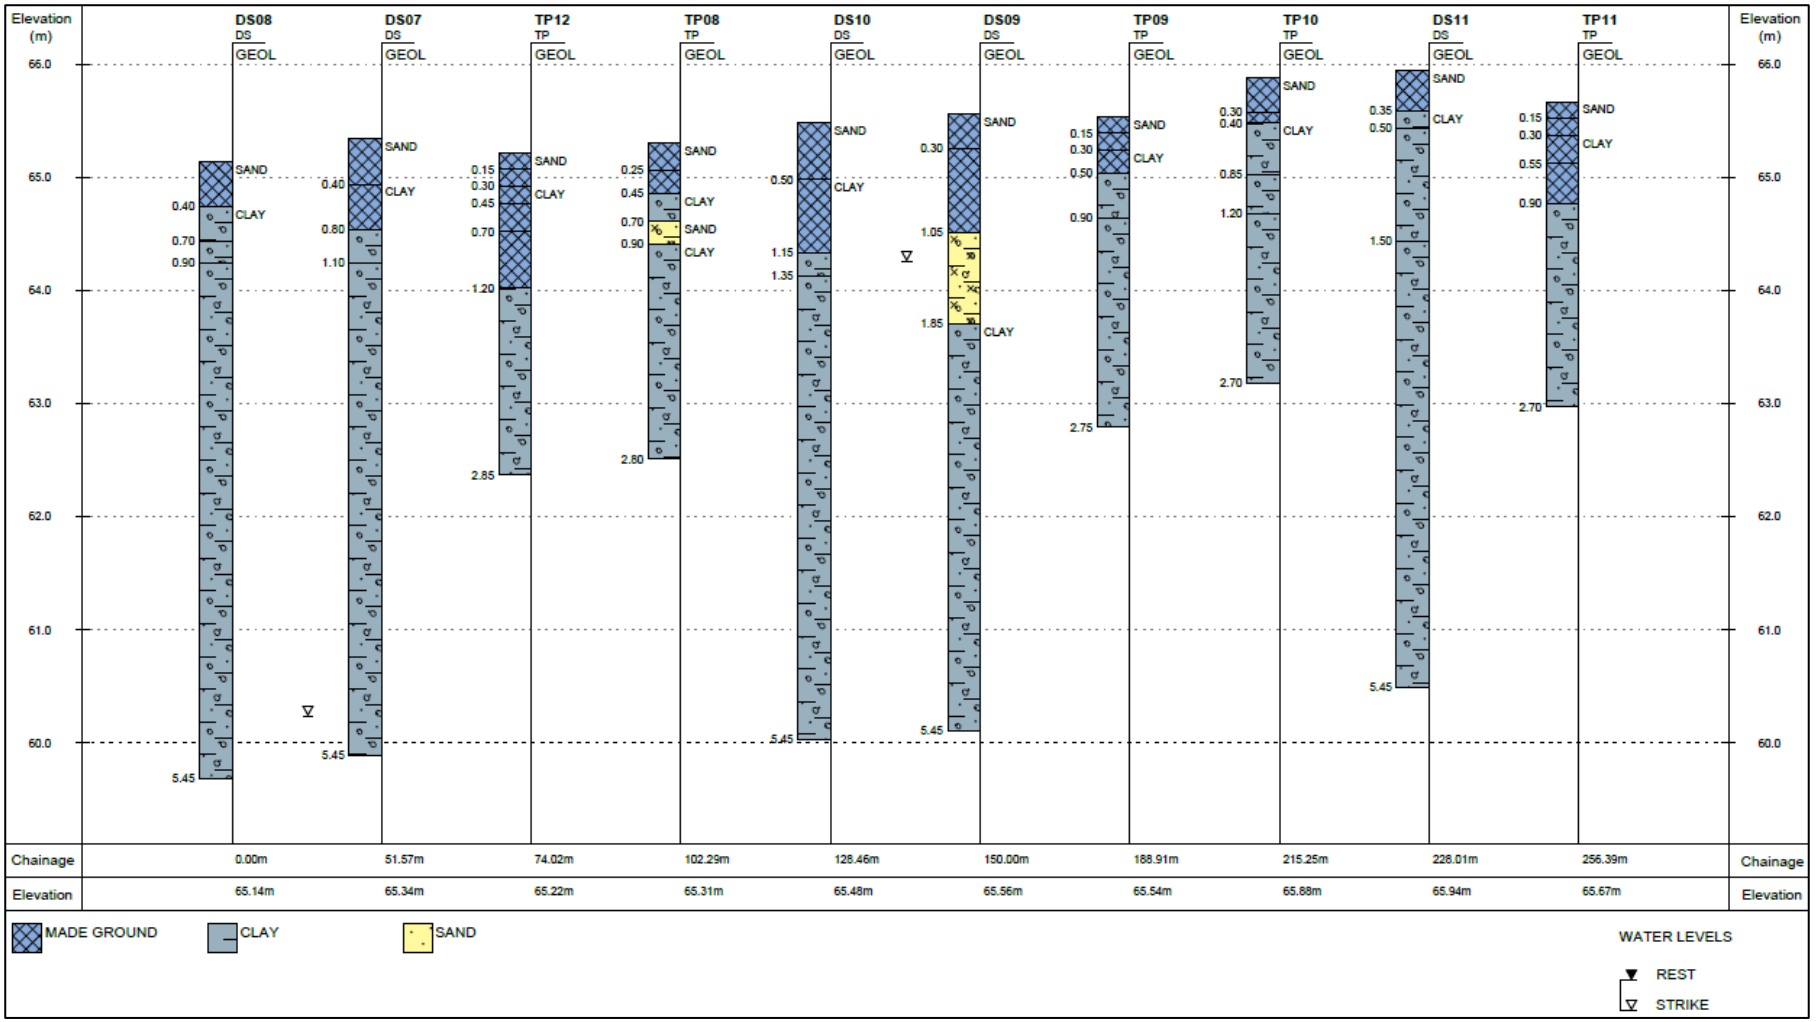
Figure 12: Indicative Cross Section of Parcel B from west to east. Blue is Made Ground. Grey and yellow are Glacial Till.

The cross section presented in Figure 12, below, highlights the recorded depths of Made Ground across the site from west to east. It should be noted that the base of the Glacial Till was not established in any of the exploratory holes. The sand encountered in DS09 and TP08 are highlighted in yellow. A detailed cross section is included in Appendix 2.

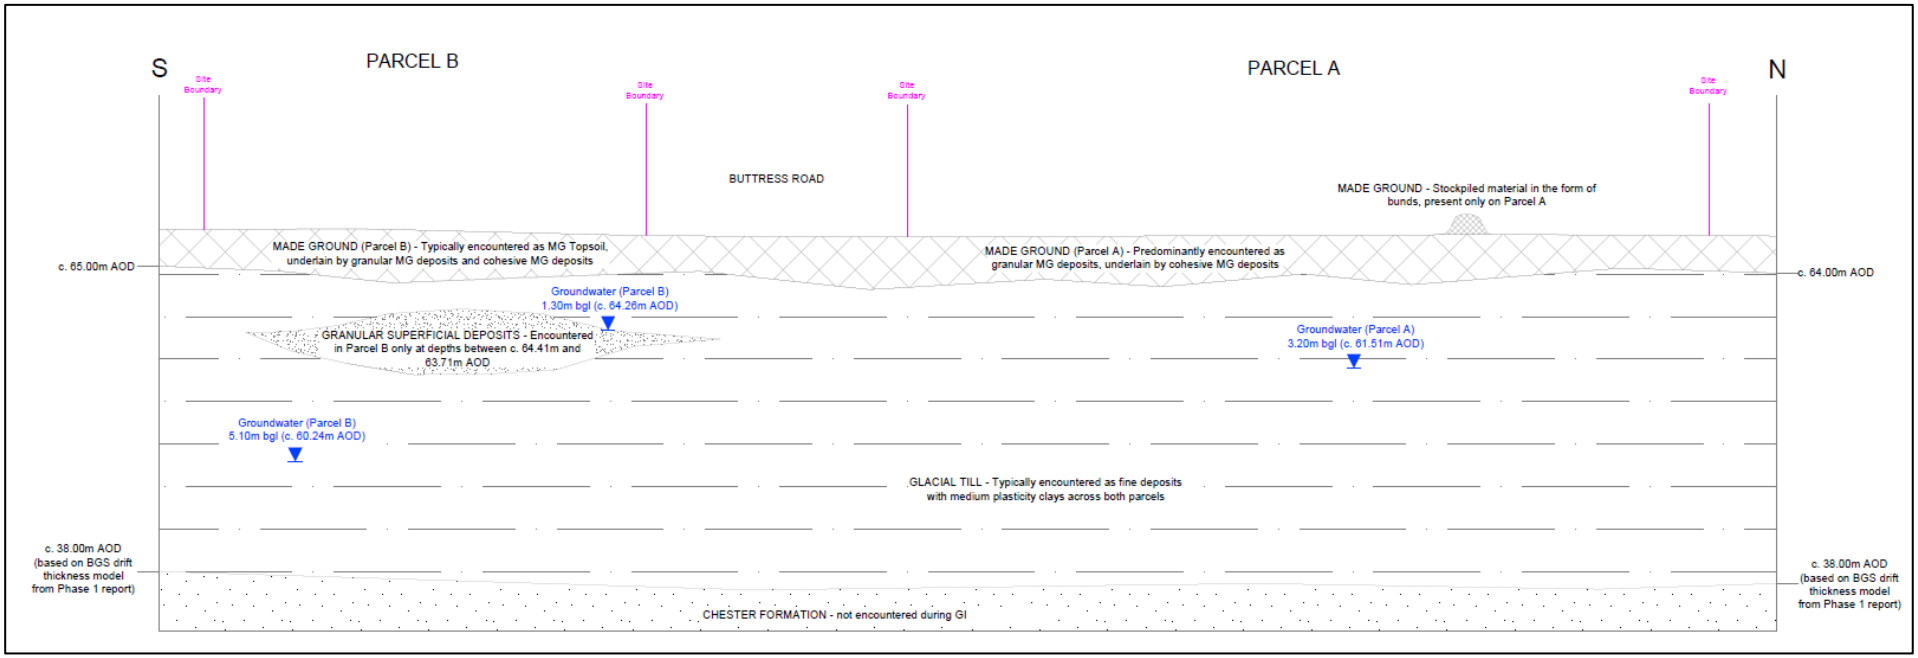
Figure 13: Extract of the conceptual ground model for the site.

deposits were not encountered during the ground investigation - their depth is anticipated to be between c. 28.00m and 31.00m bgl (38.00 and 35.00m AOD) based on the BGS drift thickness model, as stated in the Phase 1 Geo-Environmental Investigation Report.

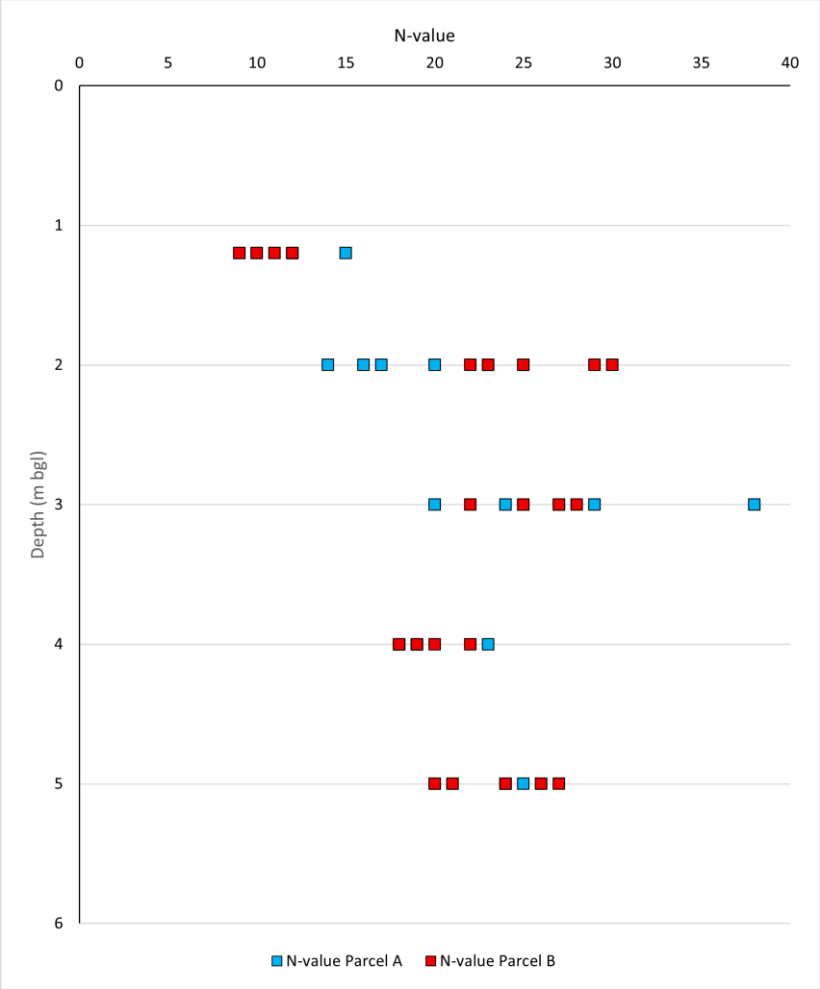
The following scatter graphs show that there was a positive correlation between increasing N-value with depth across both parcels. It should be noted those standard penetration tests crossing strata boundaries have been excluded from this graph.

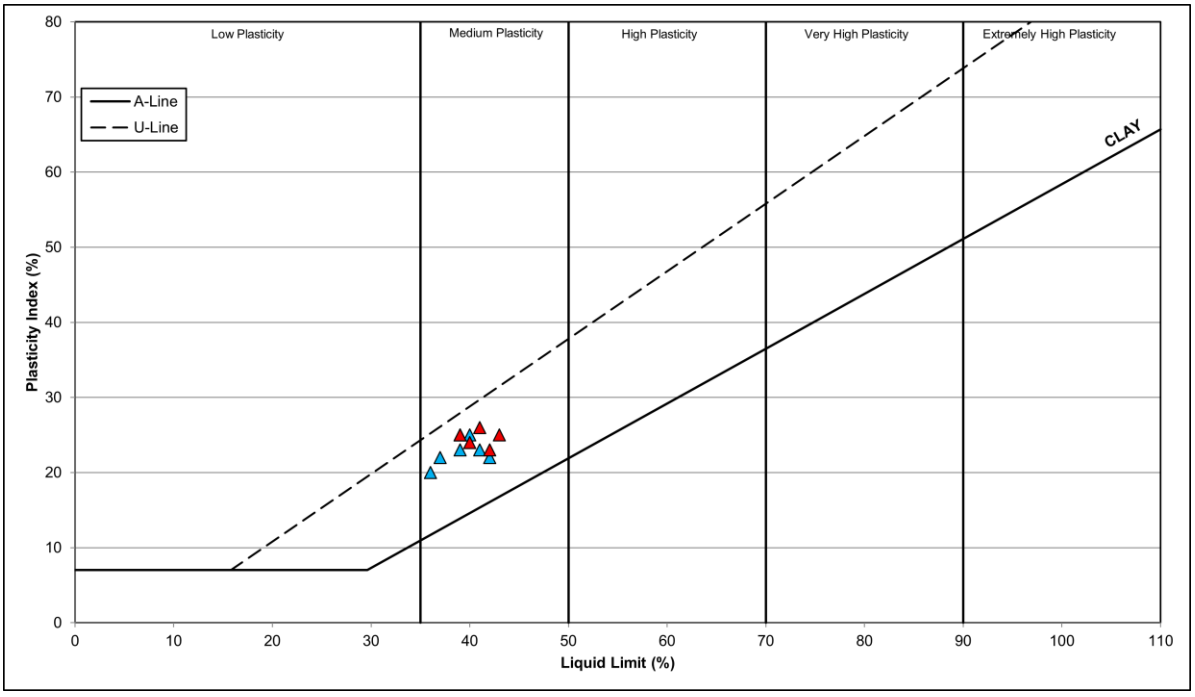
Green = low volume change potential. Orange = medium volume change potential.

The Atterberg Limit tests indicate that the Glacial Till deposits across both parcels are generally of medium plasticity in-line with BS14688 Part 2.

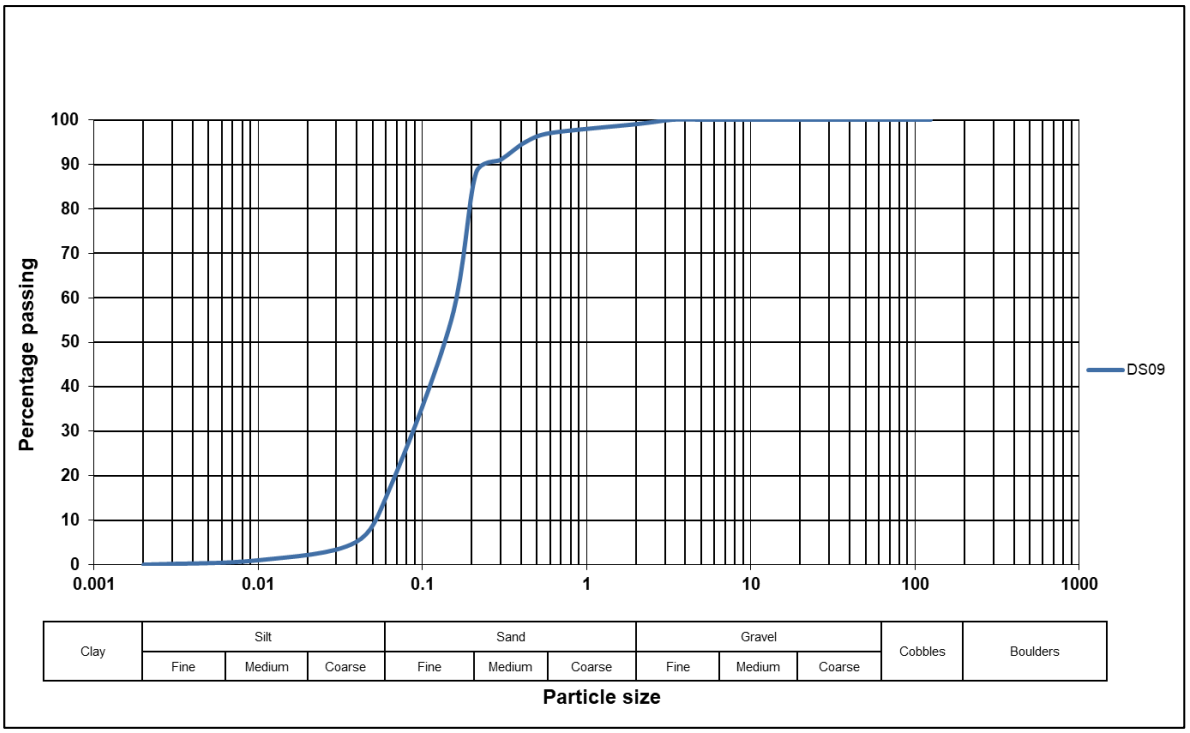
The results reported that the material encountered in DS09 at 1.10m – 1.80m would be described as a slightly gravelly silty fine to coarse SAND.

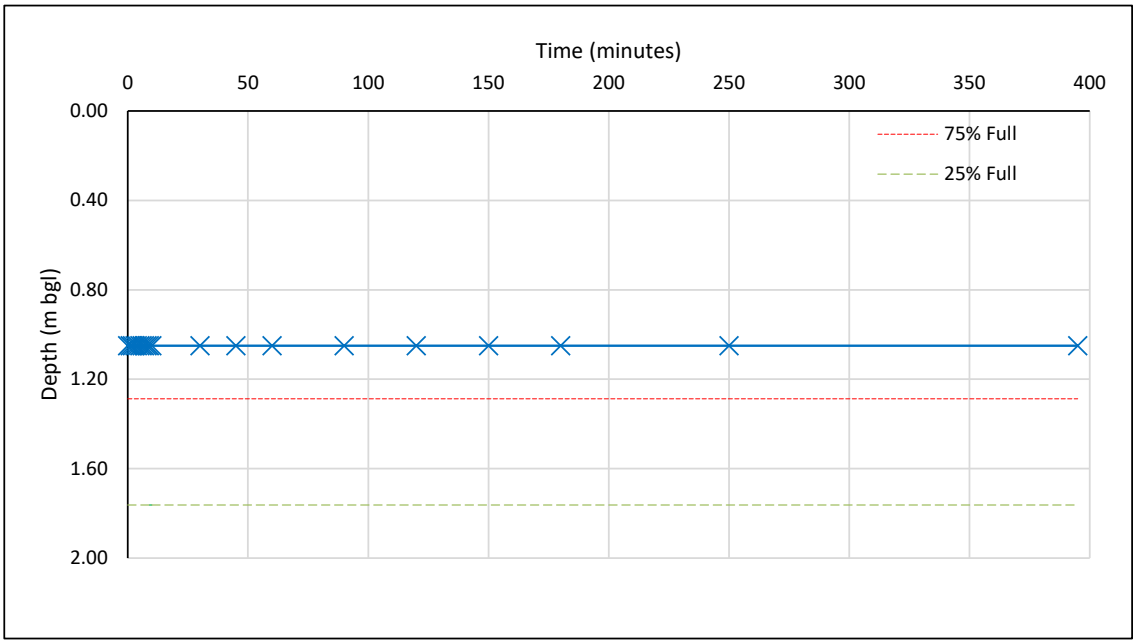
Infiltration too slow to calculate

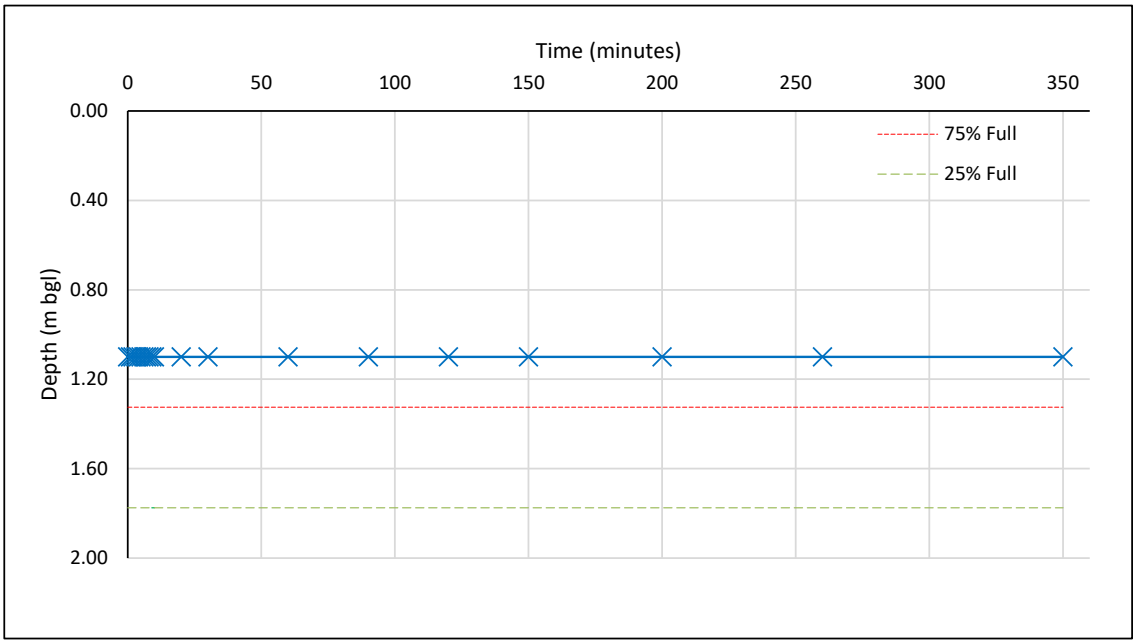
Infiltration too slow to calculate
