WINDOW CONDITION SURVEY

WINTERS BUILDING, MANCHESTER

Date: 17th December 2025

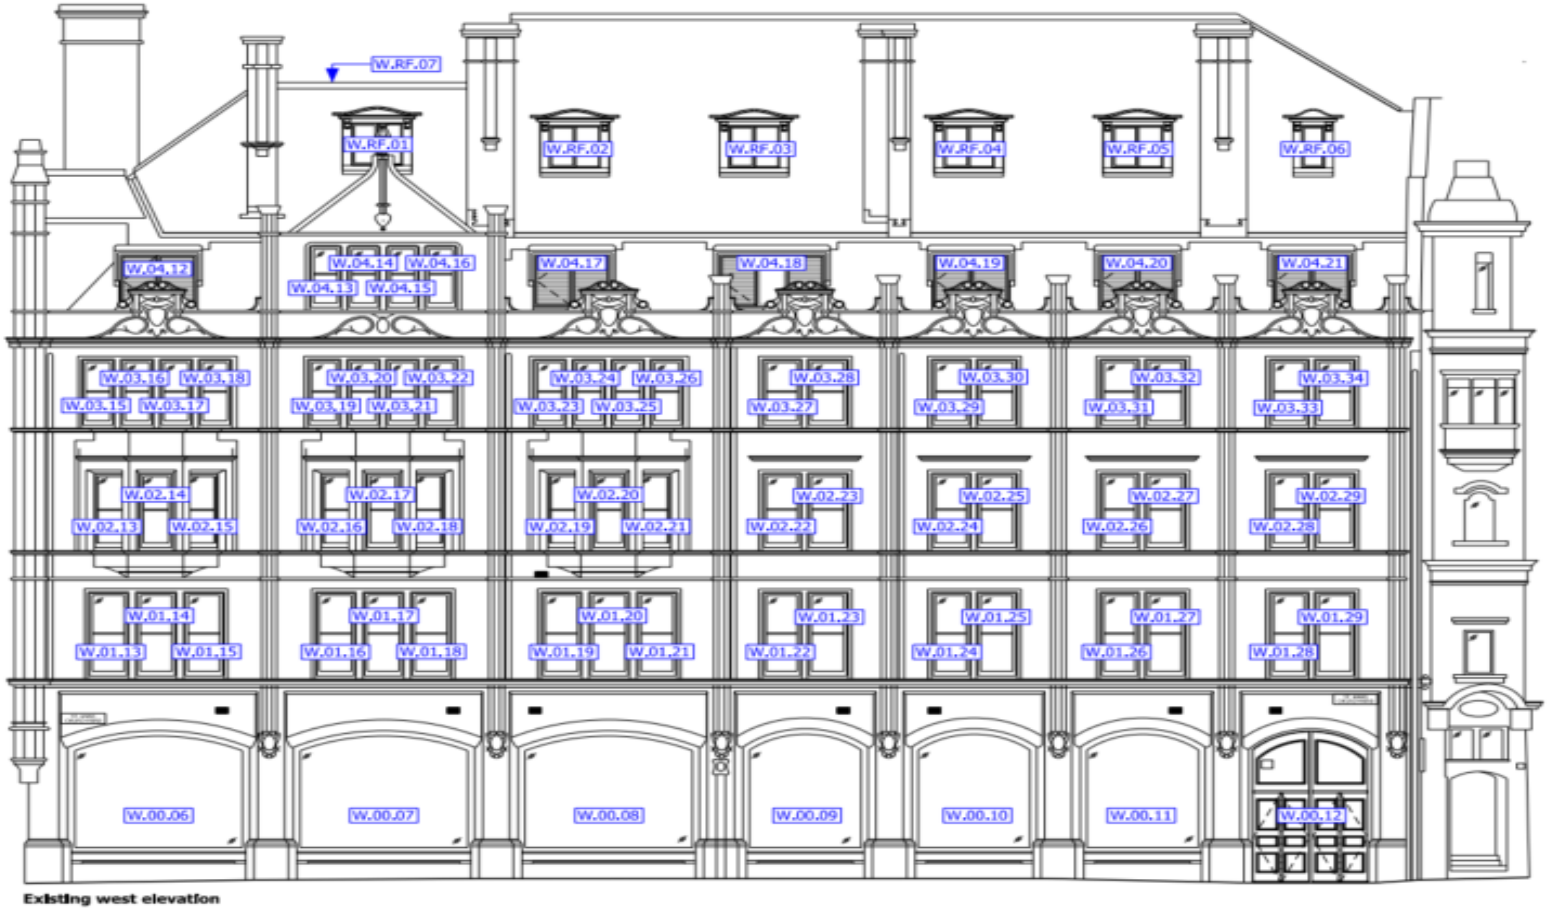
Front Elevation - 28-32 St Ann Street

2.1.3 The general overall condition of these windows are in good condition with minimal repairs/rot. It appears that the windows are original. All windows have been sealed shut and majority of the mastic appalled to the perimeter of the windows is soft and starting to fail.

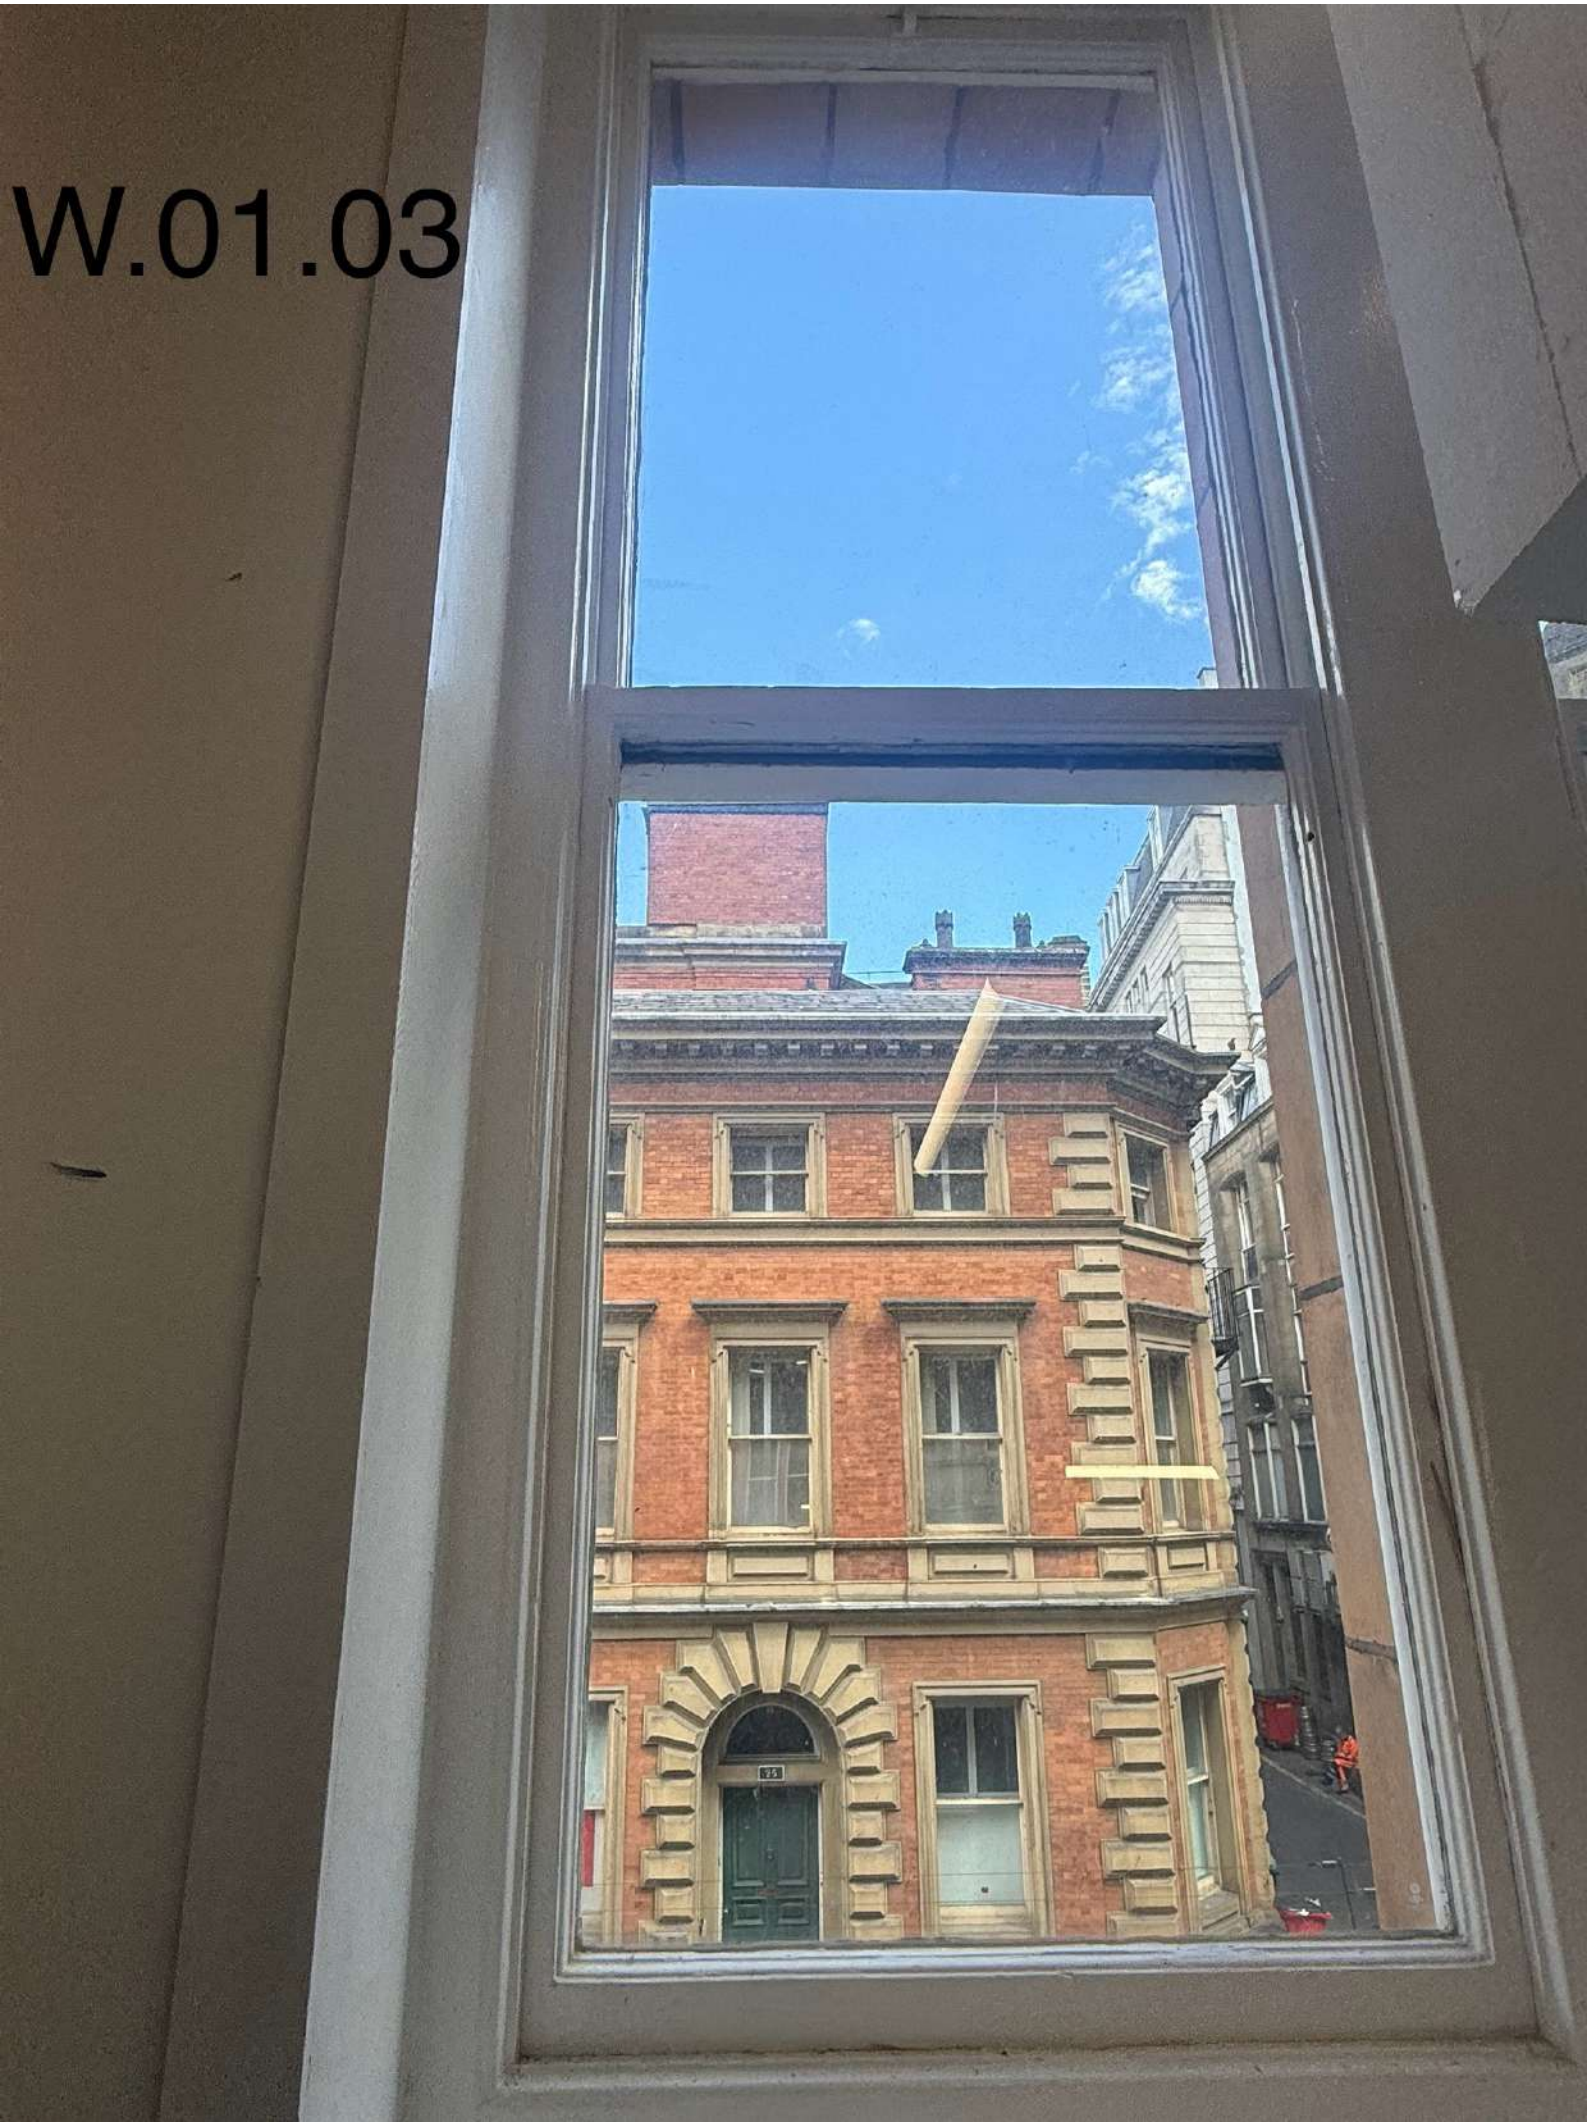
Side Elevation - 1 St Ann's Square

2.2.3 The general overall condition of the building in this area is in slightly worse condition to the front elevation, potentially due to this area being more open to the elements/weather.

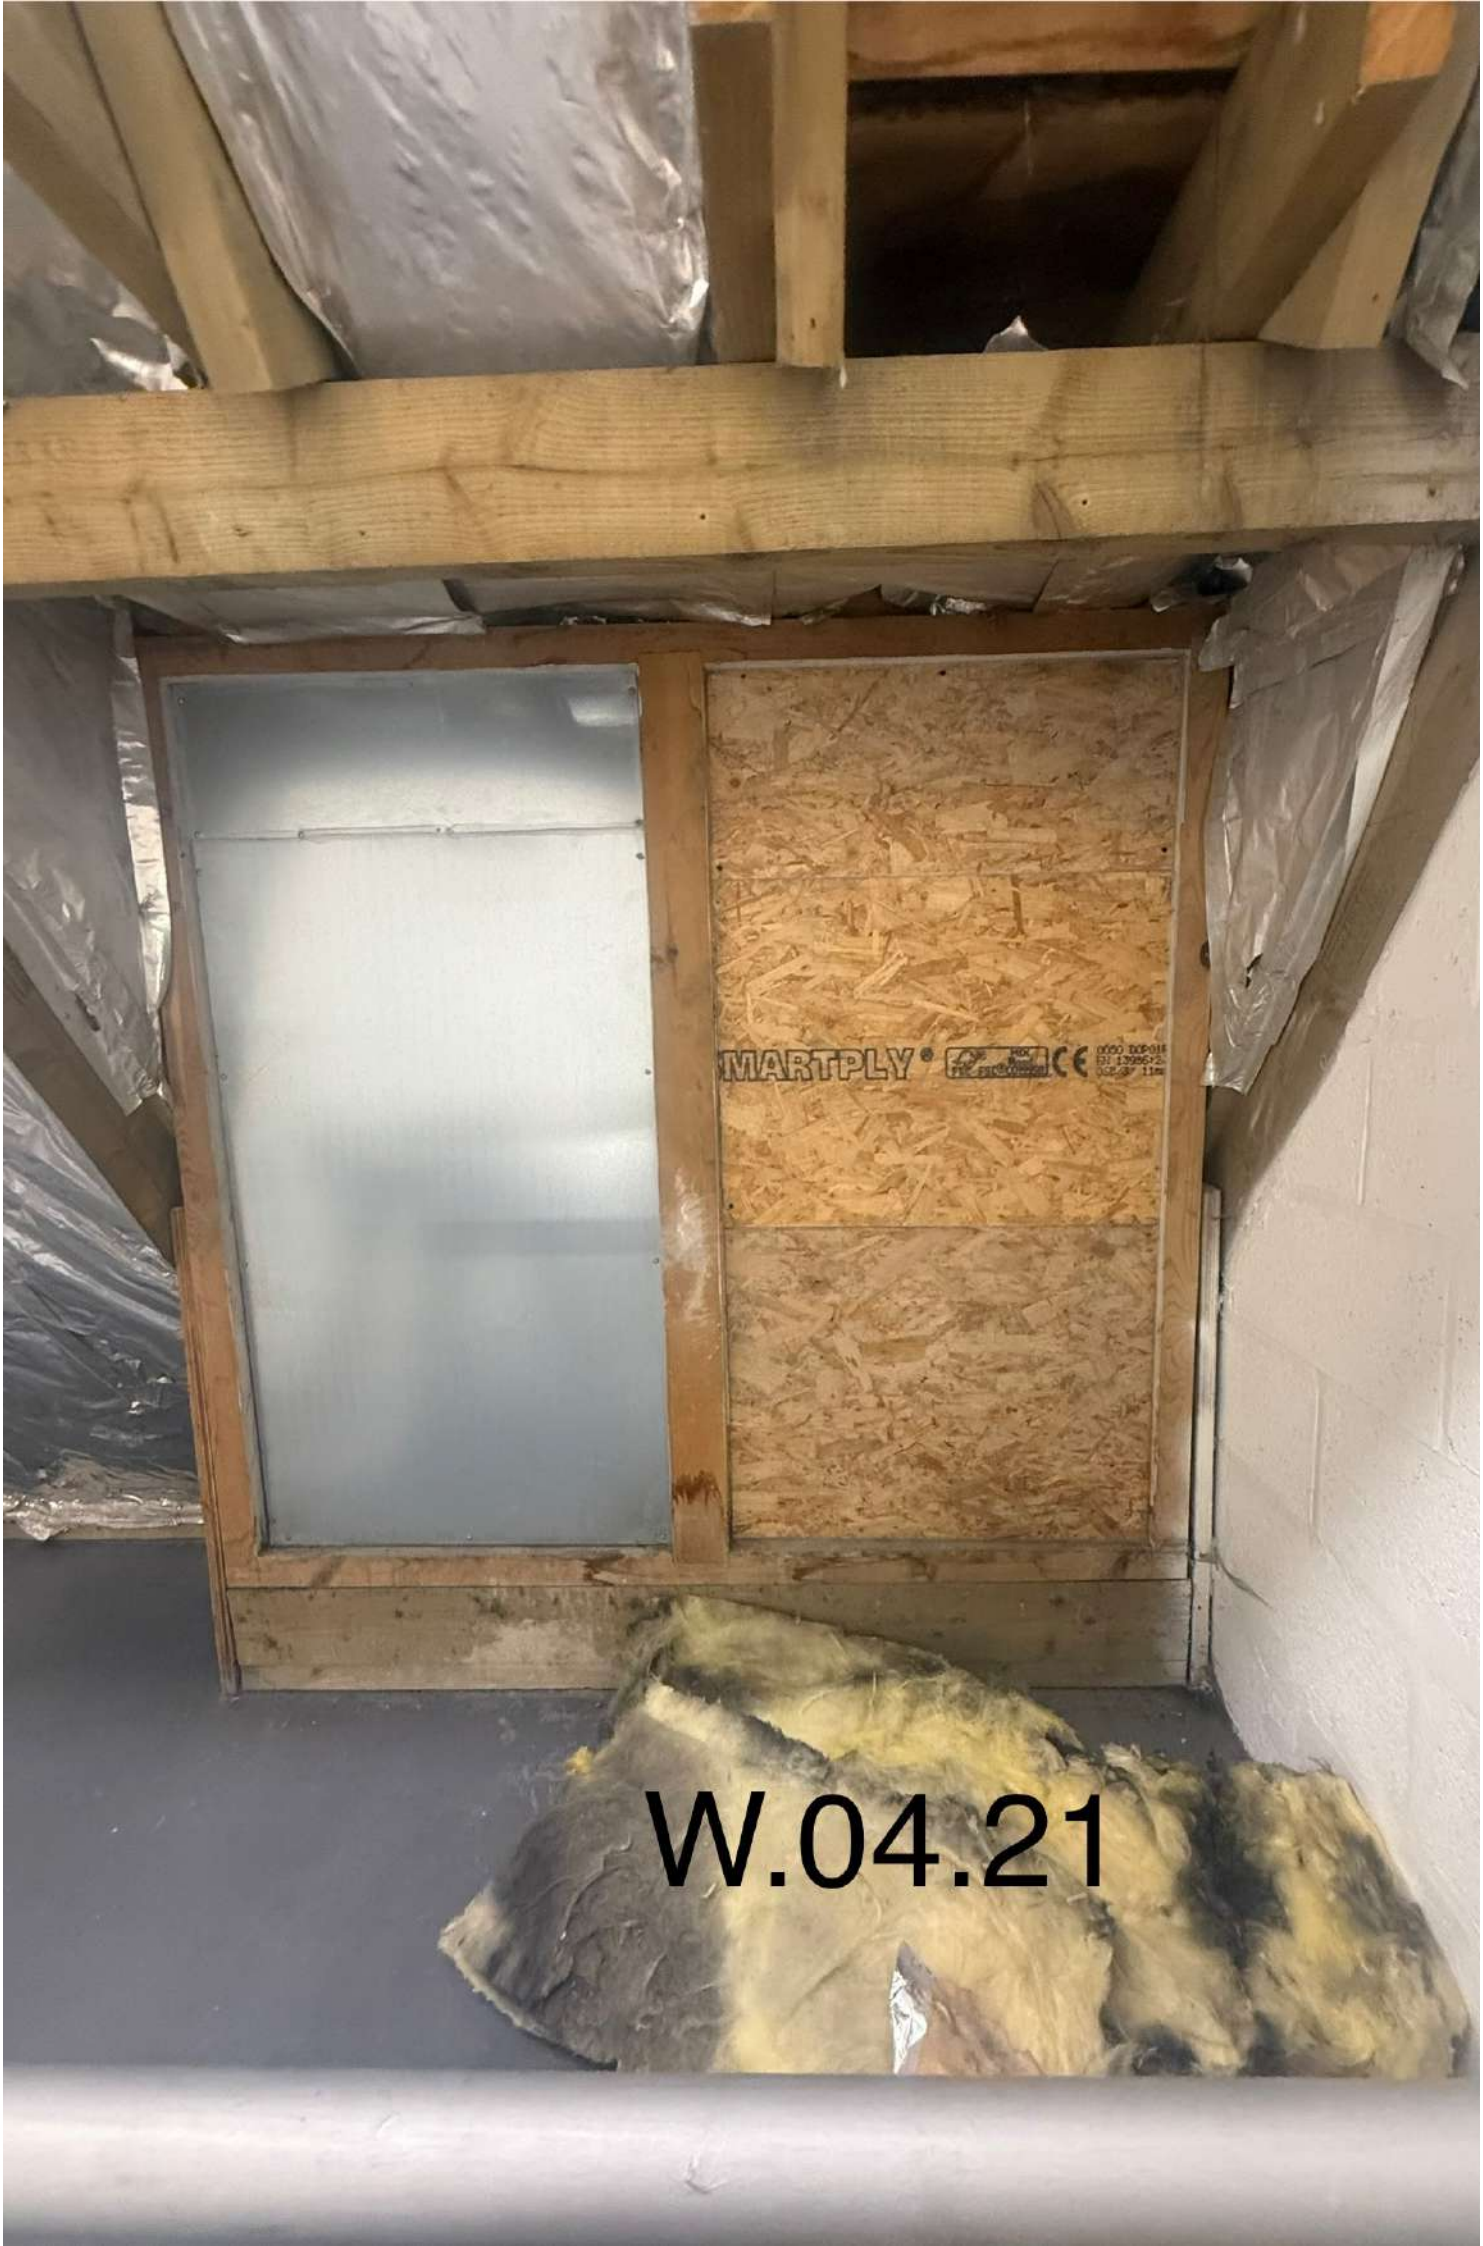
Photo of a rotten external window cill to W.04.15

W.04.13	2 x 1 pane sash	1700 x 800	Yes	SC	N/A	Single	N/A	5	4	4	Both sashes painted and sealed shut. Full cill replacement, 600 x 100 x 60. No cord to bottom sash assume the same on top sash	3
W.04.14	2 x 1 pane sash	1700 x 800	Yes	SC	N/A	Single	N/A	5	4	4	Both sashes painted and sealed shut. Full cill replacement, 600 x 100 x 60. No pully wheel & cord to bottom sash assume the same on top sash	3
W.04.15	2 x 1 pane sash	1700 x 800	Yes	SC	N/A	Single	N/A	5	4	4	Both sashes painted and sealed shut. Full cill replacement, 600 x 100 x 60. No pully wheel & cord to bottom sash assume the same on top sash	3
W.04.16	2 x 1 pane sash	1700 x 800	Yes	SC	Sash lifters	Single	N/A	5	4	4	Both sashes painted and sealed shut. Full cill replacement, 600 x 100 x 60.	3
W.04.21	2 x Louvre door casement	1600 x 1500	Yes	SH	Boarded up	Lourve	N/A	4	5	4	External access reduced via MEWP. Internally boarded up. Re hang LH door. Splace repair to frame 300 x 70.	4
