DONALD INSALL ASSOCIATES
50 Newton St, Condition Survey

West Elevation
Repairs/As proposed

Project	No
MNS.01	2213
Scale (A1)	Status / Revision
1:50	3P / 2

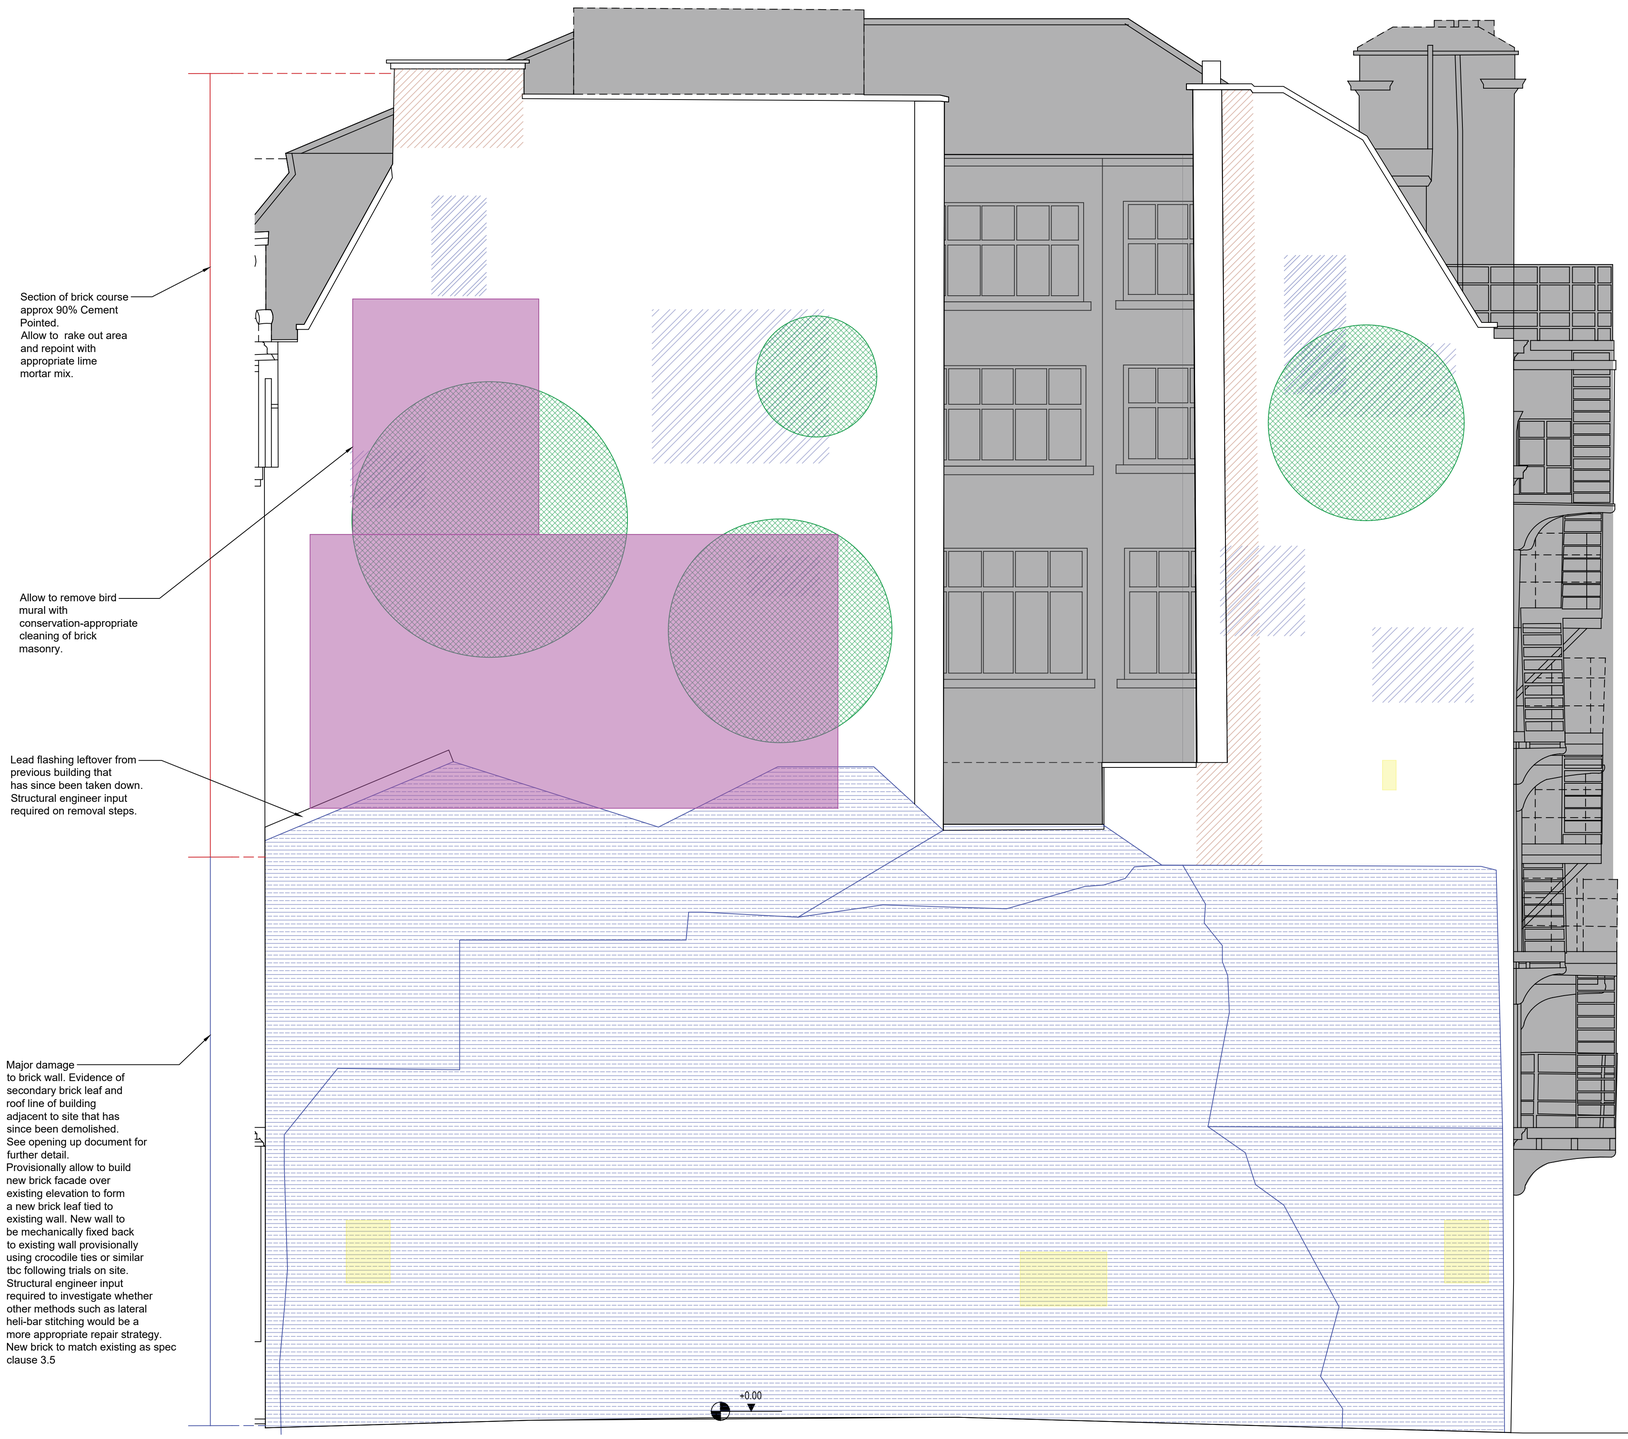
Defects to the brickwork

Delamination/ Erosion - Cut out existing bricks and renew whole brick to match exisiting as Spec Clause 3.0. Allow for 30% replacement as allowance

Cracking - Pin or grout cracks in masonry. SE to advice as Spec Clause 3.0

Chips - Replace brick unit in case of major damage as Spec Clause 3.0.

Damaged section of wall - Provisionally allow to build new brick facade over existing elevation to form a new brick leaf tied to existing wall. New wall to be mechanically fixed back to existing wall provisionally using crocodile ties or similar tbc following trials on site. Structural engineer input required to investigate whether other methods such as lateral heli-bar stitching would be a more appropriate repair strategy. New brick to match existing as spec clause 3.5

Defects to the teracotta

Delamination/Erosion - Allow to brush back and clean masonry. Replace with new to match existing in case of major damage as Spec Clause 3.5. Allow for 50% replacement as allowance

Cracking - Pin or grout cracks in masonry. SE to advice as Spec Clause 3.1.

Chips - Allow to brush back and clean masonry. Replace with new to match existing in case of major damage as Spec Clause 3.5. Allow for 50% replacement as allowance.

Defects due to soiling and vegetative growth

Salting/ Moisture in masonry: Brush off salts/efflorescence with natural bristle or synthetic nylon brush(collecting material for disposal off site) as Spec Clause.
Allow to **renew 40% masonry blocks** to saturated area as Spec Clause 3.5.

Cementitious pointing - rake out cementitious pointing & re-point area in lime mortar as Spec Clause 3.8

Open joints: re-point in lime mortar as Spec Clause 8.1

Render over teracotta - Clean area and remove render from face with after appropriate assessment. No power tools to be used in removal process. Allow to rub down undertake conservation -appropriate clean following render removal. Teracotta block may require replacement in case of damage following inspection after removal of render as Spec Clause 3.4.

Paint over teracotta - Clean area and remove paint from face with after appropriate assessment. No power tools to be used in removal process. Allow to rub down undertake conservation -appropriate clean following render removal. Teracotta block may require replacement in case of damage following inspection after removal of render as Spec Clause 3.4.

Damaged vents - Replace with new heritage appropriate vents.

Damaged RWG - Replace with new lead section to match existing as Spec Clause 7.2

Graffiti - Clean area and remove graffiti from face with after appropriate assessment. Removal and cleaning strategy to be confirmed. No power tools to be used in removal process. Allow to rub down and undertake conservation-appropriate clean as Spec Clause 2.0

Damage from removal of modern fittings - Make good section of the wall and allow to fill in all cracks and holes with appropriate lime mortar mix as Spec Clause 3.6

Damage due to render - Brush back masonry, defrass as needed and repoint all joints with appropriate lime mortar mix as Spec Clause 3.6.

Damage due to paint - Brush back masonry, defrass as needed and repoint all joints with appropriate lime mortar mix as Spec Clause 3.5.

Damaged glass - Replace with new to match existing as Spec Clause 10.1

Boarded up windows - Remove all boards and replace with new glass to match historic profiles as Spec Clause 10.1

Vents - Rub down and clean, replace with new in case of damage as per ventilation strategy as Spec Clause 10.4

Surface soiling: carry out careful analysis of masonry and surface soiling type prior to conducting cleaning trials. Conduct cleaning trials to find a suitable cleaning method and carry out, if not detrimental to the masonry condition as Spec Clause 2.1

Vegetation/ Branches: carefully remove vegetation growth and root zone and treat with suitable weed killer if required. Re-bed masonry and fill open joints where displaced by roots as Spec Clause 2.2
