DONALD INSALL ASSOCIATES
50 Newton St, Condition Survey

North Elevation
Repairs/As proposed

Project	No
MNS.01	2211
Scale (A1)	Status / Revision
1:100	3P / 2

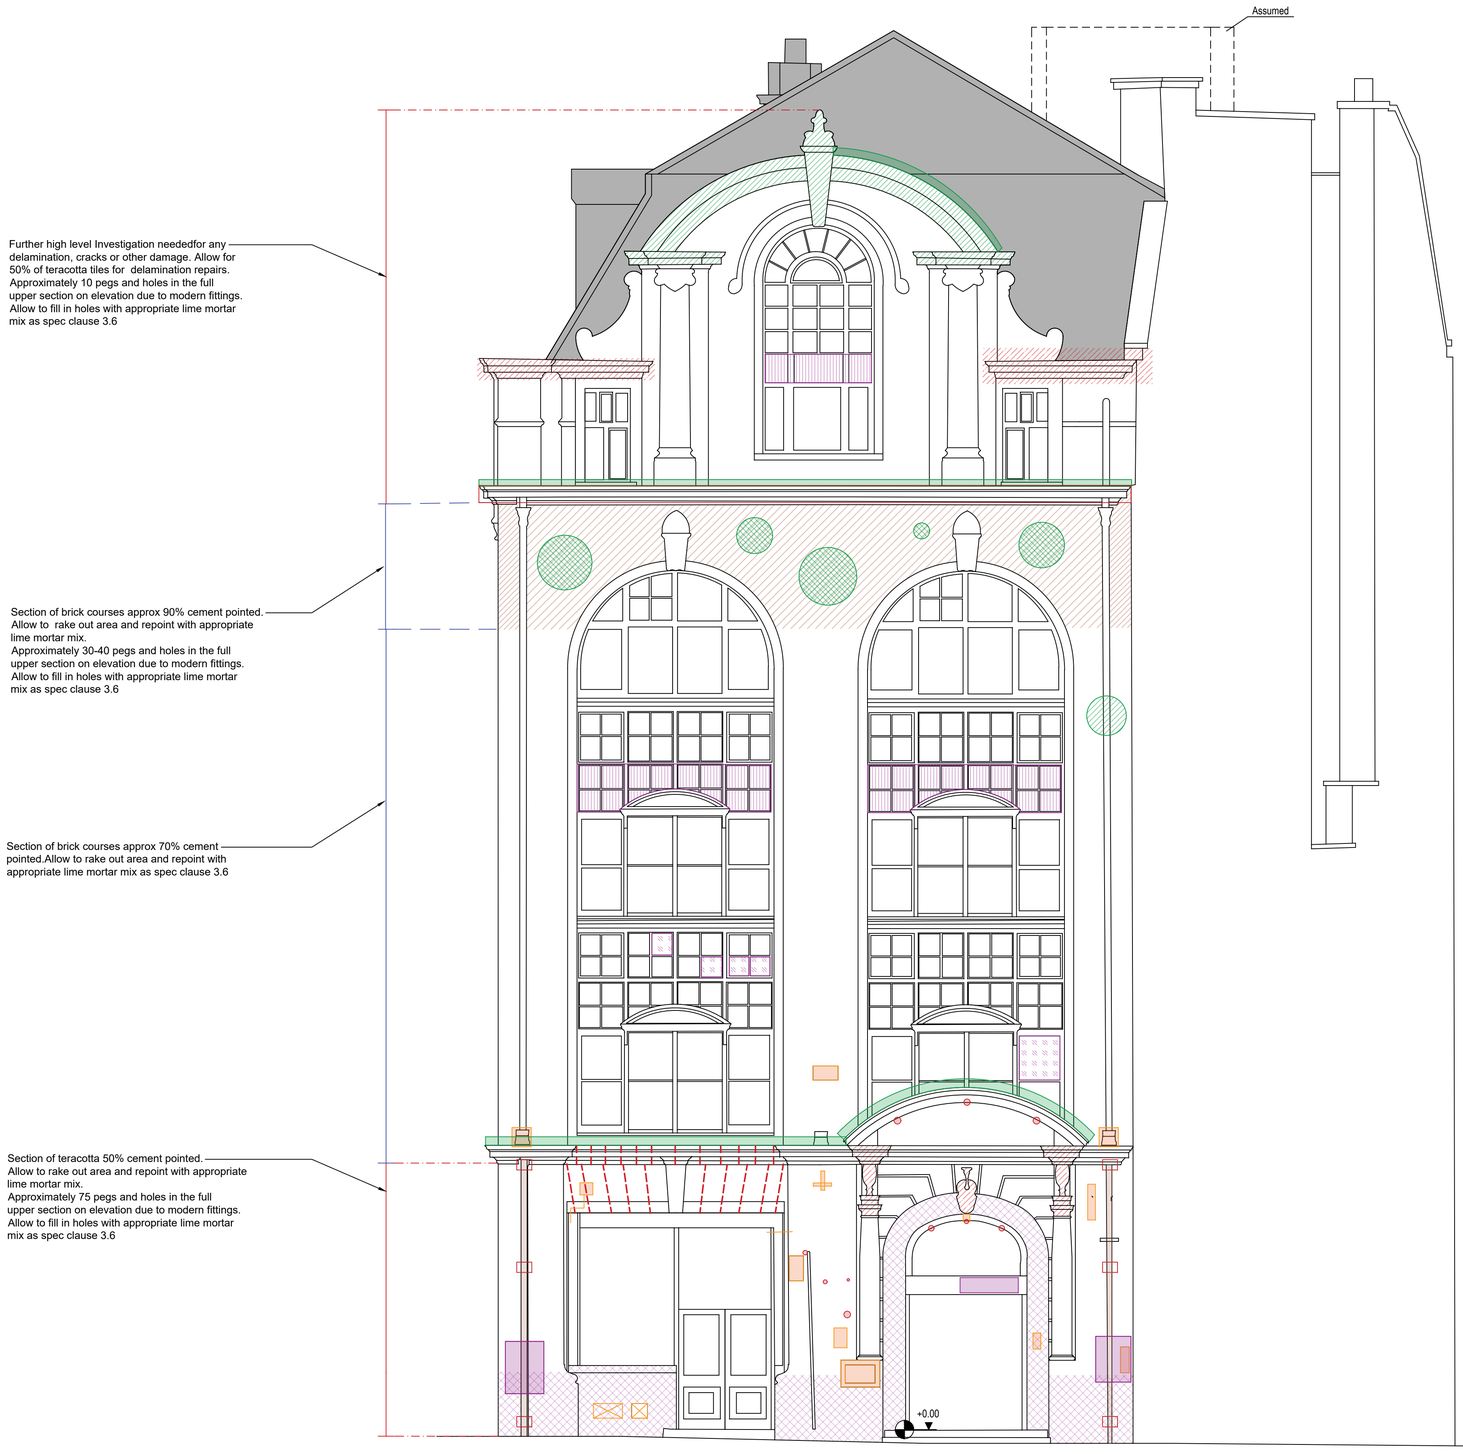
Repairs to the building fabric due to modern interventions

Defects to the brickwork

Defects to the windows

Defects to the teracotta

Defects due to soiling and vegetative growth

Items not accessible from ground level

Cementitious Pointing - rake out cementitious pointing & re-point area in lime mortar as Spec Clause 3.8

Open joints: re-point in lime mortar as Spec Clause 8.1

Modern fitting: remove where redundant & make good building fabric

Render over teracotta - Clean area and remove render from face with after appropriate assessment. No power tools to be used in removal process. Allow to rub down and undertake conservation-appropriate clean following render removal. Teracotta block may require replacement in case of damage following inspection after removal of render as Spec Clause 3.4.

Paint over teracotta - Clean area and remove paint from face with after appropriate assessment. No power tools to be used in removal process. Allow to rub down and undertake conservation-appropriate clean following render removal. Teracotta block may require replacement in case of damage following inspection after removal of render as Spec Clause 3.4.

Damaged vents - Replace with new heritage appropriate vents as Spec Clause 10.4.

Damaged modern fittings - Remove item if redundant and make good masonry as Spec Clause 3.5.

Damaged RWG - Replace with new section to match existing as Spec Clause 7.2

Graffiti - Clean area and remove graffiti from face with after appropriate assessment. Removal and cleaning strategy to be confirmed. No power tools to be used in removal process. Allow to rub down and undertake conservation-appropriate clean as Spec Clause 2.0

Delamination/ Erosion - Cut out existing bricks and renew whole brick to match exisiting as Spec Clause 3.0

Cracking - Pin or grout cracks in masonry. SE to advice as Spec Clause 3.0

Chips - Replace brick unit in case of major damage as Spec Clause 3.0

Damaged glass - Replace with new to match existing as Spec Clause 10.1

Boarded up windows - Remove all boards and replace with new glass to match historic profiles as Spec Clause 10.1

Vents - Rub down and clean, replace with new in case of damage as per ventilation strategy as Spec Clause 10.4

Delamination/Erosion - Allow to brush back and clean masonry. Replace with new to match existing in case of major damage as Spec Clause 3.5. Allow for 50% replacement as allowance

Cracking - Pin or grout cracks in masonry. SE to advice as Spec Clause 3.1.

Chips - Allow to brush back and clean masonry. Replace with new to match existing in case of major damage as Spec Clause 3.5. Allow for 50% replacement as allowance.

Damage from removal of modern fittings - Make good section of the wall and allow to fill in all cracks and holes with appropriate lime mortar mix as Spec Clause 3.6

Damage due to render - Brush back masonry, defrass as needed and repoint all joints with appropriate lime mortar mix as Spec Clause 3.6.

Damage due to paint - Brush back masonry, defrass as needed and repoint all joints with appropriate lime mortar mix as Spec Clause 3.5.

Surface soiling: carry out careful analysis of masonry and surface soiling type prior to conducting cleaning trials. Conduct cleaning trials to find a suitable cleaning method and carry out, if not detrimental to the masonry condition as Spec Clause 2.1

Vegetation/ Branches: carefully remove vegetation growth and root zone and treat with suitable weed killer if required. Re-bed masonry and fill open joints where displaced by roots as Spec Clause 2.2

Salting/ Moisture in masonry: Brush off salts/efflorescence with natural bristle or synthetic nylon brush(collecting material for disposal off site).
Allow to **renew 40% masonry blocks** to saturated area as Spec Clause 3.5.
