INTERIOR ELEVATIONS

Project Title	SIM CONFERENCE CENTRE
Client	SCIENCE MUSEUM GROUP
Location	MANCHESTER
Drawing ref	Fabric Repair Elevations as Proposed
Date	12/03/2025
Checker	AS
Job No:	9657
Scale	As indicated
Size	A1
Status	CONSTRUCTION

SMGCON-BUT-SI-02-DR-A-05001-C02

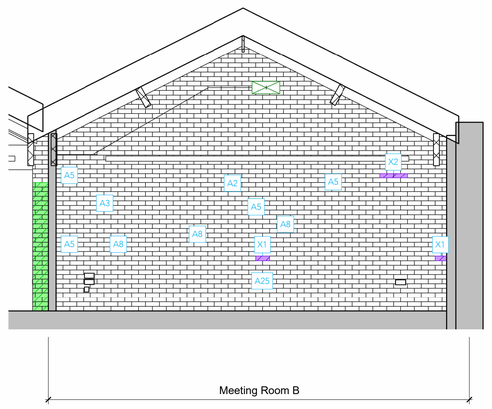
Cill Repairs Notes:

- Existing windows are to remain insitu.
- Protect all existing fabric (windows / walls / floors etc.).
- Provide samples for inspection, prior to wholesale works.

1. Brush down all cills with a stiff bristle brush to remove all loose and friable material, ensuring the removal of all tape, adhesive residues, and surface contaminates etc.
2. Where cills have been identified to require a mortar repair, the exact extent is to be confirmed following defrass / redressing to a sound surface.
3. Repair mortar is to match existing stone in colour and texture, and profiled to replicate the original cill detail.
4. In instances where large extent of cill has failed / become defective, allow for careful cutting out and indent new stone to match existing in size, colour, texture and profile.
