MARLSBRO HOUSE, MANCHESTER

ATTIC EXISTING STRUCTURE WITH DEFECTS PLAN

DRAWING No.	REV
1698-CIV-XX-04-D-S-10004	P03

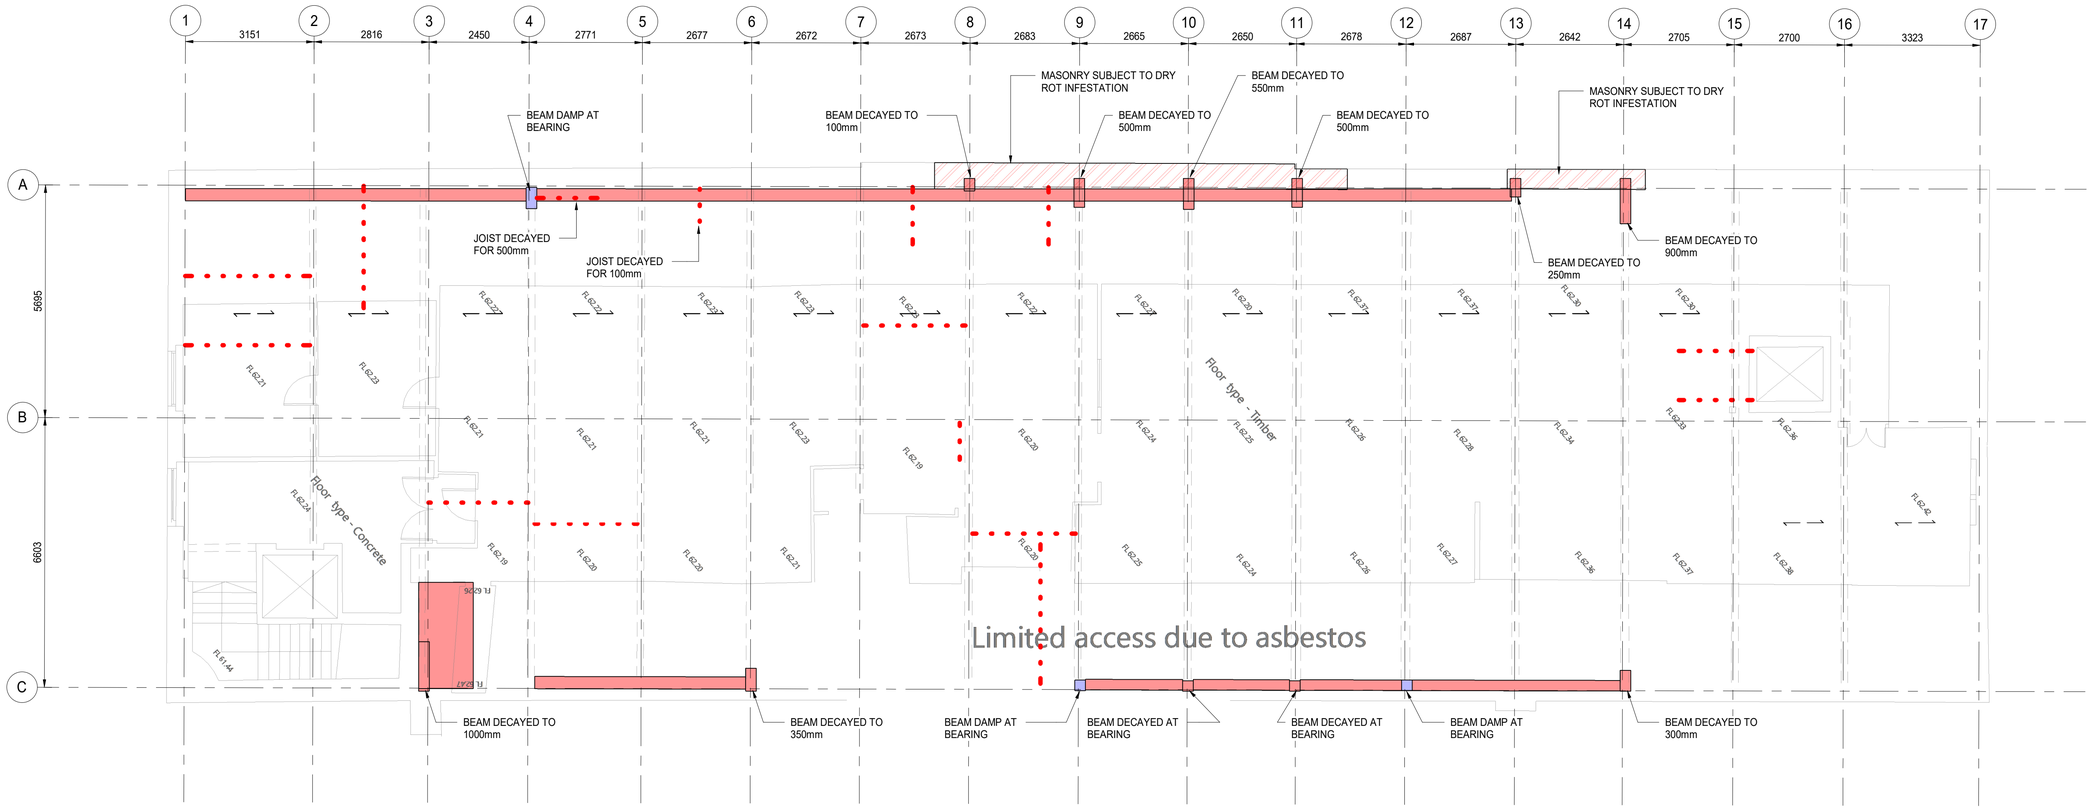
FOURTH FLOOR LAYOUT

FURTHER DEFECTS MAY BECOME APPARENT AS FURTHER FLOOR, CEILING AND WALL FINISHES ARE REMOVED

1. EXTENTS OF STRENGTHENING WORKS HAS BEEN DETERMINED BASED ON THE FOLLOWING ASSUMPTIONS:-
   - MILLBOARDS ARE MINIMUM TIMBER GRADE C16
   - EXISTING TIMBER BEAMS ARE GRADE C24

- ALL EXISTING FLOOR FINISHES, CEILINGS & SERVICES ARE REMOVED, LEAVING THE PRIMARY STRUCTURE OF THE MILLBOARDS & TIMBER BEAMS ONLY
   - SUPER IMPOSED DEAD LOAD ALLOWANCE OF 0.55kN/m²

- VARIABLE IMPOSED LOAD ALLOWANCE FOR RESTAURANT, LOUNGE & CIRCULATION AREAS = 4kN/m²
   - VARIABLE IMPOSED LOAD ALLOWANCE FOR OFFICE AREAS = 3.5 kN/m²

- VARIABLE IMPOSED LOAD ALLOWANCE FOR BASEMENT BAR = 5.0 kN/m²
2. ANY BEAMS WHICH CANNOT BE DESIGNATED AS SS/C24 WILL REQUIRE STRENGTHENING
3. IF LOUNGE & RESTAURANT AREAS COULD BE SUBJECTED TO LOADS DUE TO PHYSICAL ACTIVITIES OR OVERCROWDING, EG ROOM USED AS A DANCE FLOOR, THE IMPOSED LOADS WILL BE HIGHER & MORE EXTENSIVE STRENGTHENING WILL BE REQUIRED.

4. THE BRICKWORK EITHER SIDE OF DAMP BEAMS SHOULD BE TEMPORARILY REMOVED FOR THE DURATION OF THE PROJECT TO IMPROVE VENTILATION & ALLOW DRYING TO OCCUR,FOLLOWING WHICH BRICKWORK CAN BE REINSTATED.

5. EXISTING METAL TONGUES SHOULD BE SALVAGED FROM DECAYED MILLBOARDS & REINSTATED WITHIN THE GROOVES OF THE NEW MILLBOARDS.
