MARLSBRO HOUSE, MANCHESTER

FIRST FLOOR EXISTING STRUCTURE WITH DEFECTS PLAN

DRAWING No.	REV
1698-CIV-XX-01-D-S-10001	P03

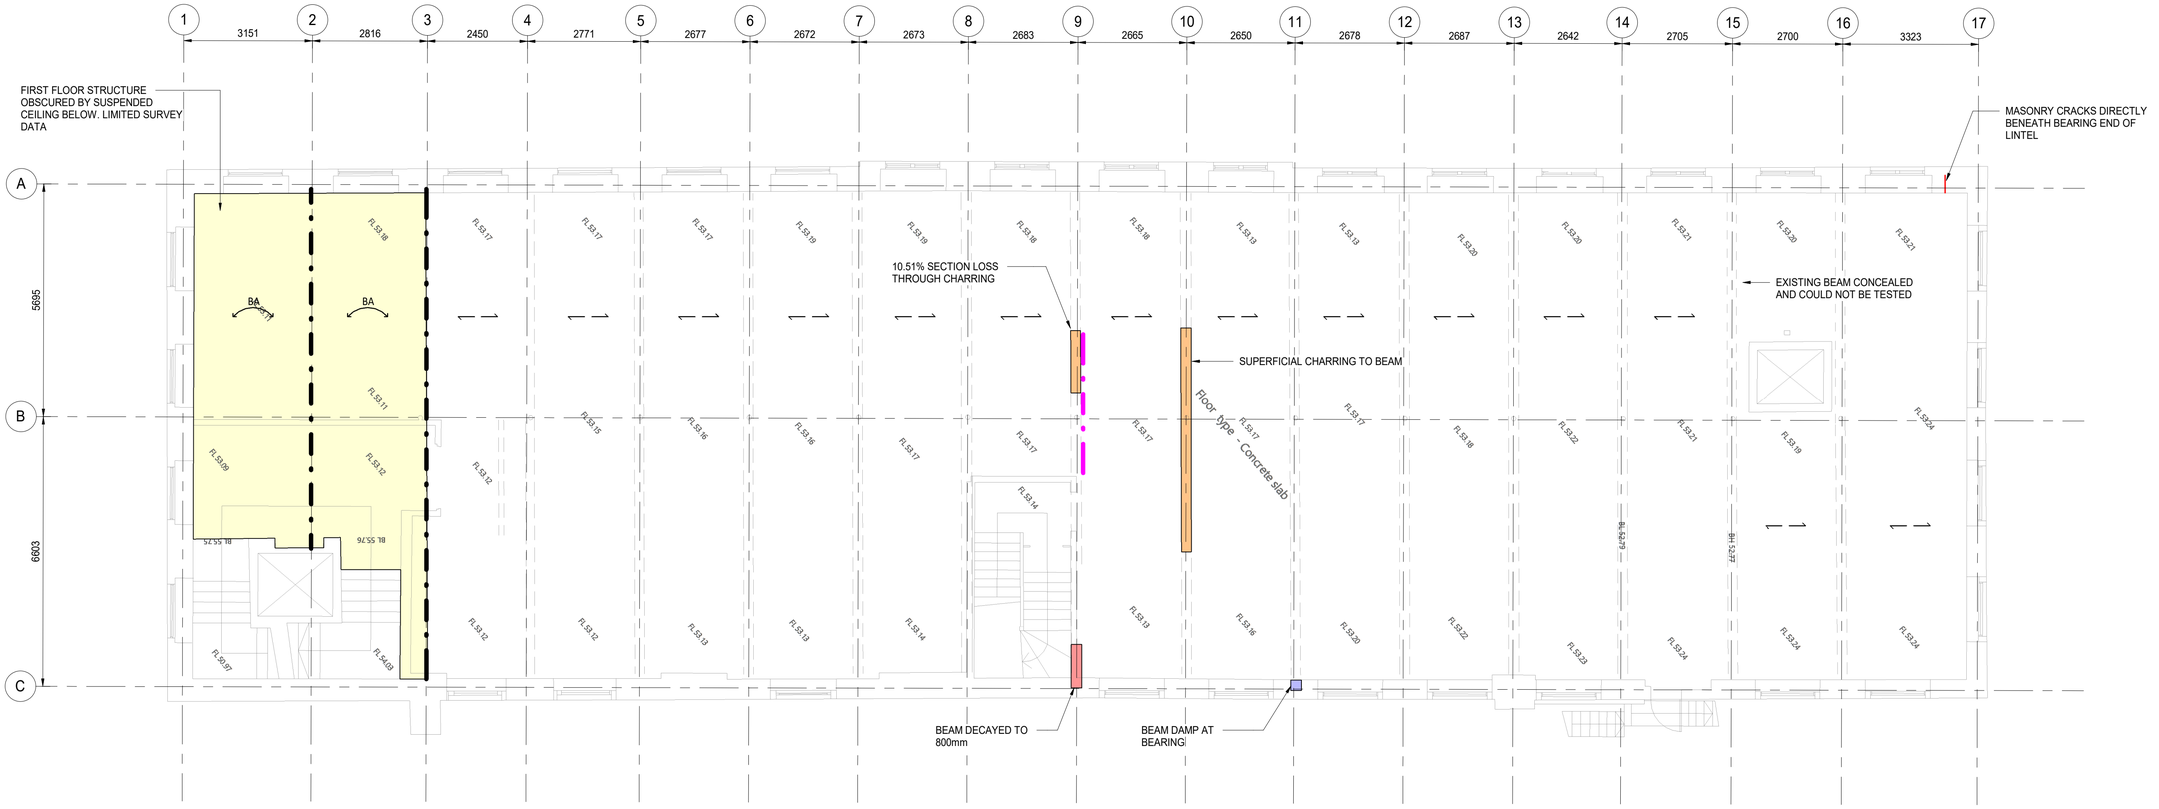
FIRST FLOOR LAYOUT

FURTHER DEFECTS MAY BECOME APPARENT AS FURTHER FLOOR, CEILING AND WALL FINISHES ARE REMOVED

1. EXTENTS OF STRENGTHENING WORKS HAS BEEN DETERMINED BASED ON THE FOLLOWING ASSUMPTIONS:-
   - MILLBOARDS ARE MINIMUM TIMBER GRADE C16
   - EXISTING TIMBER BEAMS ARE GRADE C24

- ALL EXISTING FLOOR FINISHES, CEILINGS & SERVICES ARE REMOVED, LEAVING THE PRIMARY STRUCTURE OF THE MILLBOARDS & TIMBER BEAMS ONLY
   - SUPER IMPOSED DEAD LOAD ALLOWANCE OF 0.55kN/m²

- VARIABLE IMPOSED LOAD ALLOWANCE FOR RESTAURANT, LOUNGE & CIRCULATION AREAS = 4kN/m²
   - VARIABLE IMPOSED LOAD ALLOWANCE FOR OFFICE AREAS = 3.5 kN/m²

- VARIABLE IMPOSED LOAD ALLOWANCE FOR BASEMENT BAR = 5.0 kN/m²
2. ANY BEAMS WHICH CANNOT BE DESIGNATED AS SS/C24 WILL REQUIRE STRENGTHENING
3. IF LOUNGE & RESTAURANT AREAS COULD BE SUBJECTED TO LOADS DUE TO PHYSICAL ACTIVITIES OR OVERCROWDING, EG ROOM USED AS A DANCE FLOOR, THE IMPOSED LOADS WILL BE HIGHER & MORE EXTENSIVE STRENGTHENING WILL BE REQUIRED.

4. THE BRICKWORK EITHER SIDE OF DAMP BEAMS SHOULD BE TEMPORARILY REMOVED FOR THE DURATION OF THE PROJECT TO IMPROVE VENTILATION & ALLOW DRYING TO OCCUR,FOLLOWING WHICH BRICKWORK CAN BE REINSTATED.

5. EXISTING METAL TONGUES SHOULD BE SALVAGED FROM DECAYED MILLBOARDS & REINSTATED WITHIN THE GROOVES OF THE NEW MILLBOARDS.
