MARLSBRO HOUSE, MANCHESTER

BASEMENT EXISTING STRUCTURE WITH DEFECTS PLAN

DRAWING No.	REV
1698-CIV-XX-B1-D-S-10010	P03

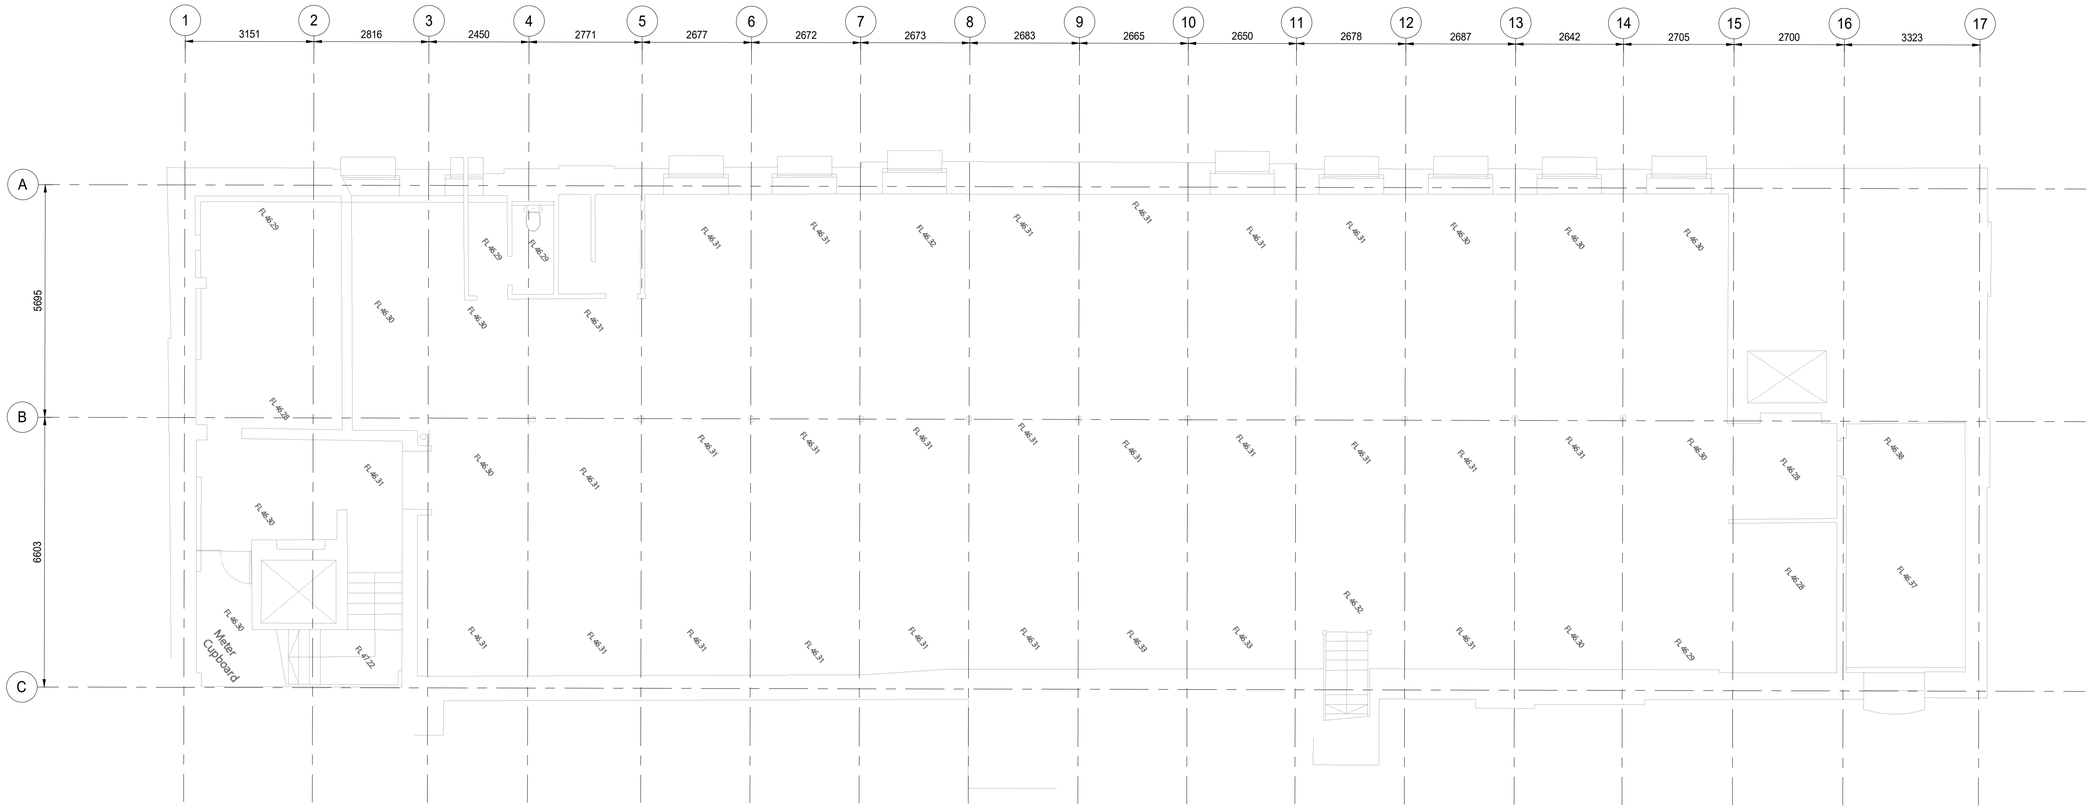
BASEMENT LAYOUT

FURTHER DEFECTS MAY BECOME APPARENT AS FURTHER FLOOR, CEILING AND WALL FINISHES ARE REMOVED

1. EXTENTS OF STRENGTHENING WORKS HAS BEEN DETERMINED BASED ON THE FOLLOWING ASSUMPTIONS:-
   - MILLBOARDS ARE MINIMUM TIMBER GRADE C16
   - EXISTING TIMBER BEAMS ARE GRADE C24

- ALL EXISTING FLOOR FINISHES, CEILINGS & SERVICES ARE REMOVED, LEAVING THE PRIMARY STRUCTURE OF THE MILLBOARDS & TIMBER BEAMS ONLY
   - SUPER IMPOSED DEAD LOAD ALLOWANCE OF 0.55kN/m^2

- VARIABLE IMPOSED LOAD ALLOWANCE FOR RESTAURANT, LOUNGE & CIRCULATION AREAS = 4kN/m^2
   - VARIABLE IMPOSED LOAD ALLOWANCE FOR OFFICE AREAS = 3.5 kN/m^2

- VARIABLE IMPOSED LOAD ALLOWANCE FOR BASEMENT BAR = 5.0 kN/m^2
2. ANY BEAMS WHICH CANNOT BE DESIGNATED AS SS/C24 WILL REQUIRE STRENGTHENING
3. IF LOUNGE & RESTAURANT AREAS COULD BE SUBJECTED TO LOADS DUE TO PHYSICAL ACTIVITIES OR OVERCROWDING, EG ROOM USED AS A DANCE FLOOR, THE IMPOSED LOADS WILL BE HIGHER & MORE EXTENSIVE STRENGTHENING WILL BE REQUIRED.

4. THE BRICKWORK EITHER SIDE OF DAMP BEAMS SHOULD BE TEMPORARILY REMOVED FOR THE DURATION OF THE PROJECT TO IMPROVE VENTILATION & ALLOW DRYING TO OCCUR,FOLLOWING WHICH BRICKWORK CAN BE REINSTATED.

5. EXISTING METAL TONGUES SHOULD BE SALVAGED FROM DECAYED MILLBOARDS & REINSTATED WITHIN THE GROOVES OF THE NEW MILLBOARDS.
