MARLSBRO HOUSE, MANCHESTER

SECOND FLOOR EXISTING STRUCTURE WITH DEFECTS PLAN

DRAWING No.	REV
1698-CIV-XX-02-D-S-10002	P03

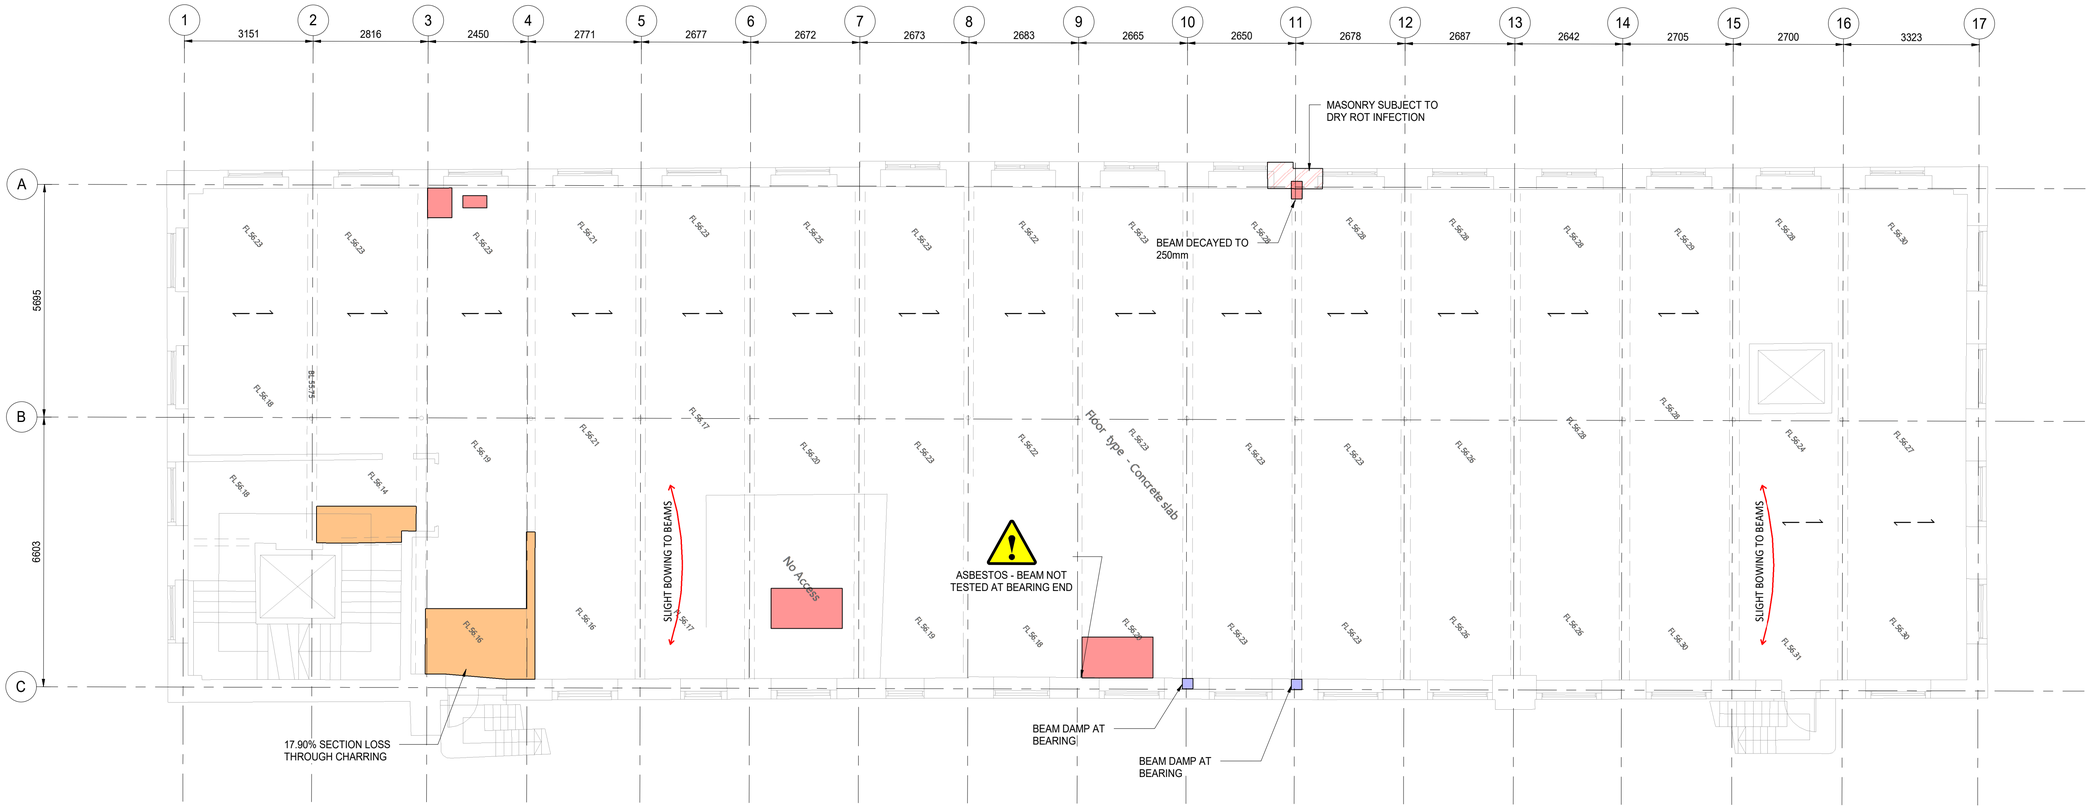
SECOND FLOOR LAYOUT

FURTHER DEFECTS MAY BECOME APPARENT AS FURTHER FLOOR, CEILING AND WALL FINISHES ARE REMOVED

- VARIABLE IMPOSED LOAD ALLOWANCE FOR BASEMENT BAR = 5.0 kN/m²
2. ANY BEAMS WHICH CANNOT BE DESIGNATED AS SS/C24 WILL REQUIRE STRENGTHENING
3. IF LOUNGE & RESTAURANT AREAS COULD BE SUBJECTED TO LOADS DUE TO PHYSICAL ACTIVITIES OR OVERCROWDING, EG ROOM USED AS A DANCE FLOOR, THE IMPOSED LOADS WILL BE HIGHER & MORE EXTENSIVE STRENGTHENING WILL BE REQUIRED.

4. THE BRICKWORK EITHER SIDE OF DAMP BEAMS SHOULD BE TEMPORARILY REMOVED FOR THE DURATION OF THE PROJECT TO IMPROVE VENTILATION & ALLOW DRYING TO OCCUR,FOLLOWING WHICH BRICKWORK CAN BE REINSTATED.

5. EXISTING METAL TONGUES SHOULD BE SALVAGED FROM DECAYED MILLBOARDS & REINSTATED WITHIN THE GROOVES OF THE NEW MILLBOARDS.
