MARLSBRO HOUSE, MANCHESTER

THIRD FLOOR EXISTING STRUCTURE WITH DEFECTS PLAN

| DRAWING No. | REV |
|---|---|
| 1698-CIV-XX-03-D-S-10003 | P03 |

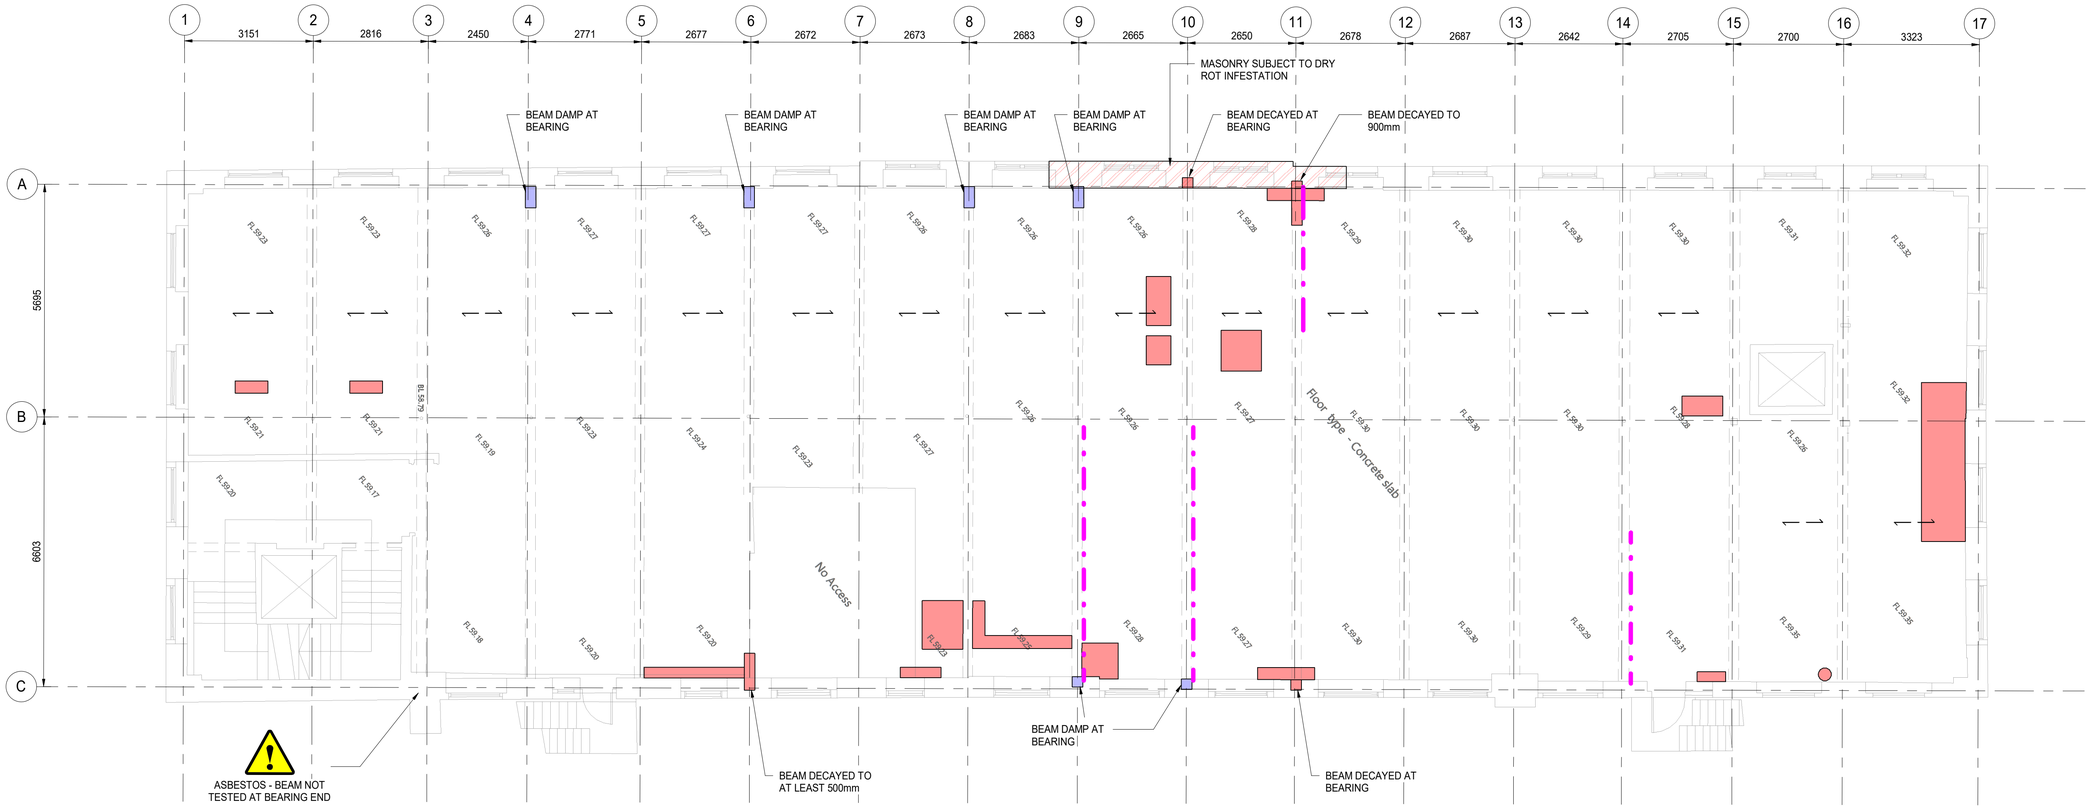
## THIRD FLOOR LAYOUT

FURTHER DEFECTS MAY BECOME APPARENT AS FURTHER FLOOR, CEILING AND WALL FINISHES ARE REMOVED

- = STRUCTURALLY DECAYED TIMBER
- = DAMP TIMBER AT RISK OF DECAY REFER TO NOTE 4
- = AREA OF FIRE DAMAGE
- = PREVIOUS STEEL REPAIR/ INTERVENTION REMOVED
- = DEMOLITION OF EXISTING BUILDING FLOORS
- = DEMOLITION OF EXISTING BUILDING WALLS
- = REINSTATEMENT/ RESTORATION OF PREVIOUS EXISTING OPENINGS & LINTELS
- = DEMOLITION OF EXISTING BUILDING FABRIC
- = FRACTURED/ DEFECTIVE/ DEFORMED JOIST
- = EXISTING STEEL REPAIR/ INTERVENTION
- = EXISTING STEEL/ IRON BEAM
- BA = EXISTING BRICK ARCH FLOOR STRUCTURE
- = SPAN OF EXISTING MILLBOARDS
- = NEW STEEL COLUMN/ HANGER
- = NEW PADSTONE
- = AREA OF DAMAGED MILLBOARDS REPLACED LIKE-FOR-LIKE WITH EXISTING (TYPICALLY SPANNING ACROSS TWO BAYS) REFER TO NOTE 5
- = NEW STEEL BEAM
- = SPAN OF NEW MILLBOARDS
- = SPAN OF NEW FLOOR BOARDS TO REPLACE EXISTING

4. THE BRICKWORK EITHER SIDE OF DAMP BEAMS SHOULD BE TEMPORARILY REMOVED FOR THE DURATION OF THE PROJECT TO IMPROVE VENTILATION & ALLOW DRYING TO OCCUR,FOLLOWING WHICH BRICKWORK CAN BE REINSTATED.

5. EXISTING METAL TONGUES SHOULD BE SALVAGED FROM DECAYED MILLBOARDS & REINSTATED WITHIN THE GROOVES OF THE NEW MILLBOARDS.
