MARLSBRO HOUSE, MANCHESTER

EXISTING STRUCTURE WITH DEFECTS ELEVATIONS

DRAWING No.	REV
1698-CIV-XX-ZZ-D-S-13001	P03

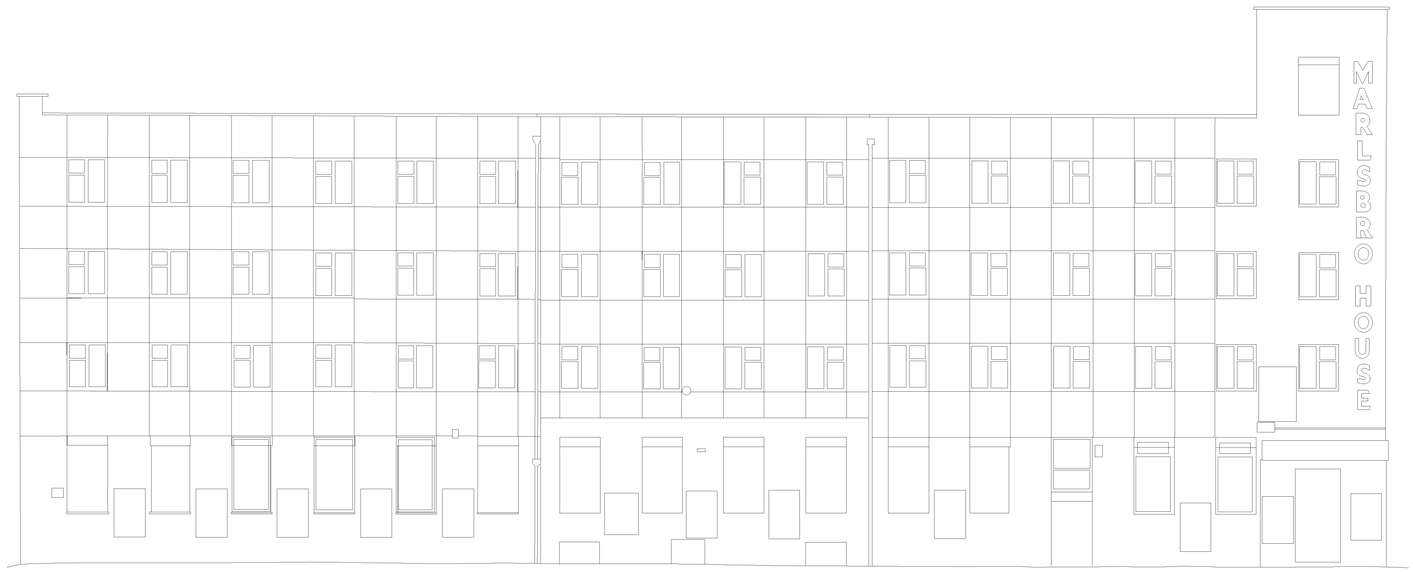
HILTON STREET EXISTING ELEVATION

SCHEDULE OF DEFECTS TO THE ELEVATIONS TO BE PRODUCED FOLLOWING REMOVAL OF EXISTING RENDER TO ALL FACADES.
