MARLSBRO HOUSE, MANCHESTER

ROOF EXISTING STRUCTURE WITH DEFECTS PLAN

DRAWING No.	REV
1698-CIV-XX-R1-D-S-10005	P03

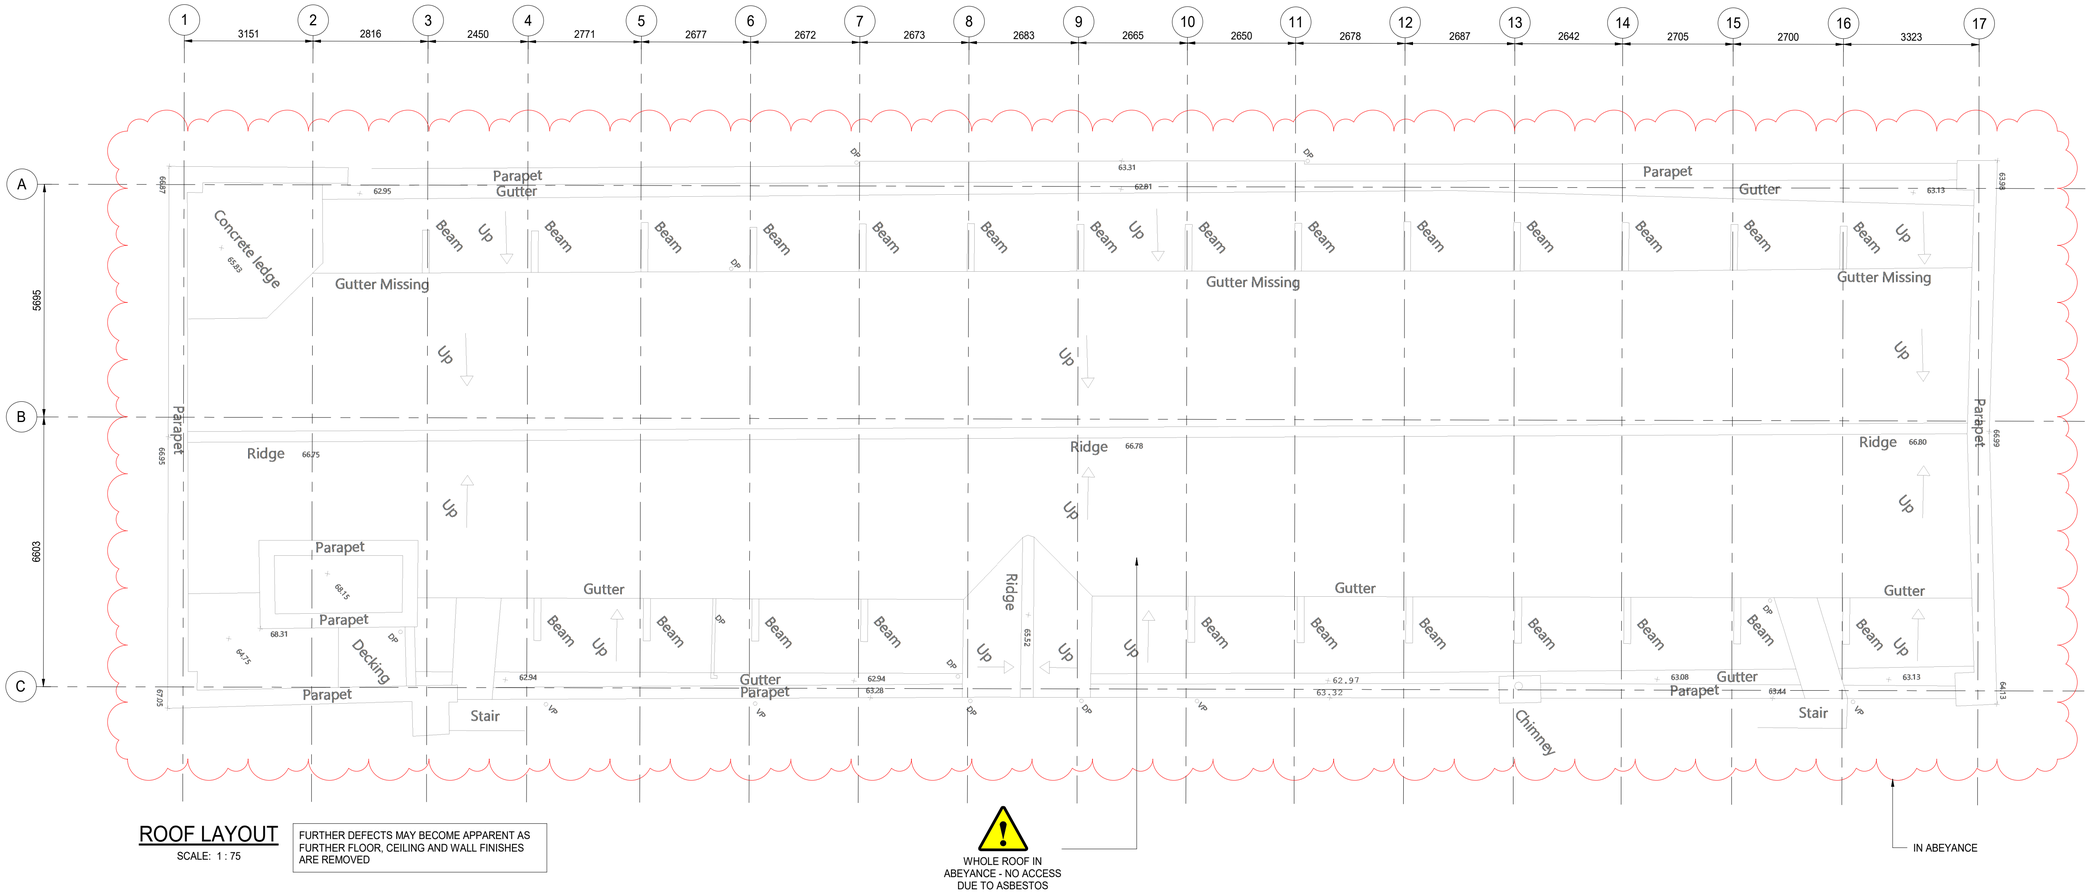
ROOF LAYOUT

FURTHER DEFECTS MAY BECOME APPARENT AS FURTHER FLOOR, CEILING AND WALL FINISHES ARE REMOVED

WHOLE ROOF IN ABEYANCE - NO ACCESS DUE TO ASBESTOS

BASED ON AVAILABLE PHOTOGRAPHIC EVIDENCE, IT IS ANTICIPATED THAT THE MAJORITY OF THE EXISTING TIMBER RAFTERS AND SARKING BOARDS WILL BE SIGNIFICANTLY STRUCTURALLY DECAYED TO THE POINT WHERE THEY REQUIRE REPLACEMENT.

THIS IS TO BE FURTHER INVESTIGATED THOUGH SPECIALIST SURVEYS AND TESTING FOLLOWING ASBESTOS REMOVAL
