Fabric Repairs_West Elevation (Right) as Existing

Project
Education North: Undergraduate Building

Drawing Title
Fabric Repairs - West Elevation as Existing (Sheet 1 of 2)

Department No:	Drg No.	Revision	Sheet Size
MAN	L(02)205	P02	1 : 50

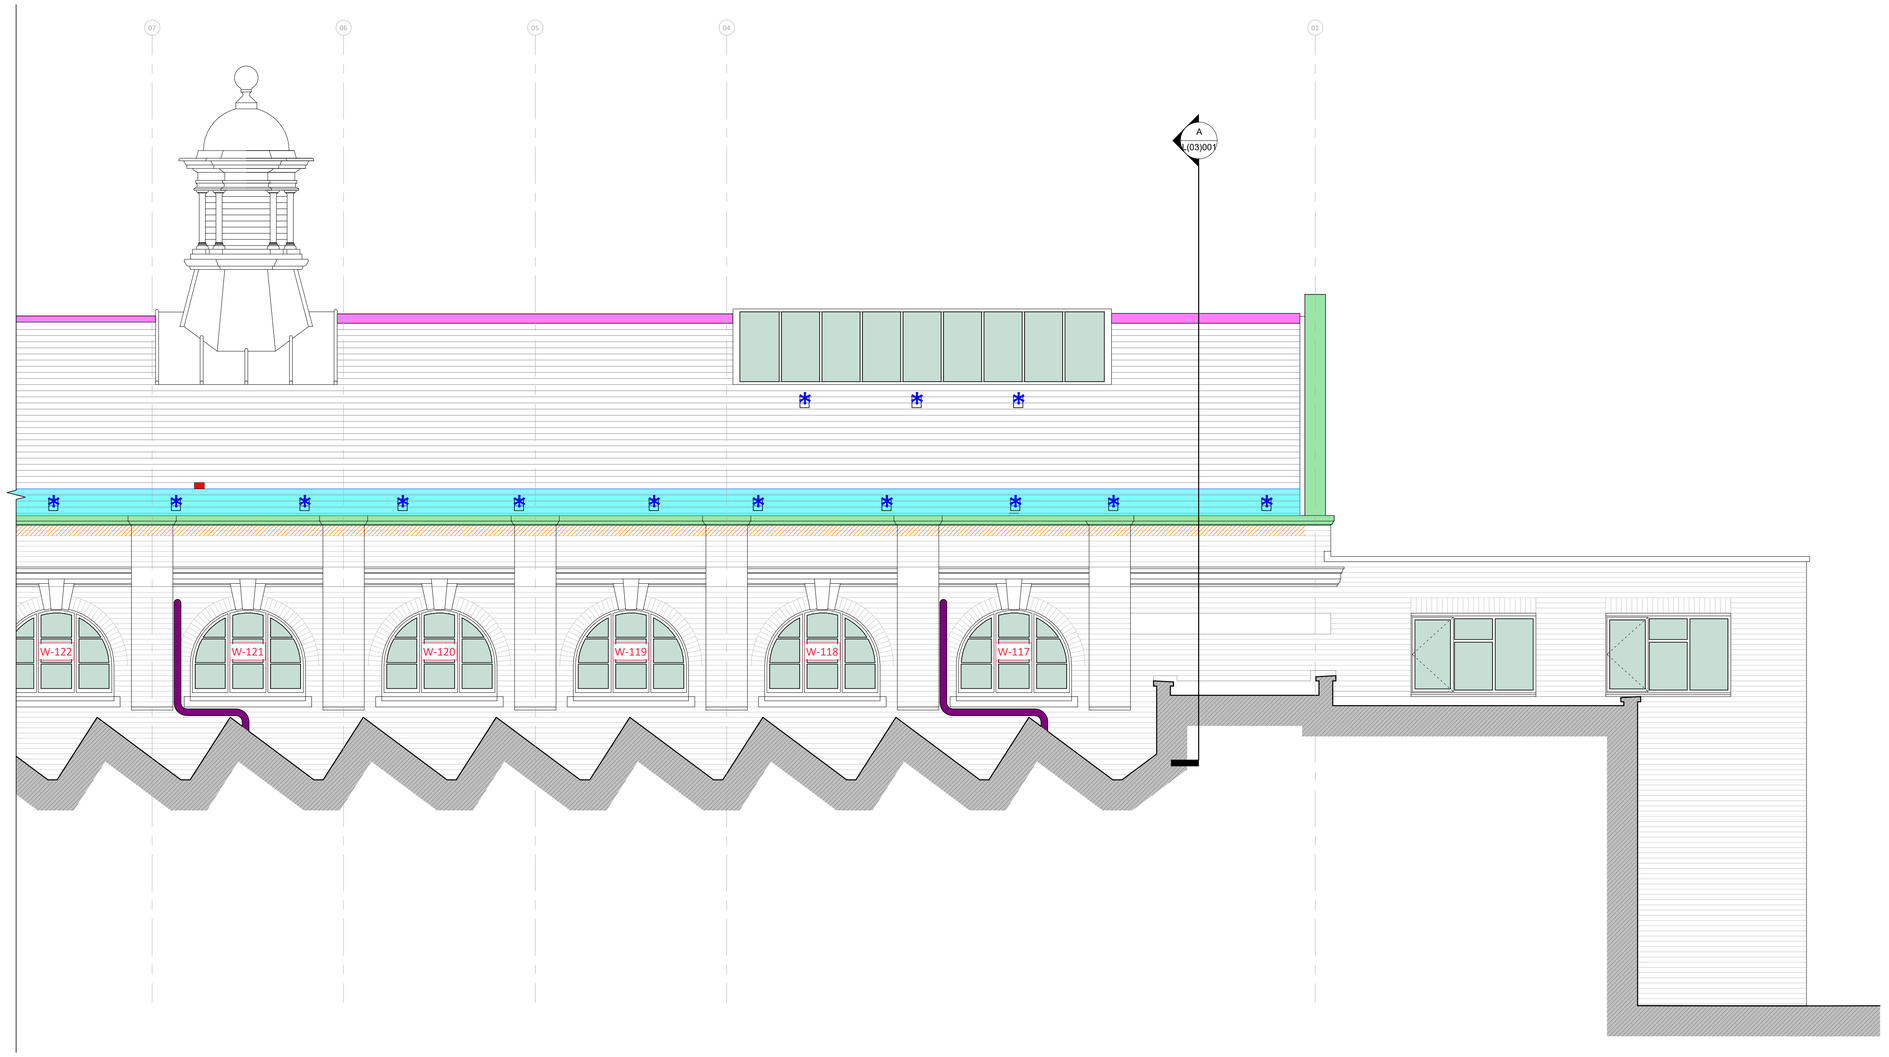
- Carefully remove and replace existing slates. Allowance to replace any broken slates with new/reclaimed Westmorland Green Slate (size to match existing), *- see Restoration Specification **RS11**.*

- Code 6 lead lined parapet gutter @ 1:80 fall to match existing *- see Restoration Specification **RS12**.*
- Carefully remove existing ashlar coping stone to facilitate the replacement of the parapet gutter. Remove any vegetation and wooded growth between joints. Rebed coping stones on hydraulic lime mortar bed with Code 4 lead soaker. *- see Restoration Specification **RS4**, **RS5**, **RS9** and **RS12**.*

- Slipped/Damaged Slate. Replacement with new/reclaimed Westmorland Green Slate (to match existing) *- see Restoration Specification **RS11**.*
- Carefully remove and rebed existing Ridge Tile with Hydraulic Lime Mortar. *- see Restoration Specification **RS4**.*

- Existing Loggia roof to be replaced with IKO Permaphalt Asphalt Roofing Systems *- see Restoration Specification **RS13**.*
- * Existing plastic cowel roof vent to be replaced with Nature Vent Inline Slate Vent - *see Restoration Specification **RS11.6**.*

- Existing Lightening Protection *- see Restoration Specification **RS11.5**.*
- Repoint areas of missing pointing in Hydraulic Lime Mortar *- see Restoration Specification **RS04**.*

- W-### Redecorate Window. Undertake timber repairs where necessary upon closer inspection by CA. *- see Restoration Specification **RS15**.*
- Redecorate Rainwater Goods *- see Restoration Specification **RS14**.*
