Client
Equans

Project
Education North: Undergraduate Building

Address
Manchester Royal Informary University Hospital
Nelson Street, Chorlton-on-Medlock, Manchester

Drawing Title
Fabric Repairs - East Elevation as Existing (Sheet 2 of 2)

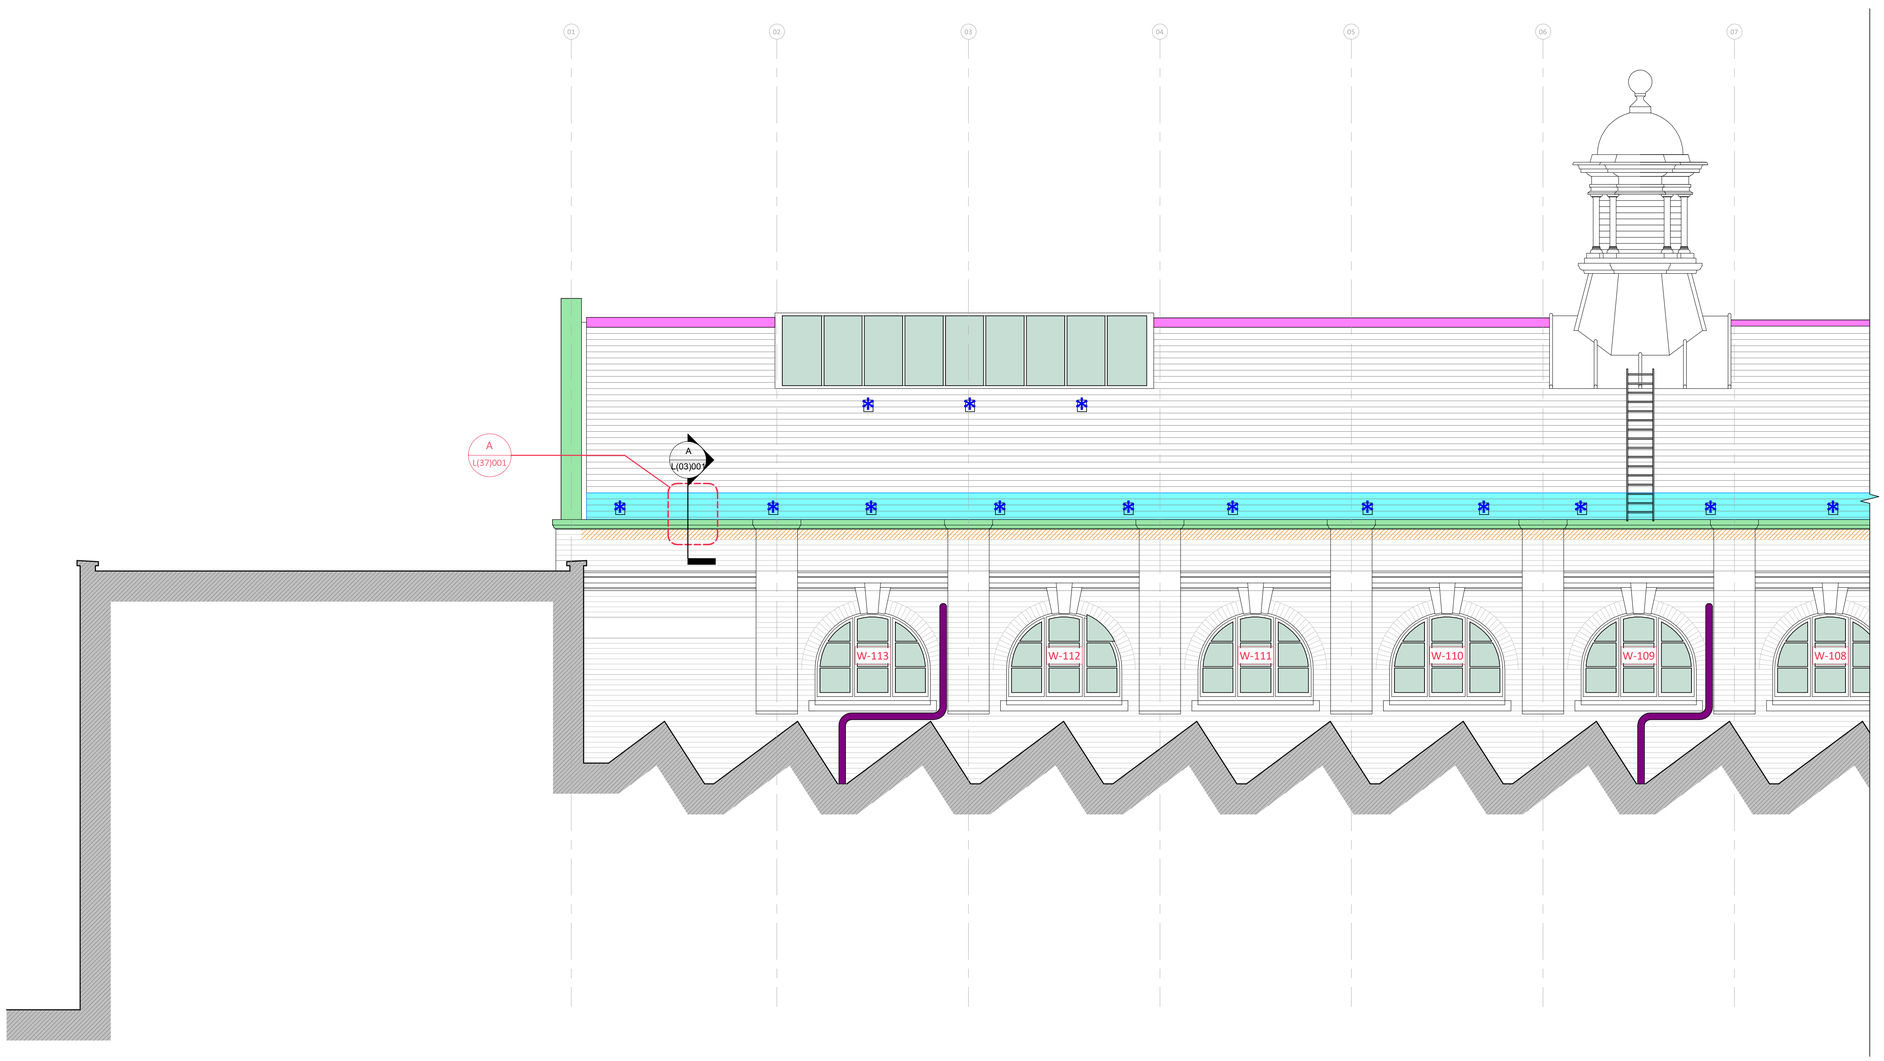
Fabric Repairs_East Elevation (Left) as Existing

- Slipped/Damaged Slate. Replacement with new/reclaimed Westmorland Green Slate (to match existing) - *see Restoration Specification **RS11***.
- Carefully remove and rebed existing Ridge Tile with Hydraulic Lime Mortar. - *see Restoration Specification **RS4***.

- Existing Lightening Protection - *see Restoration Specification **RS11.5***.
- Repoint areas of missing pointing in Hydraulic Lime Mortar - *see Restoration Specification **RS04***.

- Carefully remove and replace existing slates. Allowance to replace any broken slates with new/reclaimed Westmorland Green Slate (size to match existing), - *see Restoration Specification **RS11***.

- Code 6 lead lined parapet gutter @ 1:80 fall to match existing - *see Restoration Specification **RS12***.
- Carefully remove existing ashlar coping stone to facilitate the replacement of the parapet gutter. Remove any vegetation and wooded growth between joints. Rebed coping stones on hydraulic lime mortar bed with Code 4 lead soaker. - *see Restoration Specification **RS4, RS5, RS9 and RS12***.

- Existing Loggia roof to be replaced with IKO Permaphalt Asphalt Roofing Systems - *see Restoration Specification **RS13***.
- * Existing plastic cowel roof vent to be replaced with Nature Vent Inline Slate Vent - *see Restoration Specification **RS11.6***.

- W-### Redecorate Window. Undertake timber repairs where necessary upon closer inspection by CA. - *see Restoration Specification **RS15***.
- Redecorate Rainwater Goods - *see Restoration Specification **RS14***.
