Project
Education North: Undergraduate Building

Drawing Title
Fabric Repairs - East Elevation as Existing (Sheet 1 of 2)

Department No:	Drg No.	Revision	Sheet Size
MAN	L(02)202	P02	1 : 50
Aims No. 2025 / 02 / 0015			Drawing Status PLANNING
Drawn By S.Wardle	Checked By C.Latham		Date 03/09/2026 14:11:04

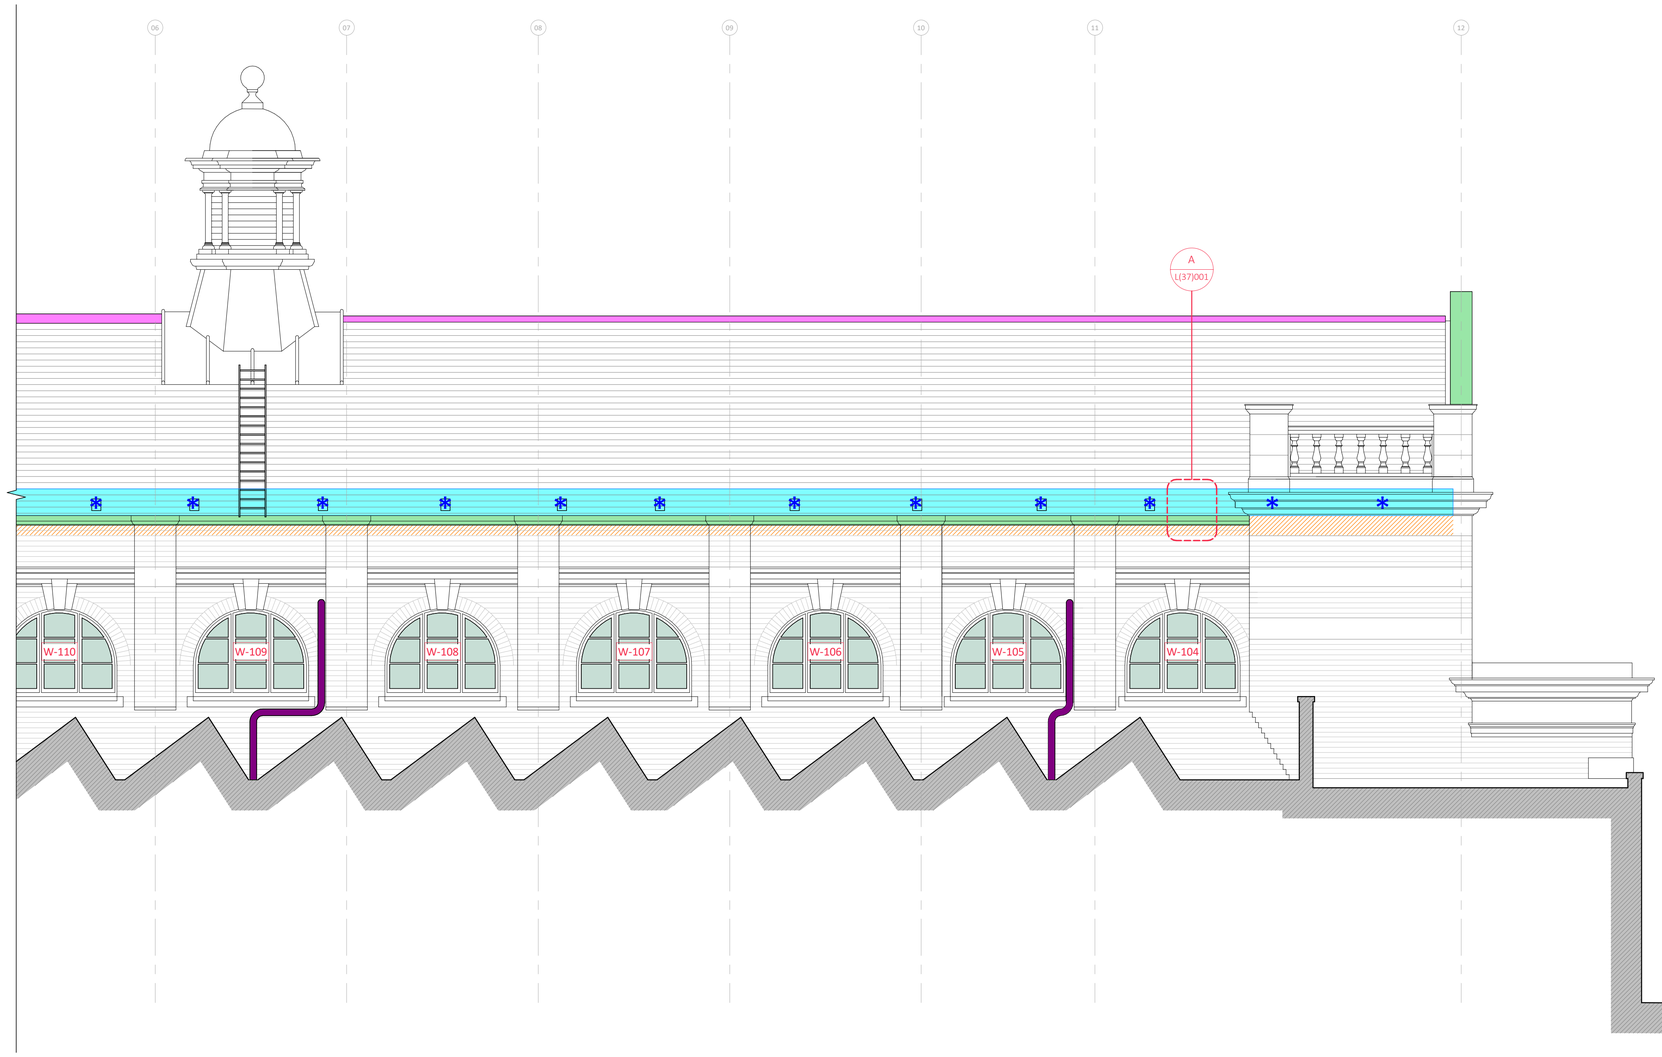
Fabric Repairs_East Elevation (Right)

- Slipped/Damaged Slate. Replacement with new/reclaimed Westmorland Green Slate (to match existing) *- see Restoration Specification **RS11**.*
- Carefully remove and rebed existing Ridge Tile with Hydraulic Lime Mortar. *- see Restoration Specification **RS4**.*

- Existing Lightening Protection *- see Restoration Specification **RS11.5**.*
- Repoint areas of missing pointing in Hydraulic Lime Mortar *- see Restoration Specification **RS04**.*

- Carefully remove and replace existing slates. Allowance to replace any broken slates with new/reclaimed Westmorland Green Slate (size to match existing), *- see Restoration Specification **RS11**.*

- Code 6 lead lined parapet gutter @ 1:80 fall to match existing *- see Restoration Specification **RS12**.*
- Carefully remove existing ashlar coping stone to facilitate the replacement of the parapet gutter. Remove any vegetation and wooded growth between joints. Rebed coping stones on hydraulic lime mortar bed with Code 4 lead soaker. *- see Restoration Specification **RS4**, **RS5**, **RS9** and **RS12**.*

- Existing Loggia roof to be replaced with IKO Permaphalt Asphalt Roofing Systems *- see Restoration Specification **RS13**.*
- * Existing plastic cowel roof vent to be replaced with Nature Vent Inline Slate Vent - *see Restoration Specification **RS11.6**.*

- W-### Redecorate Window. Undertake timber repairs where necessary upon closer inspection by CA. *- see Restoration Specification **RS15**.*
- Redecorate Rainwater Goods *- see Restoration Specification **RS14**.*
