Project
Education North: Undergraduate Building

Drawing Title
Fabric Repairs - South Elevation as Existing

Department No:	Drg No.	Revision	Sheet Size
MAN	L(02)204	P02	1 : 50

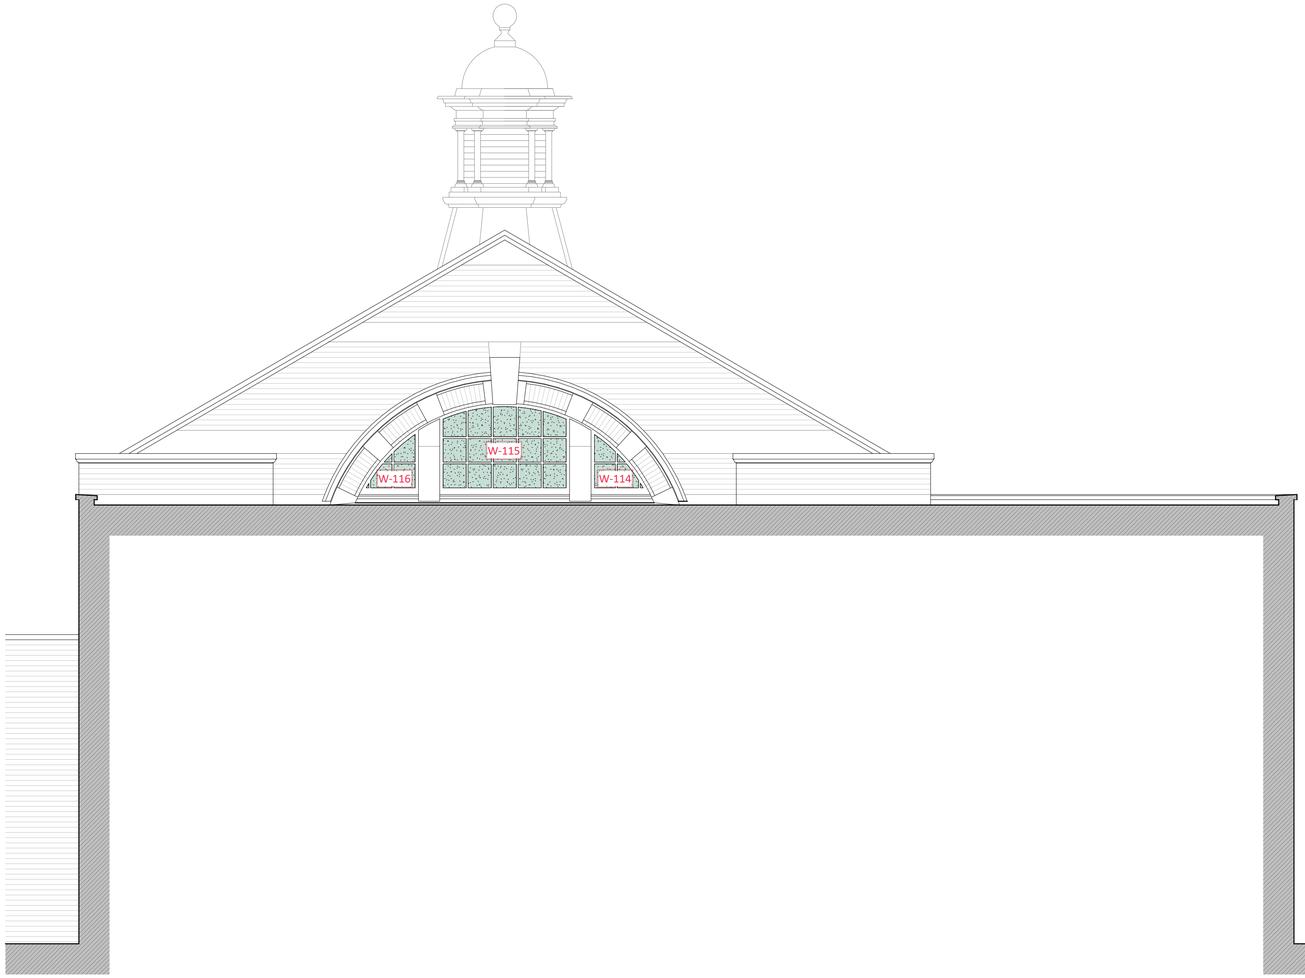
Existing_South Elevation_Repairs
Scale @ 1 : 50

- Carefully remove and replace existing slates. Allowance to replace any broken slates with new/reclaimed Westmorland Green Slate (size to match existing),

- Carefully remove existing ashlar coping stone to facilitate the replacement of the parapet gutter. Remove any vegetation and wooded growth between joints. Rebed coping stones on hydraulic lime mortar bed with Code 4 lead soaker.

- *see Restoration Specification **RS4, RS5, RS9 and RS12**.*
- Slipped/Damaged Slate. Replacement with new/reclaimed Westmorland Green Slate (to match existing)

- *see Restoration Specification **RS11**.*
- Carefully remove and rebed existing Ridge Tile with Hydraulic Lime Mortar.
  - *see Restoration Specification **RS4**.*

- Existing Loggia roof to be replaced with IKO Permaphalt Asphalt Roofing Systems
  - *see Restoration Specification **RS13**.*
- * Existing plastic cowel roof vent to be replaced with Nature Vent Inline Slate Vent -
  *see Restoration Specification **RS11.6**.*

- Existing Lightening Protection
  - *see Restoration Specification **RS11.5**.*
- Repoint areas of missing pointing in Hydraulic Lime Mortar
  - *see Restoration Specification **RS04**.*

- W-### Redecorate Window. Undertake timber repairs where necessary upon closer inspection by CA.
  - *see Restoration Specification **RS15**.*
- Redecorate Rainwater Goods
