Title: Cleaning and Consolidation Trials

Great Hall Ceiling. Manchester Town Hall

Doc number: OTH-HIR-TH-XX-RPT-X-0016

Document Type: Technical Submittal

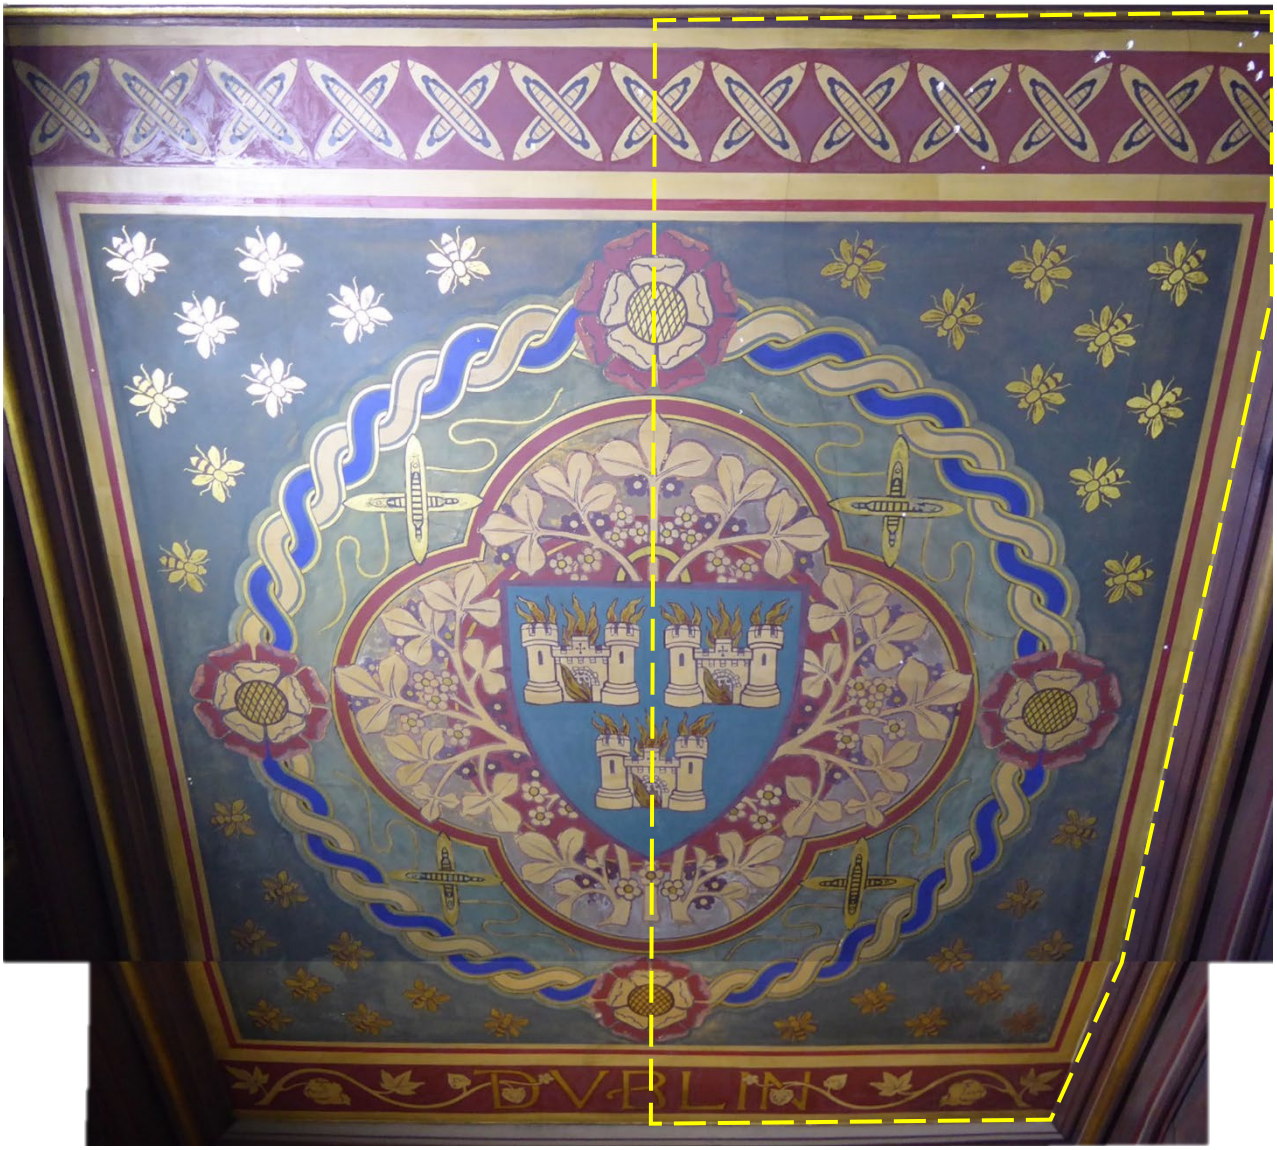
Figure 1 DUBLIN panel selected for cleaning trials. The right side of the panel within the rectangle identifies the cleaning test area.

Figure 2 Overview photos of VICTORIA REGINA*, specifically selected for consolidation trials due to extensive paint failure. Some areas of panel obstructed due to poor access. The bottom image within the rectangle represents the consolidation test area.*
