Project: Barracks House

Title: Existing Side Elevations

Drawing NO: 1220

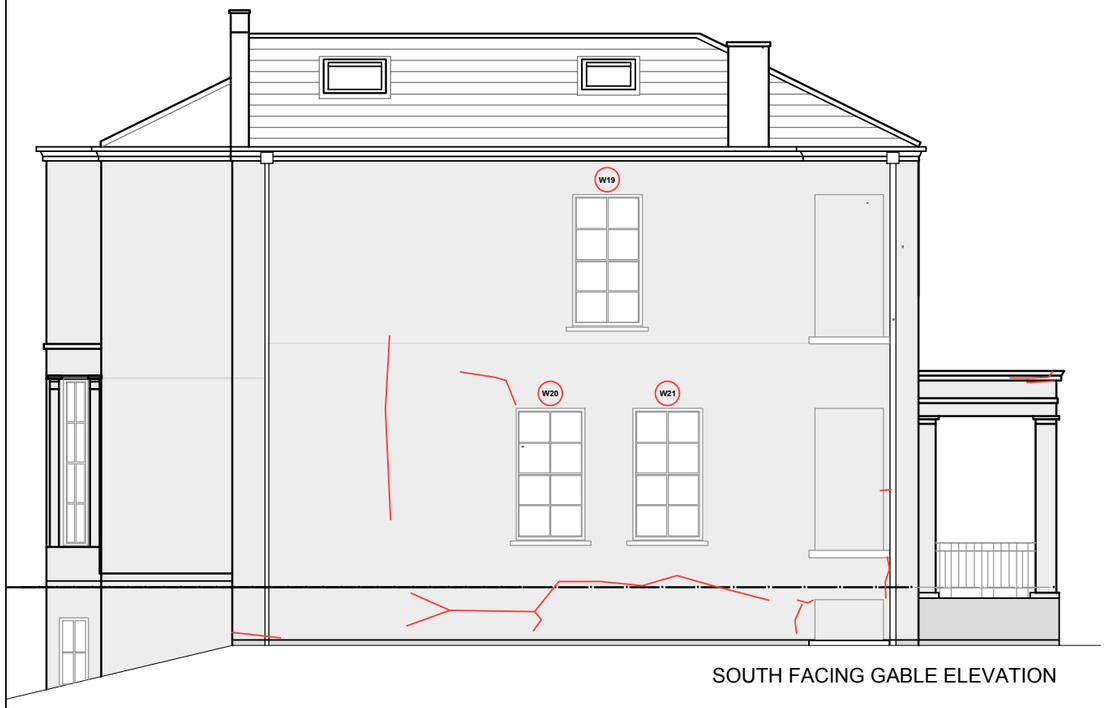
SOUTH FACING GABLE ELEVATION

- Vegetation growth through cracks in the render poses various challenges & implication for structural integrity and aesthetics. This assessment focuses on the impacts of such growth, specifically addressing vegetation emerging from cracks in the render and around window frames.

- NY LEAVED TOADFLAX (or similar)
Can be seen growing through various area of the facade, through cracks in the render & mortar joints. This should be carefully removed, being mindful of potential damage.

- To the underlying structure. If plant is seen to be established, consider using a systemic herbicide to kill it before removal. Repair any damage caused by the vegetation, including cracks in the render (Please refer to window schedule).

- All hanging wires should be fixed neatily to the facade by fixing to sacrificium materials such as mortar joints.
Example can be seen on north facade elevation.

- Ensure any fixing points such as screws are fixed into mortar join, rather than failing brick.

- Existing penetrations for boiler flue to be revisited and made good by removing & re-installing.
