01 **Mid Section - South Elevation**
Scale: **1:20**

OUR TOWN HALL PROJECT

PROJECT STATUS	RIBA STAGE 5
CLIENT	MANCHESTER CITY COUNCIL
PROJECT	OUR TOWN HALL
DRAWING TITLE	Albert Memorial Mid Section - South Elevation
SIZE & SCALE	A1: As indicated
DRAWING STATUS	FOR CONSTRUCTION
JOB NUMBER	236959
DRAWING NO.	OTH-PUR-EE-ZZ-DWG-A-7137 -
REV

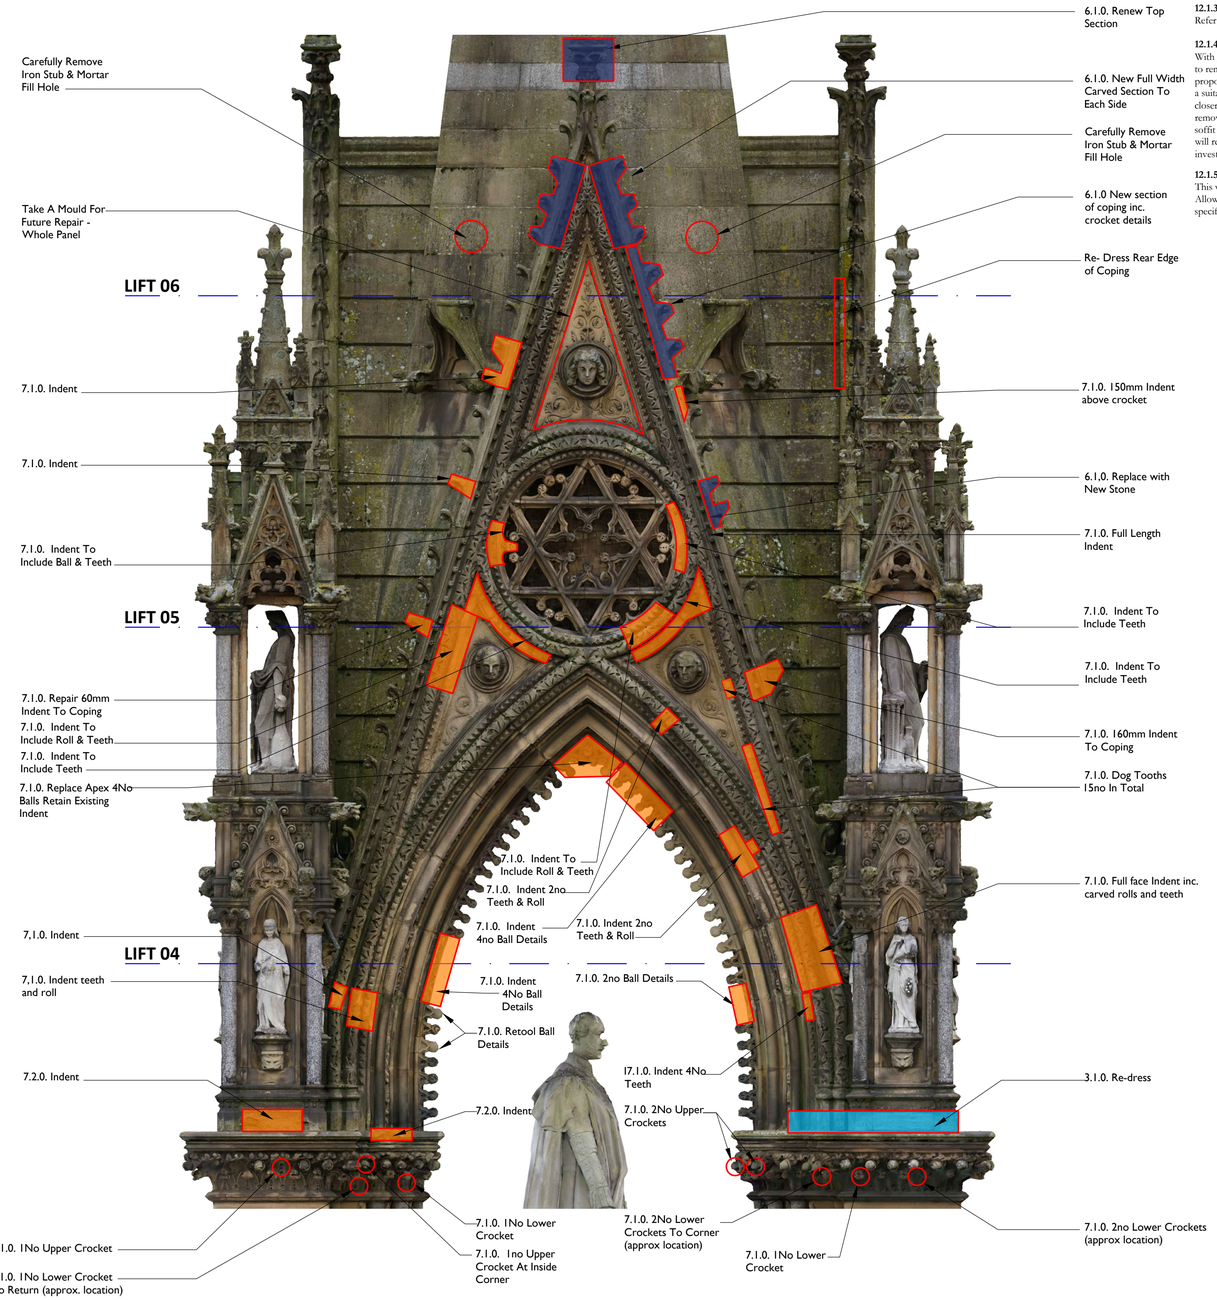
4.1.2 Refix existing Angel to South Elevation Gable NBS Specification Reference - C41/310, C41/151B-170B, C41/250, C41/284B-286
During the inspection of the monument it became apparent that the angel to the head of the South Gable was exhibiting signs of movement and was considered to be unstable. As a result the Angel was carefully removed to refixing as part of the main works.

NOTE: All repairs subject to site inspection of the monument from scaffold to enable repairs to be validated.

1.1.0 Remove/ overhaul NBS Specification Reference - C40/143B, C41/411-412B
Remove existing mesh from the rear of the tracery panels to the spire gablets and make good the masonry to the rear.Remove any plant growth by removing plant and roots in their entirety from stonework and joints. Existing 4no. perimeter lamps to be restored and upgraded according to ARUP lighting design information and requirements. Includes retaining and refurbishing lamp columns and replacement of top lamp housings to historic design. Lightning conductor system to be serviced according to ARUP specification.

2.1.0 Clean NBS Specification Reference - C40
Undertake conservation cleaning of stonework of memorial according to trial and control samples carried out at commencement of project.

3.1.0 Descale stone NBS Specification Reference - C41/456-459
Carefully rationalise failing stone surfaces by hand.

3.2.0 Decorative stonework consolidation NBS Specification Reference - C41/461B
Carefully remove loose scaling and powdered stone from surface of decorative stonework. Extent of surface removal to be advised by conservator / specialist mason.

4.1.1 Existing Granite Steps: NBS Specification Reference - C41/310, C41/151B-170B, C41/250, C41/284B-286
Carefully record, remove and store on site existing granite steps around the base of the monument. Following removal allow for an inspection by the Conservation Architect in order to ascertain any repairs required to the assumed brickwork construction to the rear. Prepare granite steps and reinstate in original positions. Re-point steps, including at abutments.

4.1.3 Rebuilding existing corner pinnacles: NBS Specification Reference - C41/310, C41/151B-170B, C41/250, C41/284B-286
Allow for a high level inspection by the Design Team and the Conservation Planner to ascertain the fixing details of the pinnacles. Carefully dismantle 1no. existing pinnacle with a watching brief from the Design Team inc Structural Engineer. All ferrous cramps to be recorded and removed where discovered and replaced with Phosphor bronze to match original. Condition, size and bedding orientation to be recorded prior to removal and condition of the stones noted. Once the pinnacle has been dismantled and the construction method understood, allow for removal of the 20th century structural support. Carefully record and remove the existing statues including any support at the base. Remove the plain stone bases that were installed at the time of undertaking the structural repairs. Once this has been undertaken and the fixing methods and defects understood, allow for dismantling and rebuilding the remaining 3no. pinnacles following the insertion of the new structural support in accordance with 12.1.4.

5.1.0 Crack stitching / Repair NBS Specification Reference - C41/611B-693
Repair cracked stone where appropriate to retain in situ.

6.1.0 Stone Replacement / Repair NBS Specification Reference - C41/220-349B C41/460B for re-carving of inscriptions, C41/241B
Where a stone is showing evidence of failure and/or an element of stonework has been replaced with an inappropriate repair this will be removed and the stone replaced in its entirety. Where a section of decorative stone has decayed to such an extent that the original design intent and form has been lost this will be replaced with either a stone indent or a replacement stone section carved to the original profile. Where a stone element has lost a functional element such as a drip mould this will also be replaced with a stone indent to match the original profile. All ferrous cramps to be recorded and removed where discovered and replaced with Phosphor bronze to match original. Any new stone details to be carved to match original Worthington archive drawings. Where this is not possible, stone detail to match extant repeated detail to original profile

7.1.0 Stone Indents NBS Specification Reference - C41/349B
In general where a stone is to be indented this should be replaced with sufficient bed depth to enable the indent to be compression fixed with joggle joints and bronze dog cramps where required. All voids to be grouted and joints pointed using lime mortar.

7.1.1 Indent fine decorative stone details NBS Specification Reference - C41/353B
Where a fine stone detail indent is required which may not meet the required size to allow compression fixing, joggle joints should be used where possible and the use of carbon rods for dowels. Indent should not rely on adhesives for retaining the stone.

8.1.0 Mortar Repairs NBS Specification Reference - Z21, C41/509-555
Mortar repairs only to be undertaken in accessible areas and to small areas of stonework which do not warrant an indent repair.

10.1.0 Repointing and regrouting NBS Specification Reference - Z21, C41/611B-862B, C41/390B, C41/290-300B
All joints to be carefully raked out and complete repointing of monument to be undertaken in lime mortar throughout.
Open joints to projecting cills, copings and to plinth to be undertaking using lead caulking on lead wire infill to plinth and using temporary lead shuttering to projecting stone details.

11.1.0 New weatherings / drainage NBS Specification Reference - C41/137B, C41/710B
Existing water disposal arrangements to be surveyed by Design Team and contractor at commencement of project. Allow to apply discreet mortar flaunchings/weathering to exposed surfaces showing signs of water retention and delamination due to water ingress. Allow for existing drainage chutes to pinnacles to be have existing linings removed and new Code 4 lead linings provided to ensure water is shed away from the monument. Existing drainage routes leading from statue plinth and discharging onto stone steps at base to be cleared to reinstate working order. Allow to reline with lead and catchment grates added at plinth level. New lead gutters/linings to be provided to rear of pinnacles leading into drainage chutes. Co-ordinate with ARUP (Public Health) and Ramboll (sub-surface drainage) as necessary.

12.1.4 Construction of new structural support to pinnacles
With good documentary evidence of the original stone verticals (all four mouldings) and the decorative stone plinth, the proposal is to remove and replace the 3no columns to each corner in a non-ferrous metal, to follow exactly (in silhouette) the original intent. The proposal is to construct a new welded swayframe "table" constructed from stainless steel, the surface of which would be etched to get a suitable "dull" finish to adhere to it. The current proposal is that the corner supports will be designed as three tubes pushed out closer the back of the original granite verticals in the location of the original columns. The head of the "table" will be redesigned to remove the horizontal table top which currently obscures the light to the statues reducing their visibility and creates much a lower soffit over the statues than was originally intended. This re-positioning will improve the view of the statues to what is seen today and will restore the original design intent for these statues. Final specification and fabrication information to be confirmed upon investigation and liaison with Ramboll (structural engineers).
