01 Upper Section - South Elevation
Scale: 1:20

OUR TOWN HALL PROJECT
PURCELL
Project Office, Room 308, Town Hall, MANCHESTER M60 2LA
+44 (0) 7970 097 432
www.purcelluk.com

PROJECT STATUS	RIBA STAGE 5
CLIENT	MANCHESTER CITY COUNCIL
PROJECT	OUR TOWN HALL
DRAWING TITLE	Albert Memorial Upper Section - South Elevation
SIZE & SCALE	A1: As indicated
DRAWING STATUS	FOR CONSTRUCTION
JOB NUMBER	236959
DRAWING NO.	OTH-PUR-EE-ZZ-DWG-A-7133
REV	-

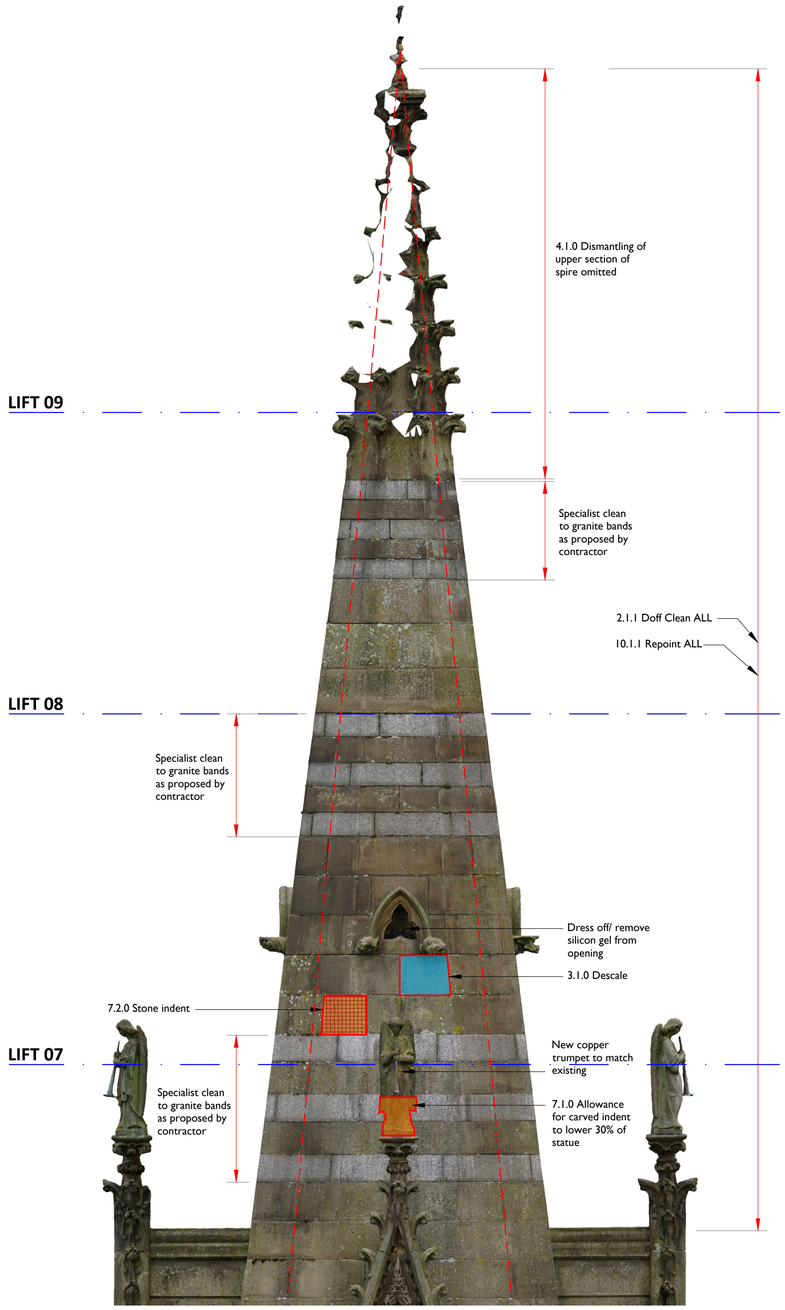
4.1.2 Refix existing Angel to South Elevation Gable NBS Specification Reference - C41/310, C41/151B-170B, C41/250, C41/284B-286
During the inspection of the monument it became apparent that the angel to the head of the South Gable was exhibiting signs of movement and was considered to be unstable. As a result the Angel was carefully removed to refixing as part of the main works.

1.1.0 Remove/ overhaul NBS Specification Reference - C40/143B, C41/411-412B
Remove existing mesh from the rear of the tracery panels to the spire gablets and make good the masonry to the rear.Remove any plant growth by removing plant and roots in their entirety from stonework and joints. Existing 4no. perimeter lamps to be restored and upgraded according to ARUP lighting design information and requirements. Includes retaining and refurbishing lamp columns and replacement of top lamp housings to historic design. Lightning conductor system to be serviced according to ARUP specification.

2.1.0 Clean NBS Specification Reference - C40
Undertake conservation cleaning of stonework of memorial according to trial and control samples carried out at commencement of project.

3.1.0 Descale stone NBS Specification Reference - C41/456-459
Carefully rationalise failing stone surfaces by hand.

3.2.0 Decorative stonework consolidation NBS Specification Reference - C41/461B
Carefully remove loose scaling and powdered stone from surface of decorative stonework. Extent of surface removal to be advised by conservator / specialist mason.

4.1.1 Existing Granite Steps: NBS Specification Reference - C41/310, C41/151B-170B, C41/250, C41/284B-286
Carefully record, remove and store on site existing granite steps around the base of the monument. Following removal allow for an inspection by the Conservation Architect in order to ascertain any repairs required to the assumed brickwork construction to the rear. Prepare granite steps and reinstate in original positions. Re-point steps, including at abutments.

4.1.3 Rebuilding existing corner pinnacles: NBS Specification Reference - C41/310, C41/151B-170B, C41/250, C41/284B-286
Allow for a high level inspection by the Design Team and the Conservation Planner to ascertain the fixing details of the pinnacles. Carefully dismantle 1no. existing pinnacle with a watching brief from the Design Team inc Structural Engineer. All ferrous cramps to be recorded and removed where discovered and replaced with Phosphor bronze to match original. Condition, size and bedding orientation to be recorded prior to removal and condition of the stones noted. Once the pinnacle has been dismantled and the construction method understood, allow for removal of the 20th century structural support. Carefully record and remove the existing statues including any support at the base. Remove the plain stone bases that were installed at the time of undertaking the structural repairs. Once this has been undertaken and the fixing methods and defects understood, allow for dismantling and rebuilding the remaining 3no. pinnacles following the insertion of the new structural support in accordance with 12.1.4.

5.1.0 Crack stitching / Repair NBS Specification Reference - C41/611B-693
Repair cracked stone where appropriate to retain in situ.

6.1.0 Stone Replacement / Repair NBS Specification Reference - C41/220-349B
C41/460B for re-carving of inscriptions, C41/241B
Where a stone is showing evidence of failure and/or an element of stonework has been replaced with an inappropriate repair this will be removed and the stone replaced in its entirety. Where a section of decorative stone has decayed to such an extent that the original design intent and form has been lost this will be replaced with either a stone indent or a replacement stone section carved to the original profile. Where a stone element has lost a functional element such as a drip mould this will also be replaced with a stone indent to match the original profile. All ferrous cramps to be recorded and removed where discovered and replaced with Phosphor bronze to match original. Any new stone details to be carved to match original Worthington archive drawings. Where this is not possible, stone detail to match extant repeated detail to original profile

7.1.0 Stone Indents NBS Specification Reference - C41/349B
In general where a stone is to be indented this should be replaced with sufficient bed depth to enable the indent to be compression fixed with joggle joints and bronze dog cramps where required. All voids to be grouted and joints pointed using lime mortar.

7.1.1 Indent fine decorative stone details NBS Specification Reference - C41/353B
Where a fine stone detail indent is required which may not meet the required size to allow compression fixing, joggle joints should be used where possible and the use of carbon rods for dowels. Indent should not rely on adhesives for retaining the stone.

8.1.0 Mortar Repairs NBS Specification Reference - Z21, C41/509-555
Mortar repairs only to be undertaken in accessible areas and to small areas of stonework which do not warrant an indent repair.

10.1.0 Repointing and regrouting NBS Specification Reference - Z21, C41/611B-862B, C41/390B, C41/290-300B
All joints to be carefully raked out and complete repointing of monument to be undertaken in lime mortar throughout.
Open joints to projecting cills, copings and to plinth to be undertaking using lead caulking on lead wire infill to plinth and using temporary lead shuttering to projecting stone details.

11.1.0 New weatherings / drainage NBS Specification Reference - C41/137B, C41/710B
Existing water disposal arrangements to be surveyed by Design Team and contractor at commencement of project. Allow to apply discreet mortar flaunchings/weathering to exposed surfaces showing signs of water retention and delamination due to water ingress. Allow for existing drainage chutes to pinnacles to be have existing linings removed and new Code 4 lead linings provided to ensure water is shed away from the monument. Existing drainage routes leading from statue plinth and discharging onto stone steps at base to be cleared to reinstate working order. Allow to reline with lead and catchment grates added at plinth level. New lead gutters/linings to be provided to rear of pinnacles leading into drainage chutes. Co-ordinate with ARUP (Public Health) and Ramboll (sub-surface drainage) as necessary.

12.1.4 Construction of new structural support to pinnacles
With good documentary evidence of the original stone verticals (all four mouldings) and the decorative stone plinth, the proposal is to remove and replace the 3no columns to each corner in a non-ferrous metal, to follow exactly (in silhouette) the original intent. The proposal is to construct a new welded swayframe "table" constructed from stainless steel, the surface of which would be etched to get a suitable "dull" finish to adhere to it. The current proposal is that the corner supports will be designed as three tubes pushed out closer the back of the original granite verticals in the location of the original columns. The head of the "table" will be redesigned to remove the horizontal table top which currently obscures the light to the statues reducing their visibility and creates much a lower soffit over the statues than was originally intended. This re-positioning will improve the view of the statues to what is seen today and will restore the original design intent for these statues. Final specification and fabrication information to be confirmed upon investigation and liason with Ramboll (structural engineers).
