SITE RECORD SHEET

Aconex Ref: OTH-PUR-TH-ZZ-SRS-A-0717	**Date:** 31/10/2024
Document Title: Albert Memorial – Works to Plinth	**Revision:** 01
Visit By: Jamie Coath, Andrew Bailey (Purcell)	**Status: -** For Construction
Attended: See below sections	**Attachments:** Photos embedded where applicable

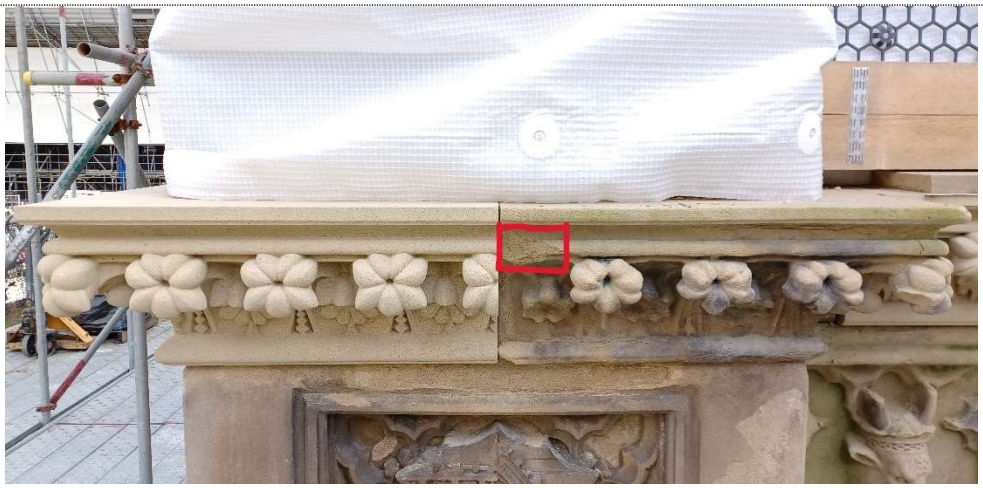
No	Item/Room	Comments	Action
		Following site review on 22.10.24, a series of works were identified at plinth level as follows:	
1.1	Albert Memorial – West Elevation	 A mortar repair is required to make good the upper moulding of the cornice where damage has occurred during site works. This will ensure the stonework below is properly weathered. Repair to be colour matched to the stone.	
1.2	Albert Memorial – South Elevation (west shield)	 The upper roll to the shield is at risk of detaching and being lost. It is believed that the cleaning of this area (as a result of the significant repairs undertaken above) has led to this damage. The fissure is to be filled with lime grout and then weathered with lime mortar to ensure the detail is preserved.

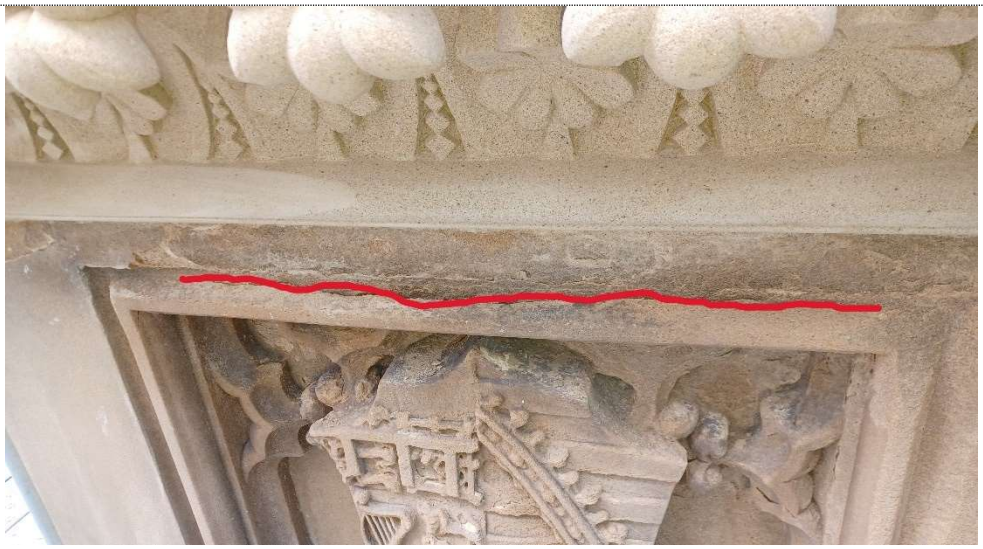
1.3	Albert Memorial – South Elevation (east shield)	 The upper roll to the shield is at risk of detaching and being lost. It is believed that the cleaning of this area (as a result of the significant repairs undertaken above) has led to this damage. The fissure is to be filled with lime grout and then weathered with lime mortar to ensure the detail is preserved.
