OUR TOWN HALL PROJECT

PROJECT STATUS	**RIBA STAGE 5**
CLIENT	**MANCHESTER CITY COUNCIL**
PROJECT	**OUR TOWN HALL**
DRAWING TITLE	**Albert Memorial Pinnacle Elevations (Sheet 3 of 4)**
SIZE & SCALE	**A1: As indicated**
DRAWING STATUS	**FOR CONSTRUCTION**
JOB NUMBER	**236959**
DRAWING NO.	**OTH-PUR-EE-ZZ-DWG-A-7145**
REV	**-**

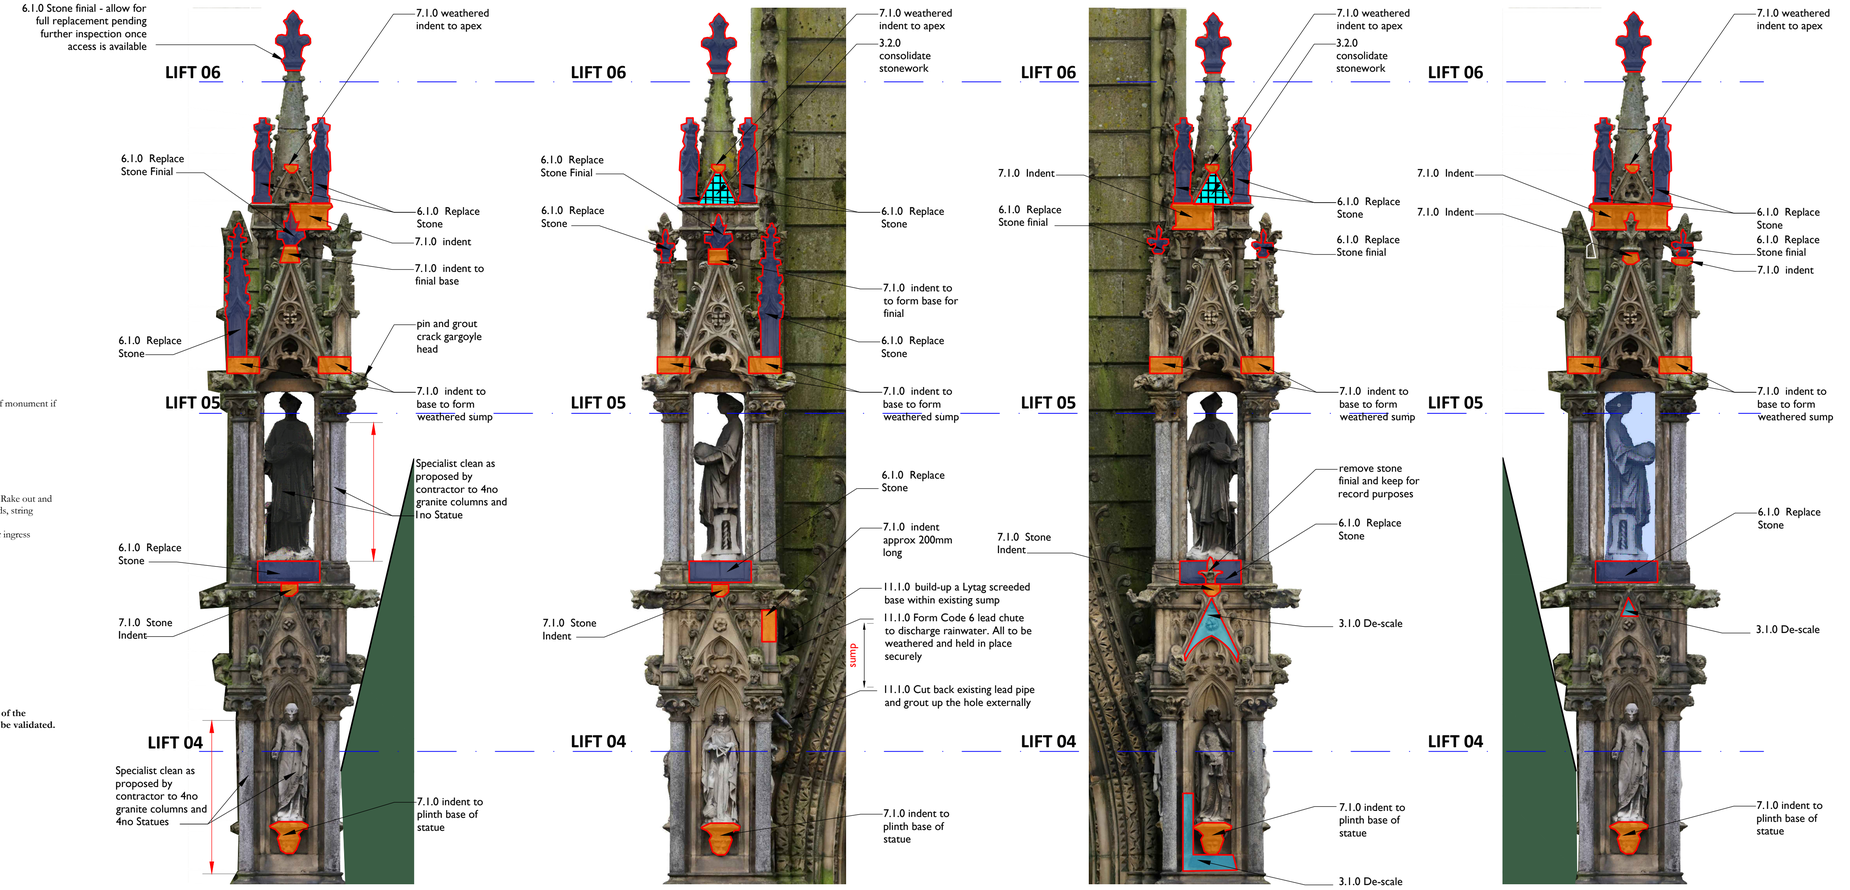
4.1.3 Rebuilding existing corner pinnacles: NBS Specification Reference - C41/310, C41/151B-170B, C41/250, C41/284B-286
Allow for a high level inspection by the Design Team and the Conservation Planner to ascertain the fixing details of the pinnacles. Carefully dismantle 1no. existing pinnacle with a watching brief from the Design Team inc Structural Engineer. All ferrous cramps to be recorded and removed where discovered and replaced with Phosphor bronze to match original. Condition, size and bedding orientation to be recorded prior to removal and condition of the stones noted. Once the pinnacle has been dismantled and the construction method understood, allow for removal of the 20th century structural support. Carefully record and remove the existing statues including any support at the base. Remove the plain stone bases that were installed at the time of undertaking the structural repairs. Once this has been undertaken and the fixing methods and defects understood, allow for dismantling and rebuilding the remaining 3no. pinnacles following the insertion of the new structural support in accordance with 12.1.4.

12.1.4 Construction of new structural support to pinnacles
With good documentary evidence of the original stone verticals (all four mouldings) and the decorative stone plinth, the proposal is to remove and replace the 3no columns to each corner in a non-ferrous metal, to follow exactly (in silhouette) the original intent. The proposal is to construct a new welded swayframe "table" constructed from stainless steel, the surface of which would be etched to get a suitable "dull" finish to adhere to it. The current proposal is that the corner supports will be designed as three tubes pushed out closer the back of the original granite verticals in the location of the original columns. The head of the "table" will be redesigned to remove the horizontal table top which currently obscures the light to the statues reducing their visibility and creates much a lower soffit over the statues than was originally intended. This re-positioning will improve the view of the statues to what is seen today and will restore the original design intent for these statues. Final specification and fabrication information to be confirmed upon investigation and liaison with Ramboll (structural engineers).
