01 **Upper Section - West Elevation**
Scale: **1:20**

OUR TOWN HALL PROJECT
PURCELL
Project Office, Room 308, Town Hall, MANCHESTER M60 2LI
+44 (0) 7970 097 432
www.purcelluk.com

PROJECT STATUS	RIBA STAGE 5
CLIENT	MANCHESTER CITY COUNCIL
PROJECT	OUR TOWN HALL
DRAWING TITLE	Albert Memorial Upper Section -West Elevation
SIZE & SCALE	A1: As indicated
DRAWING STATUS	FOR CONSTRUCTION
JOB NUMBER	236959
DRAWING NO.	OTH-PUR-EE-ZZ-DWG-A-7134
REV	-

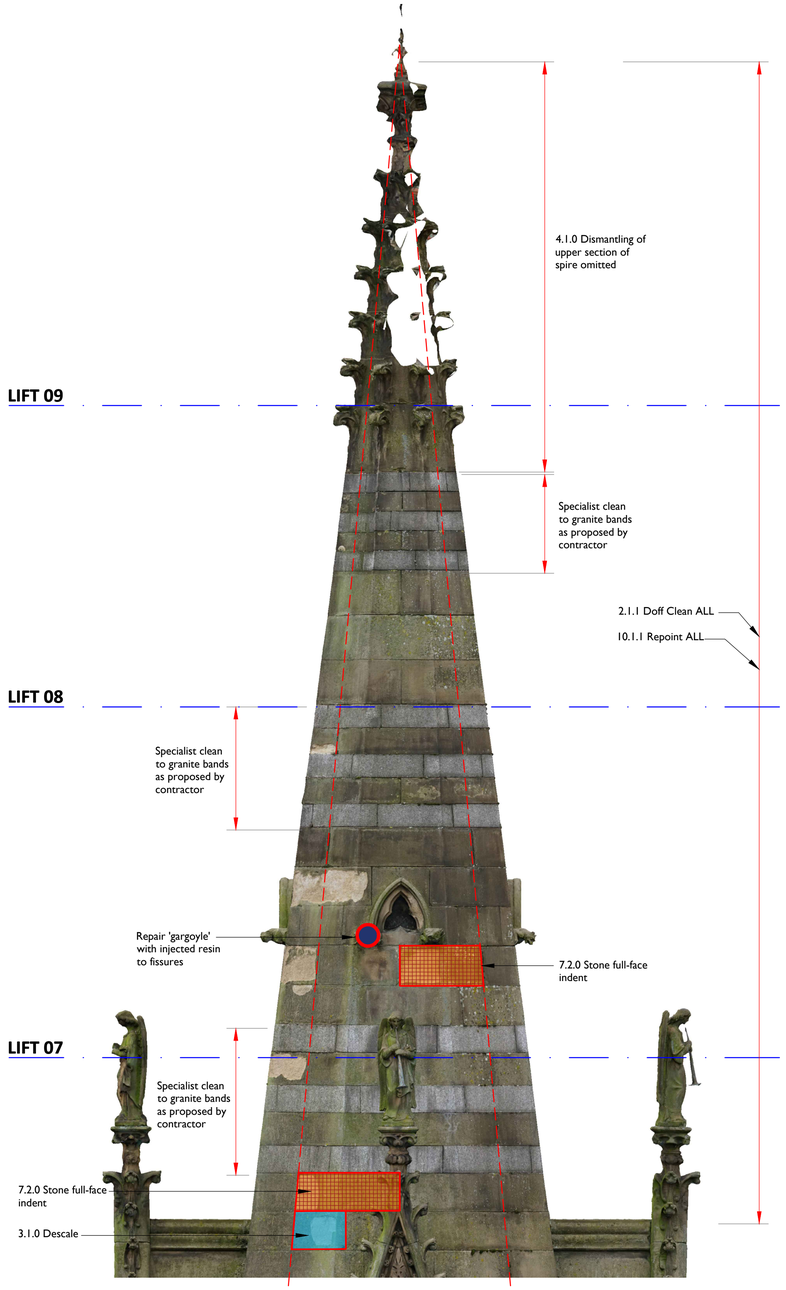
4.1.2 Refix existing Angel to South Elevation Gable NBS Specification Reference - C41/310, C41/151B-170B, C41/250, C41/284B-286
During the inspection of the monument it became apparent that the angel to the head of the South Gable was exhibiting signs of movement and was considered to be unstable. As a result the Angel was carefully removed to refixing as part of the main works.

4.1.3 Rebuilding existing corner pinnacles: NBS Specification Reference - C41/310, C41/151B-170B, C41/250, C41/284B-286
Allow for a high level inspection by the Design Team and the Conservation Planner to ascertain the fixing details of the pinnacles. Carefully dismantle 1no. existing pinnacle with a watching brief from the Design Team inc Structural Engineer. All ferrous cramps to be recorded and removed where discovered and replaced with Phosphor bronze to match original. Condition, size and bedding orientation to be recorded prior to removal and condition of the stones noted. Once the pinnacle has been dismantled and the construction method understood, allow for removal of the 20th century structural support. Carefully record and remove the existing statues including any support at the base. Remove the plain stone bases that were installed at the time of undertaking the structural repairs. Once this has been undertaken and the fixing methods and defects understood, allow for dismantling and rebuilding the remaining 3no. pinnacles following the insertion of the new structural support in accordance with 12.1.4.

1.1.0 Remove/ overhaul NBS Specification Reference - C40/143B, C41/411-412B
Remove existing mesh from the rear of the tracery panels to the spire gablets and make good the masonry to the rear.Remove any plant growth by removing plant and roots in their entirety from stonework and joints. Existing 4no. perimeter lamps to be restored and upgraded according to ARUP lighting design information and requirements. Includes retaining and refurbishing lamp columns and replacement of top lamp housings to historic design. Lightning conductor system to be serviced according to ARUP specification.

2.1.0 Clean NBS Specification Reference - C40
Undertake conservation cleaning of stonework of memorial according to trial and control samples carried out at commencement of project.

4.1.1 Existing Granite Steps: NBS Specification Reference - C41/310, C41/151B-170B, C41/250, C41/284B-286
Carefully record, remove and store on site existing granite steps around the base of the monument. Following removal allow for an inspection by the Conservation Architect in order to ascertain any repairs required to the assumed brickwork construction to the rear. Prepare granite steps and reinstate in original positions. Re-point steps, including at abutments.

5.1.0 Crack stitching / Repair NBS Specification Reference - C41/611B-693
Repair cracked stone where appropriate to retain in situ.

6.1.0 Stone Replacement / Repair NBS Specification Reference - C41/220-349B C41/460B for re-carving of inscriptions, C41/241B
Where a stone is showing evidence of failure and/or an element of stonework has been replaced with an inappropriate repair this will be removed and the stone replaced in its entirety. Where a section of decorative stone has decayed to such an extent that the original design intent and form has been lost this will be replaced with either a stone indent or a replacement stone section carved to the original profile. Where a stone element has lost a functional element such as a drip mould this will also be replaced with a stone indent to match the original profile. All ferrous cramps to be recorded and removed where discovered and replaced with Phosphor bronze to match original. Any new stone details to be carved to match original Worthington archive drawings. Where this is not possible, stone detail to match extant repeated detail to original profile

10.1.0 Repointing and regrouting NBS Specification Reference - Z21, C41/611B-862B, C41/390B, C41/290-300B
All joints to be carefully raked out and complete repointing of monument to be undertaken in lime mortar throughout.
Open joints to projecting cills, copings and to plinth to be undertaking using lead caulking on lead wire infill to plinth and using temporary lead shuttering to projecting stone details.

12.1.4 Construction of new structural support to pinnacles
With good documentary evidence of the original stone verticals (all four mouldings) and the decorative stone plinth, the proposal is to remove and replace the 3no columns to each corner in a non-ferrous metal, to follow exactly (in silhouette) the original intent. The proposal is to construct a new welded swayframe "table" constructed from stainless steel, the surface of which would be etched to get a suitable "dull" finish to adhere to it. The current proposal is that the corner supports will be designed as three tubes pushed out closer the back of the original granite verticals in the location of the original columns. The head of the "table" will be redesigned to remove the horizontal table top which currently obscures the light to the statues reducing their visibility and creates much a lower soffit over the statues than was originally intended. This re-positioning will improve the view of the statues to what is seen today and will restore the original design intent for these statues. Final specification and fabrication information to be confirmed upon investigation and liaison with Ramboll (structural engineers).
