SITE RECORD SHEET

PURCELL

Aconex Ref: OTH-PUR-TH-ZZ-SRS-A-0601	**Date:** 24/04/2024
Document Title: Albert Memorial – Confirmation of High Level Repairs	**Revision:** -
Visit By: Jamie Coath, Andrew Bailey (Purcell)	**Status: -** For Information
Attended: See below sections	**Attachments:** Photos embedded where applicable

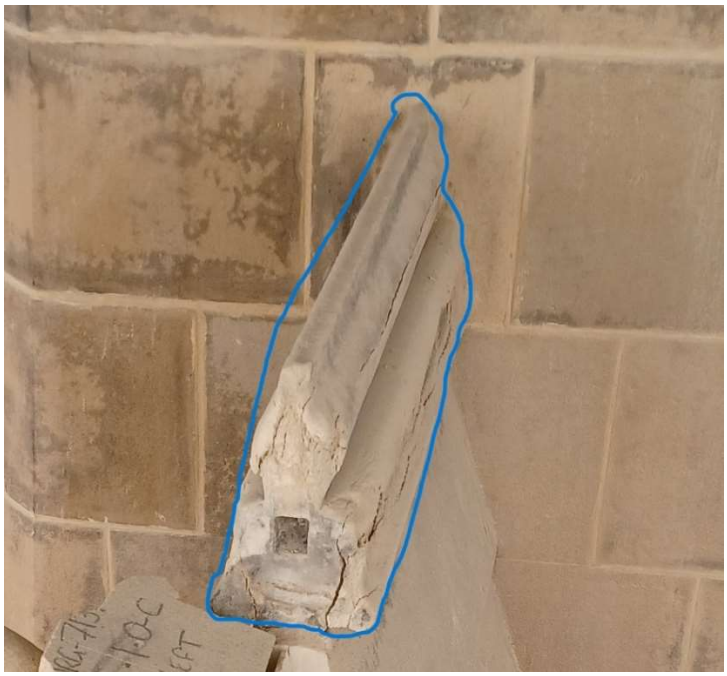
No	Item/Room	Comments	Action
		Following site review on 04.04.24, a number of high level repairs have been identified as being required.	
1.1	Albert Memorial – South Gable	Coping stone to gable on south elevation. Stone badly fractured. Full replacement recommended. 	
1.2	Albert Memorial – South East roof gablet	Considerable damage to end of small gablet. 1nr. carved indent repair required to end of ridge to match intact detail on North East roof gablet (two views of same gablet shown below)

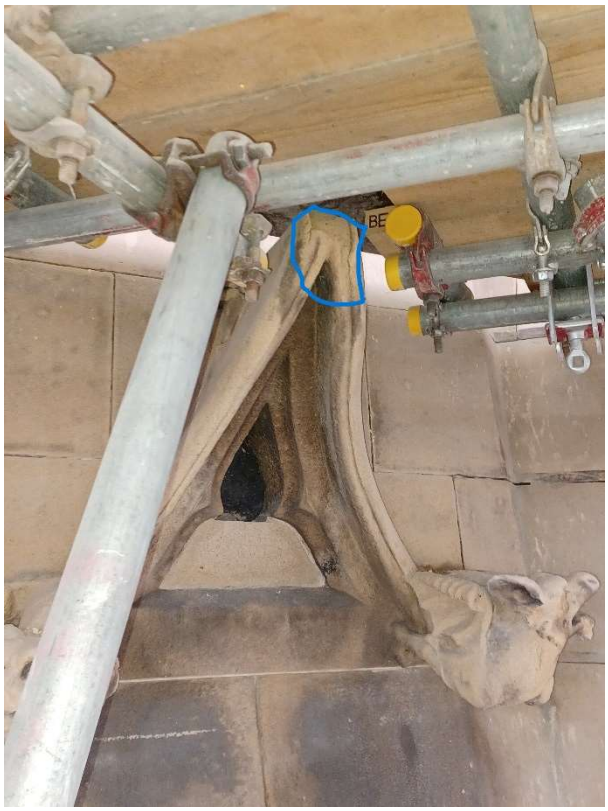
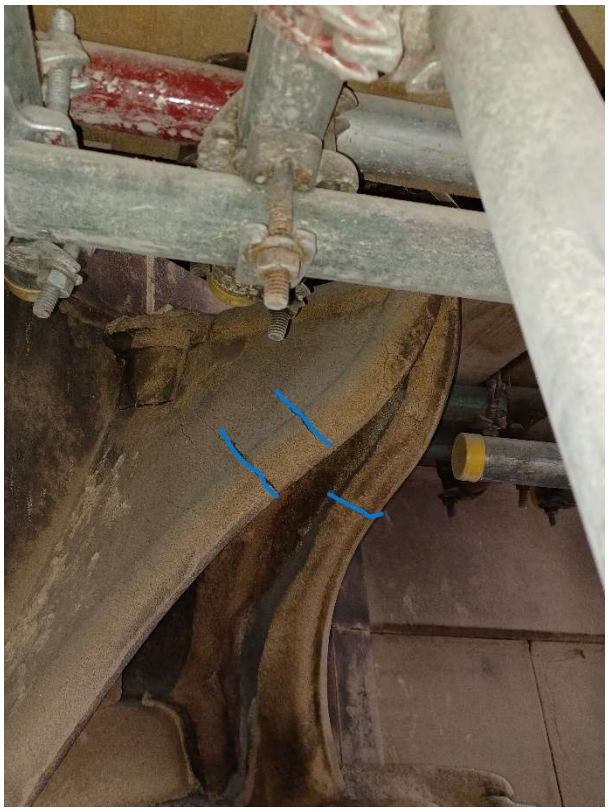
1.3	Albert Memorial – North West roof gablet	Crumbly/ delaminating stone noted to end of ridge of small gable. Defrass loose material. 	
1.4	Albert Memorial – South West roof gablet	Fissures noted to small gablet. 'V' joint each split and point with lime mortar.
