01 Upper Section -East Elevation
Scale: **1:20**

OUR TOWN HALL PROJECT
PURCELL
Project Office, Room 308, Town Hall, MANCHESTER M60 2LI
+44 (0) 7970 097 432
www.purcelluk.com

PROJECT STATUS	RIBA STAGE 5
CLIENT	MANCHESTER CITY COUNCIL
PROJECT	OUR TOWN HALL
DRAWING TITLE	Albert Memorial Upper Section -East Elevation
SIZE & SCALE	A1: As indicated
DRAWING STATUS	FOR CONSTRUCTION
JOB NUMBER	236959
DRAWING NO.	OTH-PUR-EE-ZZ-DWG-A-7132
REV	-

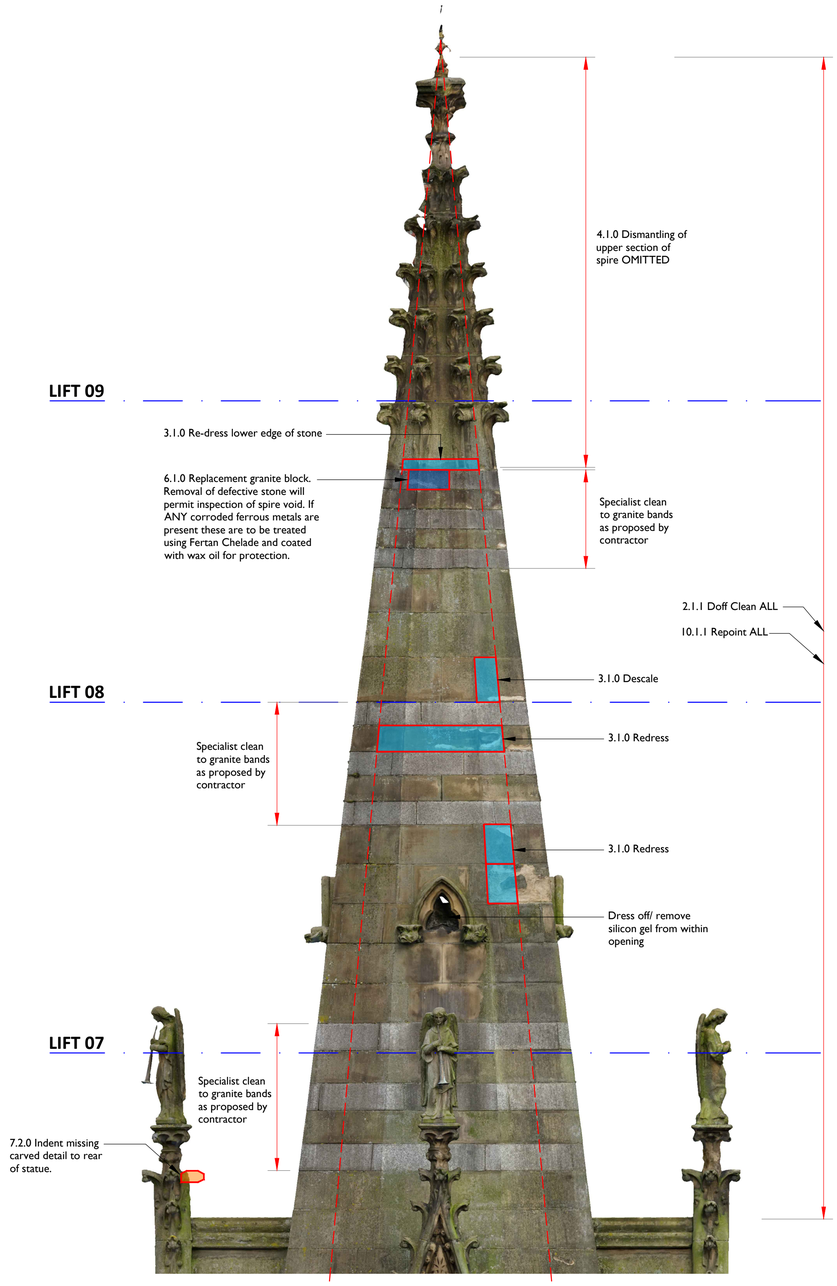
4.1.2 Refix existing Angel to South Elevation Gable NBS Specification Reference - C41/310, C41/151B-170B, C41/250, C41/284B-286
During the inspection of the monument it became apparent that the angel to the head of the South Gable was exhibiting signs of movement and was considered to be unstable. As a result the Angel was carefully removed to refixing as part of the main works.

NOTE: All repairs subject to site inspection of the monument from scaffold to enable repairs to be validated.

1.1.0 Remove/ overhaul NBS Specification Reference - C40/143B, C41/411-412B
Remove existing mesh from the rear of the tracery panels to the spire gablets and make good the masonry to the rear.Remove any plant growth by removing plant and roots in their entirety from stonework and joints. Existing 4no. perimeter lamps to be restored and upgraded according to ARUP lighting design information and requirements. Includes retaining and refurbishing lamp columns and replacement of top lamp housings to historic design. Lightning conductor system to be serviced according to ARUP specification.

2.1.0 Clean NBS Specification Reference - C40
Undertake conservation cleaning of stonework of memorial according to trial and control samples carried out at commencement of project.

3.1.0 Descale stone NBS Specification Reference - C41/456-459
Carefully rationalise failing stone surfaces by hand.

3.2.0 Decorative stonework consolidation NBS Specification Reference - C41/461B
Carefully remove loose scaling and powdered stone from surface of decorative stonework. Extent of surface removal to be advised by conservator / specialist mason.

4.1.3 Rebuilding existing corner pinnacles: NBS Specification Reference - C41/310, C41/151B-170B, C41/250, C41/284B-286
Allow for a high level inspection by the Design Team and the Conservation Planner to ascertain the fixing details of the pinnacles. Carefully dismantle 1no. existing pinnacle with a watching brief from the Design Team inc Structural Engineer. All ferrous cramps to be recorded and removed where discovered and replaced with Phosphor bronze to match original. Condition, size and bedding orientation to be recorded prior to removal and condition of the stones noted. Once the pinnacle has been dismantled and the construction method understood, allow for removal of the 20th century structural support. Carefully record and remove the existing statues including any support at the base. Remove the plain stone bases that were installed at the time of undertaking the structural repairs. Once this has been undertaken and the fixing methods and defects understood, allow for dismantling and rebuilding the remaining 3no. pinnacles following the insertion of the new structural support in accordance with 12.1.4.

5.1.0 Crack stitching / Repair NBS Specification Reference - C41/611B-693
Repair cracked stone where appropriate to retain in situ.

6.1.0 Stone Replacement / Repair NBS Specification Reference - C41/220-349B C41/460B for re-carving of inscriptions, C41/241B
Where a stone is showing evidence of failure and/or an element of stonework has been replaced with an inappropriate repair this will be removed and the stone replaced in its entirety. Where a section of decorative stone has decayed to such an extent that the original design intent and form has been lost this will be replaced with either a stone indent or a replacement stone section carved to the original profile. Where a stone element has lost a functional element such as a drip mould this will also be replaced with a stone indent to match the original profile. All ferrous cramps to be recorded and removed where discovered and replaced with Phosphor bronze to match original. Any new stone details to be carved to match original Worthington archive drawings. Where this is not possible, stone detail to match extant repeated detail to original profile

7.1.0 Stone Indents NBS Specification Reference - C41/349B
In general where a stone is to be indented this should be replaced with sufficient bed depth to enable the indent to be compression fixed with joggle joints and bronze dog cramps where required. All voids to be grouted and joints pointed using lime mortar.

10.1.0 Repointing and regrouting NBS Specification Reference - Z21, C41/611B-862B, C41/390B, C41/290-300B
All joints to be carefully raked out and complete repointing of monument to be undertaken in lime mortar throughout.
Open joints to projecting cills, copings and to plinth to be undertaking using lead caulking on lead wire infill to plinth and using temporary lead shuttering to projecting stone details.

11.1.0 New weatherings / drainage NBS Specification Reference - C41/137B, C41/710B
Existing water disposal arrangements to be surveyed by Design Team and contractor at commencement of project. Allow to apply discreet mortar flaunchings/weathering to exposed surfaces showing signs of water retention and delamination due to water ingress. Allow for existing drainage chutes to pinnacles to be have existing linings removed and new Code 4 lead linings provided to ensure water is shed away from the monument. Existing drainage routes leading from statue plinth and discharging onto stone steps at base to be cleared to reinstate working order. Allow to reline with lead and catchment grates added at plinth level. New lead gutters/linings to be provided to rear of pinnacles leading into drainage chutes. Co-ordinate with ARUP (Public Health) and Ramboll (sub-surface drainage) as necessary.

12.1.4 Construction of new structural support to pinnacles
With good documentary evidence of the original stone verticals (all four mouldings) and the decorative stone plinth, the proposal is to remove and replace the 3no columns to each corner in a non-ferrous metal, to follow exactly (in silhouette) the original intent. The proposal is to construct a new welded swayframe "table" constructed from stainless steel, the surface of which would be etched to get a suitable "dull" finish to adhere to it. The current proposal is that the corner supports will be designed as three tubes pushed out closer the back of the original granite verticals in the location of the original columns. The head of the "table" will be redesigned to remove the horizontal table top which currently obscures the light to the statues reducing their visibility and creates much a lower soffit over the statues than was originally intended. This re-positioning will improve the view of the statues to what is seen today and will restore the original design intent for these statues. Final specification and fabrication information to be confirmed upon investigation and liaison with Ramboll (structural engineers).

10.0
Re-pointing and re-grouting as per scope, NBS and pricing schedule
10.1.1 Complete repointing in lime mortar 100%. Rake out and repoint all joints to copings, cornices, hood moulds, string courses, ashlar and other areas indicated.
10.1.2 Fill joint with lead caulking to reduce water ingress
