01 Lower Section - South Elevation
Scale: 1:20

OUR TOWN HALL PROJECT
PURCELL
Project Office, Room 308, Town Hall, MANCHESTER M60 2LI
+44 (0) 7970 097 432
www.purcelluk.com

PROJECT STATUS	RIBA STAGE 5
CLIENT	MANCHESTER CITY COUNCIL
PROJECT	OUR TOWN HALL
DRAWING TITLE	Albert Memorial Lower Section - South Elevation
SIZE & SCALE	A1: As indicated
DRAWING STATUS	FOR CONSTRUCTION
JOB NUMBER	236959
DRAWING NO.	OTH-PUR-EE-ZZ-DWG-A-7141
REV	02

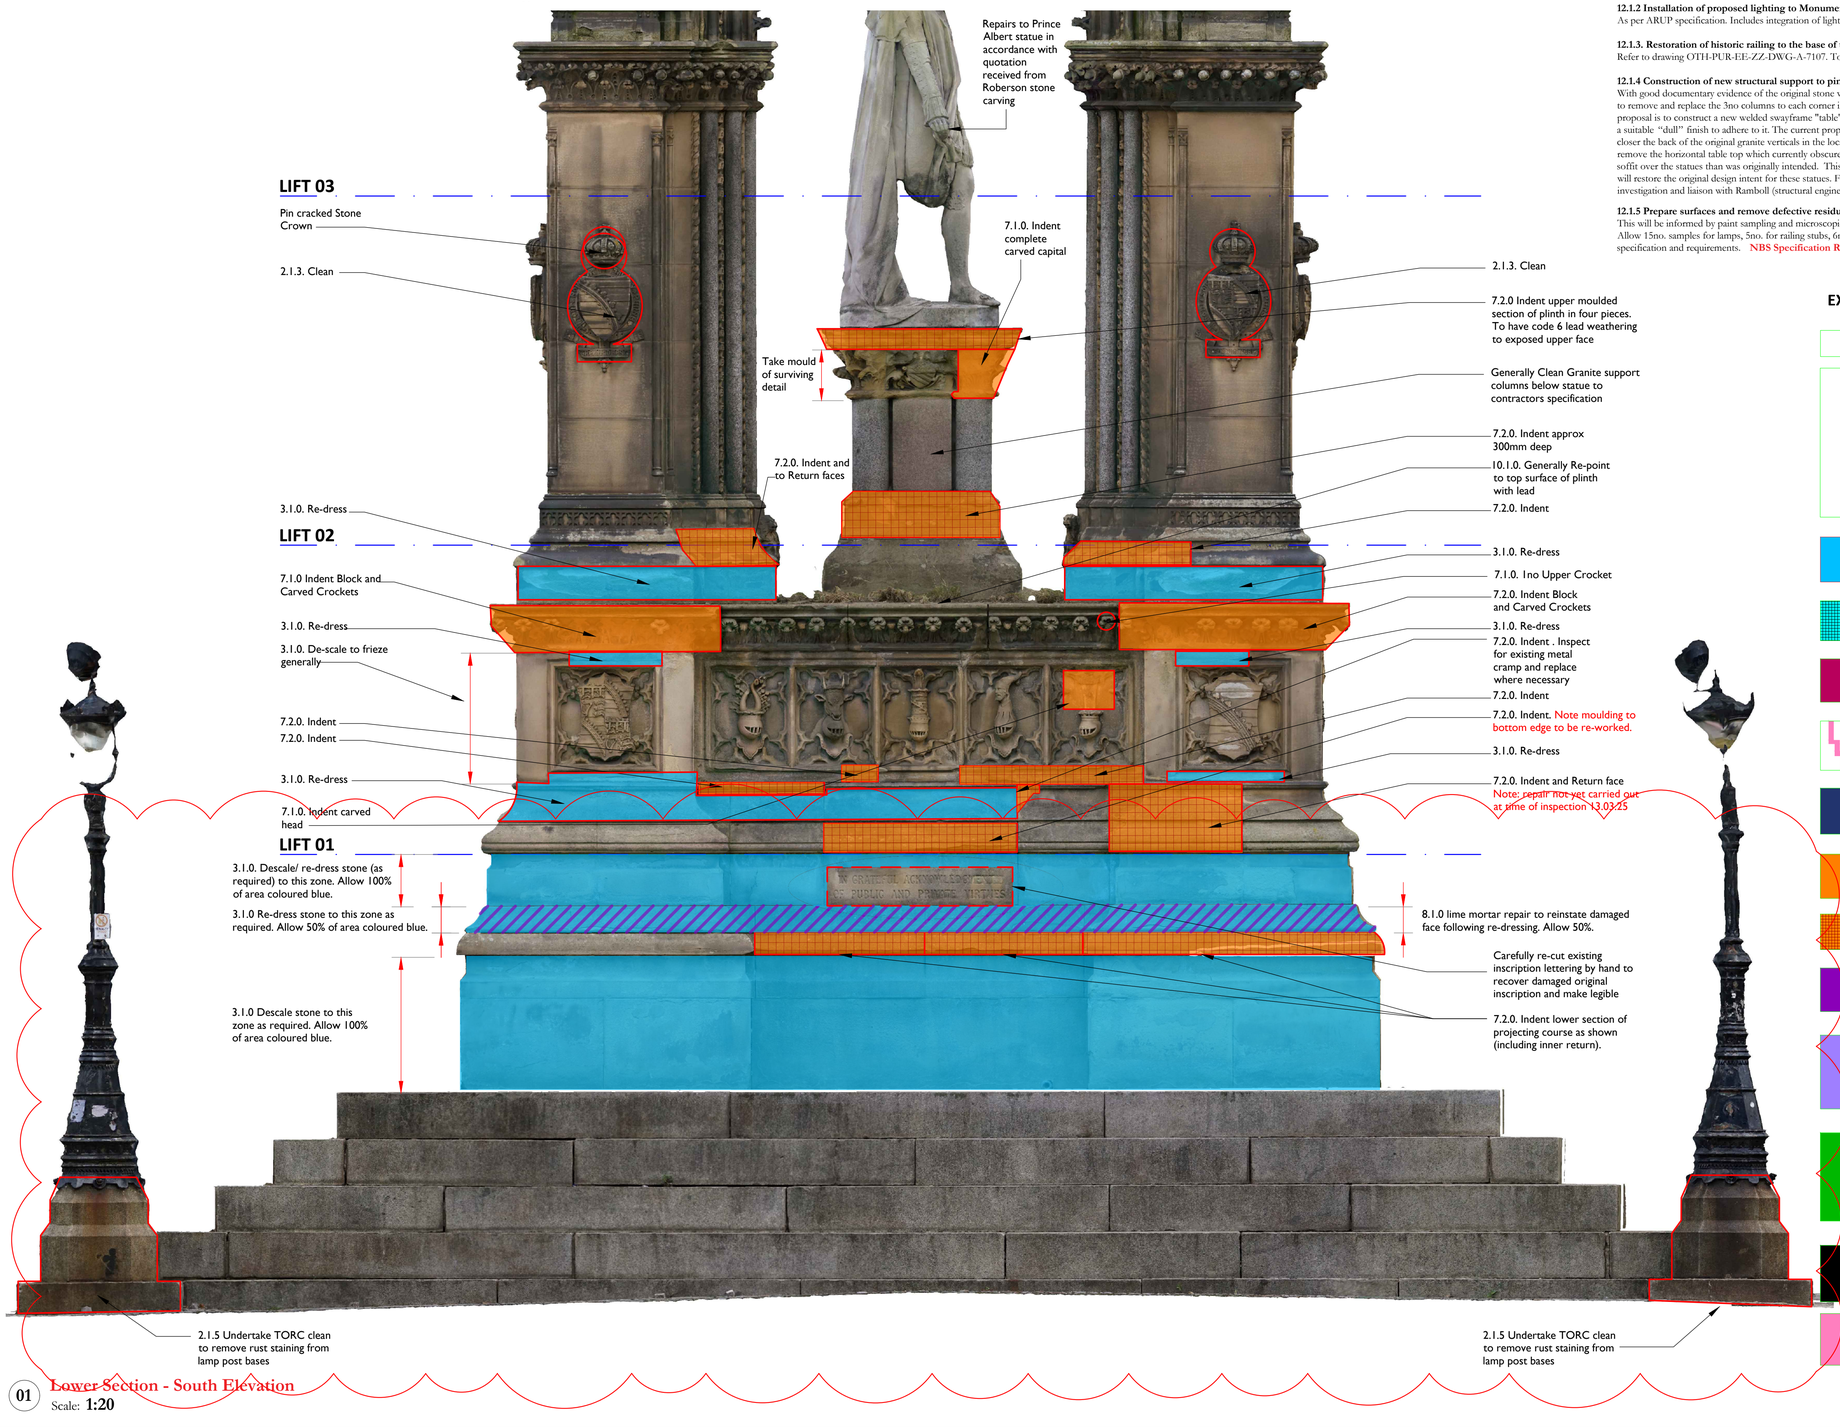
4.1.2 Refix existing Angel to South Elevation Gable NBS Specification Reference - C41/310, C41/151B-170B, C41/250, C41/284B-286
During the inspection of the monument it became apparent that the angel to the head of the South Gable was exhibiting signs of movement and was considered to be unstable. As a result the Angel was carefully removed to refixing as part of the main works.

1.1.0 Remove/ overhaul NBS Specification Reference - C40/143B, C41/411-412B
Remove existing mesh from the rear of the tracery panels to the spire gablets and make good the masonry to the rear.Remove any plant growth by removing plant and roots in their entirety from stonework and joints. Existing 4no. perimeter lamps to be restored and upgraded according to ARUP lighting design information and requirements. Includes retaining and refurbishing lamp columns and replacement of top lamp housings to historic design. Lightning conductor system to be serviced according to ARUP specification.

2.1.0 Clean NBS Specification Reference - C40
Undertake conservation cleaning of stonework of memorial according to trial and control samples carried out at commencement of project.

3.1.0 Descale stone NBS Specification Reference - C41/456-459
Carefully rationalise failing stone surfaces by hand.

3.2.0 Decorative stonework consolidation NBS Specification Reference - C41/461B
Carefully remove loose scaling and powdered stone from surface of decorative stonework. Extent of surface removal to be advised by conservator / specialist mason.

4.1.1 Existing Granite Steps: NBS Specification Reference - C41/310, C41/151B-170B, C41/250, C41/284B-286
Carefully record, remove and store on site existing granite steps around the base of the monument. Following removal allow for an inspection by the Conservation Architect in order to ascertain any repairs required to the assumed brickwork construction to the rear. Prepare granite steps and reinstate in original positions. Re-point steps, including at abutments.

4.1.3 Rebuilding existing corner pinnacles: NBS Specification Reference - C41/310, C41/151B-170B, C41/250, C41/284B-286
Allow for a high level inspection by the Design Team and the Conservation Planner to ascertain the fixing details of the pinnacles. Carefully dismantle 1no. existing pinnacle with a watching brief from the Design Team inc Structural Engineer. All ferrous cramps to be recorded and removed where discovered and replaced with Phosphor bronze to match original. Condition, size and bedding orientation to be recorded prior to removal and condition of the stones noted. Once the pinnacle has been dismantled and the construction method understood, allow for removal of the 20th century structural support. Carefully record and remove the existing statues including any support at the base. Remove the plain stone bases that were installed at the time of undertaking the structural repairs. Once this has been undertaken and the fixing methods and defects understood, allow for dismantling and rebuilding the remaining 3no. pinnacles following the insertion of the new structural support in accordance with 12.1.4.

5.1.0 Crack stitching / Repair NBS Specification Reference - C41/611B-693
Repair cracked stone where appropriate to retain in situ.

6.1.0 Stone Replacement / Repair NBS Specification Reference - C41/220-349B C41/460B for re-carving of inscriptions, C41/241B
Where a stone is showing evidence of failure and/or an element of stonework has been replaced with an inappropriate repair this will be removed and the stone replaced in its entirety. Where a section of decorative stone has decayed to such an extent that the original design intent and form has been lost this will be replaced with either a stone indent or a replacement stone section carved to the original profile. Where a stone element has lost a functional element such as a drip mould this will also be replaced with a stone indent to match the original profile. All ferrous cramps to be recorded and removed where discovered and replaced with Phosphor bronze to match original. Any new stone details to be carved to match original Worthington archive drawings. Where this is not possible, stone detail to match extant repeated detail to original profile

7.1.0 Stone Indents NBS Specification Reference - C41/349B
In general where a stone is to be indented this should be replaced with sufficient bed depth to enable the indent to be compression fixed with joggle joints and bronze dog cramps where required. All voids to be grouted and joints pointed using lime mortar.

8.1.0 Mortar Repairs NBS Specification Reference - Z21, C41/509-555
Mortar repairs only to be undertaken in accessible areas and to small areas of stonework which do not warrant an indent repair.

10.1.0 Repointing and regrouting NBS Specification Reference - Z21, C41/611B-862B, C41/390B, C41/290-300B
All joints to be carefully raked out and complete repointing of monument to be undertaken in lime mortar throughout.
Open joints to projecting cills, copings and to plinth to be undertaking using lead caulking on lead wire infill to plinth and using temporary lead shuttering to projecting stone details.

11.1.0 New weatherings / drainage NBS Specification Reference - C41/137B, C41/710B
Existing water disposal arrangements to be surveyed by Design Team and contractor at commencement of project. Allow to apply discreet mortar flaunchings/weathering to exposed surfaces showing signs of water retention and delamination due to water ingress. Allow for existing drainage chutes to pinnacles to be have existing linings removed and new Code 4 lead linings provided to ensure water is shed away from the monument. Existing drainage routes leading from statue plinth and discharging onto stone steps at base to be cleared to reinstate working order. Allow to reline with lead and catchment grates added at plinth level. New lead gutters/linings to be provided to rear of pinnacles leading into drainage chutes. Co-ordinate with ARUP (Public Health) and Ramboll (sub-surface drainage) as necessary.
