01 Mid Section -East Elevation
Scale: 1:20

OUR TOWN HALL PROJECT
PURCELL
Project Office, Room 308, Town Hall, MANCHESTER M60 2LI
+44 (0) 7970 097 432
www.purcelluk.com

PROJECT STATUS	RIBA STAGE 5
CLIENT	MANCHESTER CITY COUNCIL
PROJECT	OUR TOWN HALL
DRAWING TITLE	Albert Memorial Mid Section -East Elevation
SIZE & SCALE	A1: As indicated
DRAWING STATUS	FOR CONSTRUCTION
JOB NUMBER	236959
DRAWING NO.	OTH-PUR-EE-ZZ-DWG-A-7136
REV	01

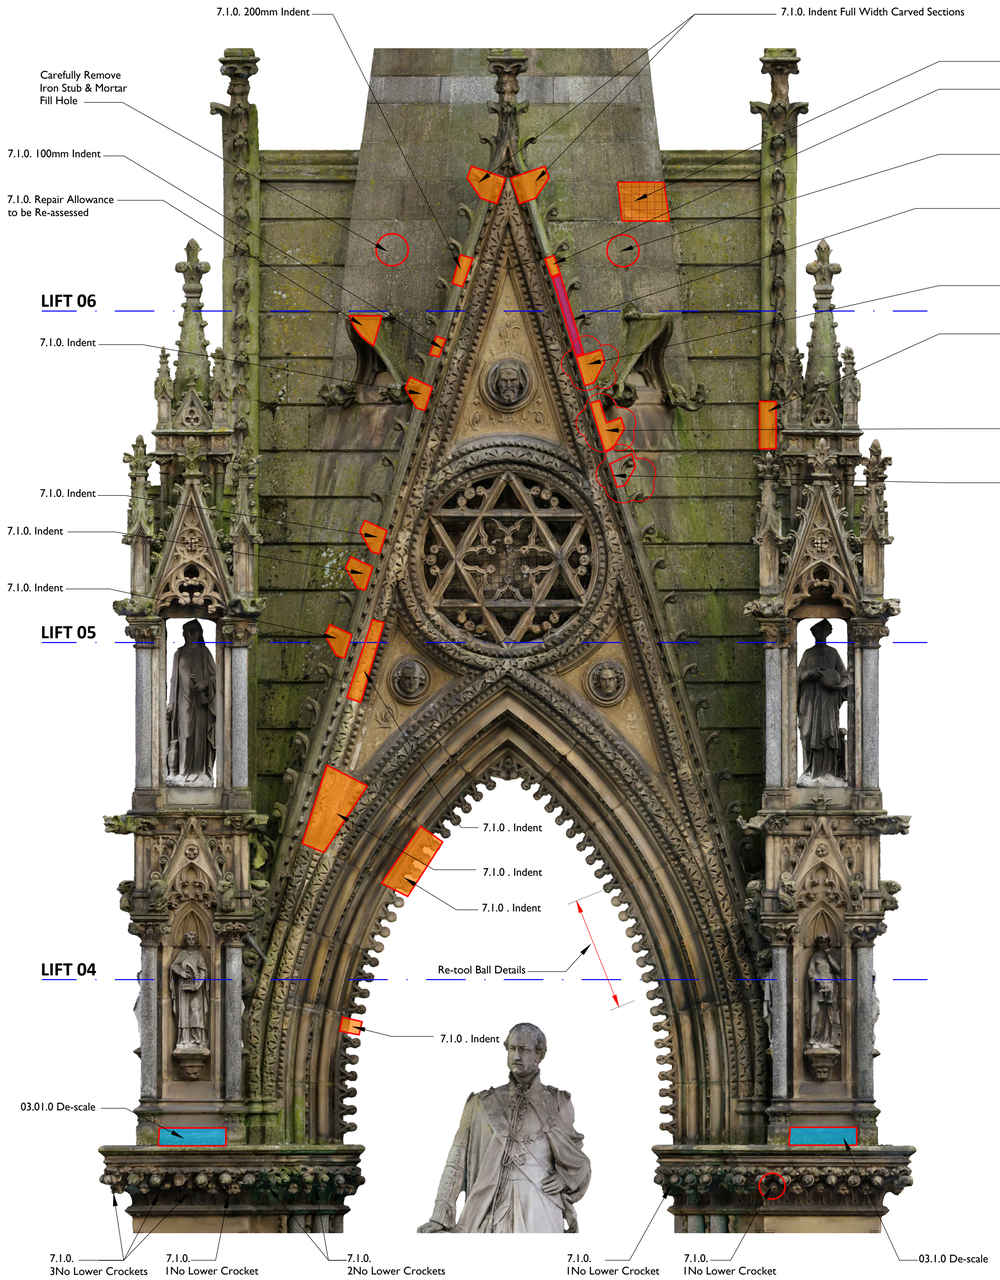
4.1.2 Refix existing Angel to South Elevation Gable NBS Specification Reference - C41/310, C41/151B-170B, C41/250, C41/284B-286
During the inspection of the monument it became apparent that the angel to the head of the South Gable was exhibiting signs of movement and was considered to be unstable. As a result the Angel was carefully removed to refixing as part of the main works.

4.1.3 Rebuilding existing corner pinnacles: NBS Specification Reference - C41/310, C41/151B-170B, C41/250, C41/284B-286
Allow for a high level inspection by the Design Team and the Conservation Planner to ascertain the fixing details of the pinnacles. Carefully dismantle 1no. existing pinnacle with a watching brief from the Design Team inc Structural Engineer. All ferrous cramps to be recorded and removed where discovered and replaced with Phosphor bronze to match original. Condition, size and bedding orientation to be recorded prior to removal and condition of the stones noted. Once the pinnacle has been dismantled and the construction method understood, allow for removal of the 20th century structural support. Carefully record and remove the existing statues including any support at the base. Remove the plain stone bases that were installed at the time of undertaking the structural repairs. Once this has been undertaken and the fixing methods and defects understood, allow for dismantling and rebuilding the remaining 3no. pinnacles following the insertion of the new structural support in accordance with 12.1.4.

1.1.0 Remove/ overhaul NBS Specification Reference - C40/143B, C41/411-412B
Remove existing mesh from the rear of the tracery panels to the spire gablets and make good the masonry to the rear.Remove any plant growth by removing plant and roots in their entirety from stonework and joints. Existing 4no. perimeter lamps to be restored and upgraded according to ARUP lighting design information and requirements. Includes retaining and refurbishing lamp columns and replacement of top lamp housings to historic design. Lightning conductor system to be serviced according to ARUP specification.

2.1.0 Clean NBS Specification Reference - C40
Undertake conservation cleaning of stonework of memorial according to trial and control samples carried out at commencement of project.

3.1.0 Descale stone NBS Specification Reference - C41/456-459
Carefully rationalise failing stone surfaces by hand.

3.2.0 Decorative stonework consolidation NBS Specification Reference - C41/461B
Carefully remove loose scaling and powdered stone from surface of decorative stonework. Extent of surface removal to be advised by conservator / specialist mason.

5.1.0 Crack stitching / Repair NBS Specification Reference - C41/611B-693
Repair cracked stone where appropriate to retain in situ.

6.1.0 Stone Replacement / Repair NBS Specification Reference - C41/220-349B C41/460B for re-carving of inscriptions, C41/241B
Where a stone is showing evidence of failure and/or an element of stonework has been replaced with an inappropriate repair this will be removed and the stone replaced in its entirety. Where a section of decorative stone has decayed to such an extent that the original design intent and form has been lost this will be replaced with either a stone indent or a replacement stone section carved to the original profile. Where a stone element has lost a functional element such as a drip mould this will also be replaced with a stone indent to match the original profile. All ferrous cramps to be recorded and removed where discovered and replaced with Phosphor bronze to match original. Any new stone details to be carved to match original Worthington archive drawings. Where this is not possible, stone detail to match extant repeated detail to original profile

7.1.0 Stone Indents NBS Specification Reference - C41/349B
In general where a stone is to be indented this should be replaced with sufficient bed depth to enable the indent to be compression fixed with joggle joints and bronze dog cramps where required. All voids to be grouted and joints pointed using lime mortar.

8.1.0 Mortar Repairs NBS Specification Reference - Z21, C41/509-555
Mortar repairs only to be undertaken in accessible areas and to small areas of stonework which do not warrant an indent repair.

10.1.0 Repointing and regrouting NBS Specification Reference - Z21, C41/611B-862B, C41/390B, C41/290-300B
All joints to be carefully raked out and complete repointing of monument to be undertaken in lime mortar throughout.
Open joints to projecting cills, copings and to plinth to be undertaking using lead caulking on lead wire infill to plinth and using temporary lead shuttering to projecting stone details.

11.1.0 New weatherings / drainage NBS Specification Reference - C41/137B, C41/710B
Existing water disposal arrangements to be surveyed by Design Team and contractor at commencement of project. Allow to apply discreet mortar flaunchings/weathering to exposed surfaces showing signs of water retention and delamination due to water ingress. Allow for existing drainage chutes to pinnacles to be have existing linings removed and new Code 4 lead linings provided to ensure water is shed away from the monument. Existing drainage routes leading from statue plinth and discharging onto stone steps at base to be cleared to reinstate working order. Allow to reline with lead and catchment grates added at plinth level. New lead gutters/linings to be provided to rear of pinnacles leading into drainage chutes. Co-ordinate with ARUP (Public Health) and Ramboll (sub-surface drainage) as necessary.

12.1.4 Construction of new structural support to pinnacles
With good documentary evidence of the original stone verticals (all four mouldings) and the decorative stone plinth, the proposal is to remove and replace the 3no columns to each corner in a non-ferrous metal, to follow exactly (in silhouette) the original intent. The proposal is to construct a new welded swayframe "table" constructed from stainless steel, the surface of which would be etched to get a suitable "dull" finish to adhere to it. The current proposal is that the corner supports will be designed as three tubes pushed out closer the back of the original granite verticals in the location of the original columns. The head of the "table" will be redesigned to remove the horizontal table top which currently obscures the light to the statues reducing their visibility and creates much a lower soffit over the statues than was originally intended. This re-positioning will improve the view of the statues to what is seen today and will restore the original design intent for these statues. Final specification and fabrication information to be confirmed upon investigation and liaison with Ramboll (structural engineers).
