OUR TOWN HALL PROJECT

PROJECT STATUS	RIBA Stage 5
CLIENT	MANCHESTER CITY COUNCIL
PROJECT	OUR TOWN HALL
DRAWING TITLE	Albert Square Memorial Elevations Sheet 2
SIZE & SCALE	A1: As indicated
DRAWING STATUS	FOR CONSTRUCTION
JOB NUMBER	236959
DRAWING NO.	OTH-PUR-EE-ZZ-DWG-A-7103
REV	06

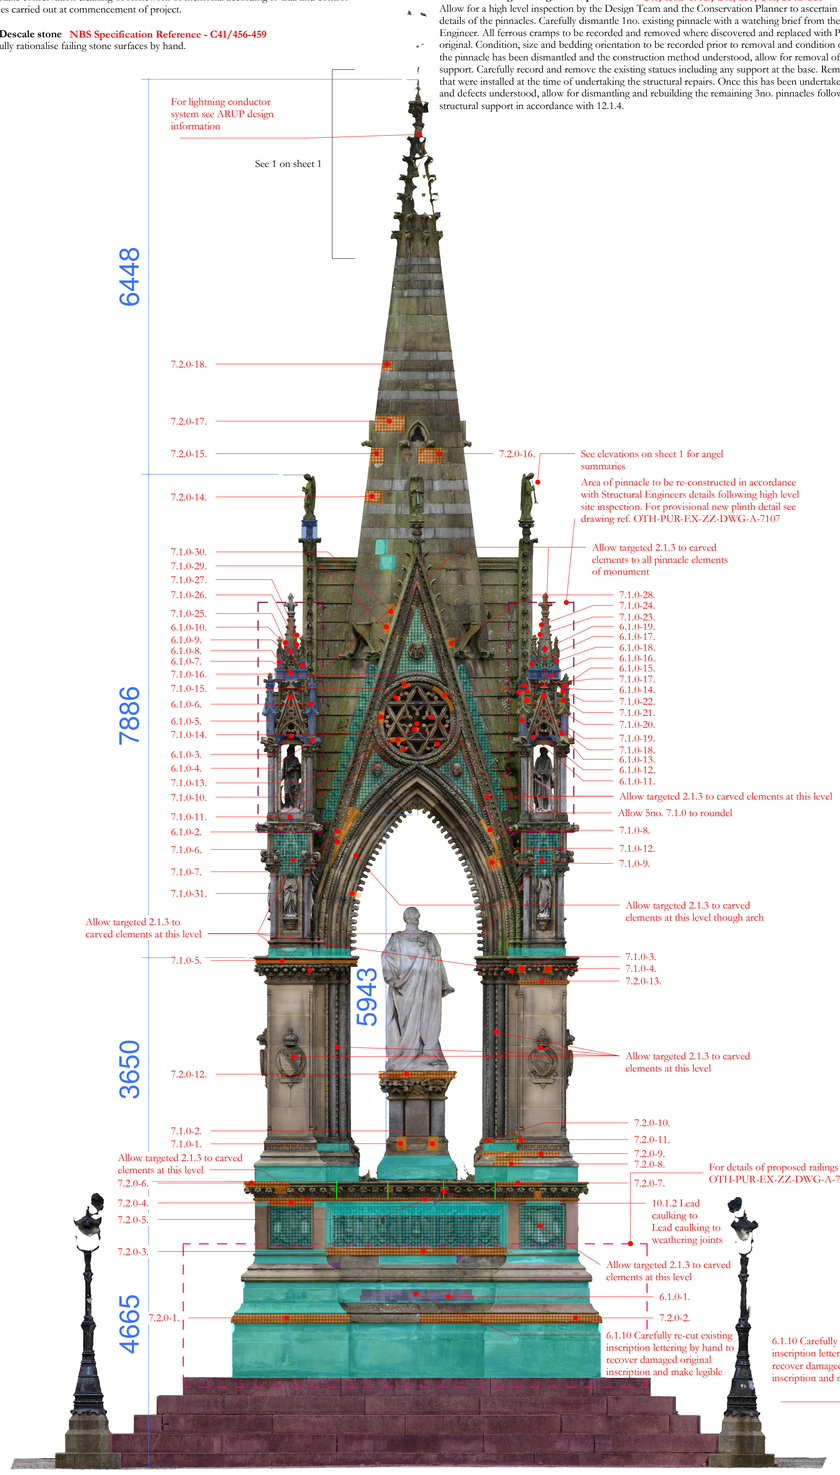
3 **Rear- West Elevation**
1 : 50

4.1.0 to Steps (all elevations) and allow 9.1.1

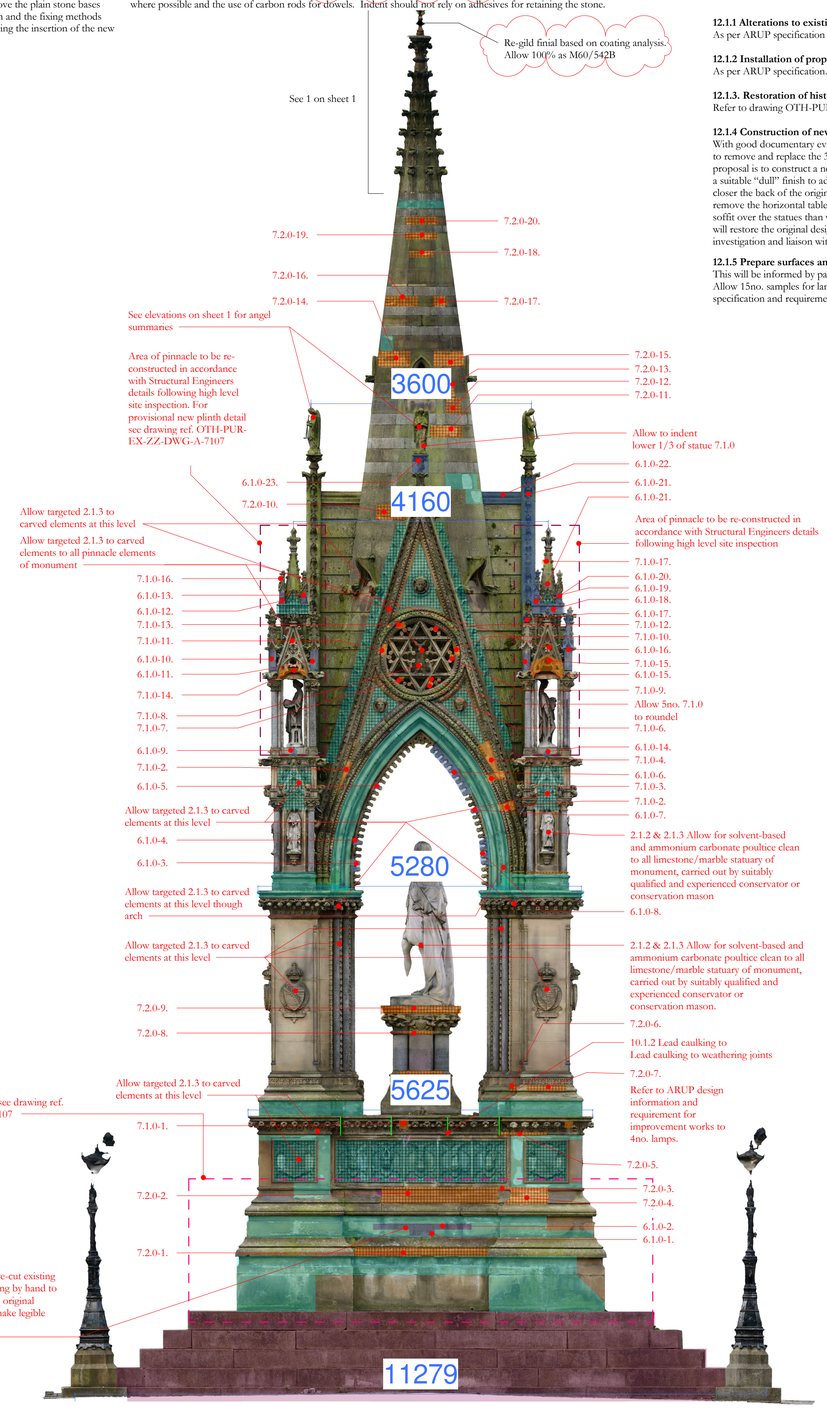
4 **Side 2 - North Elevation**
1 : 50

4.1.0 to Steps (all elevations) and allow 9.1.1
