PHOTO 1
SITE CONTACT
GINA 01612485612
SURVEYOR
NICOLE HARTNETT
07484 525199
SURVEY DATE
10/08/2026
CUSTOMER'S SITE (71 DENISON ROAD, MANCHESTER, M14 5RX)

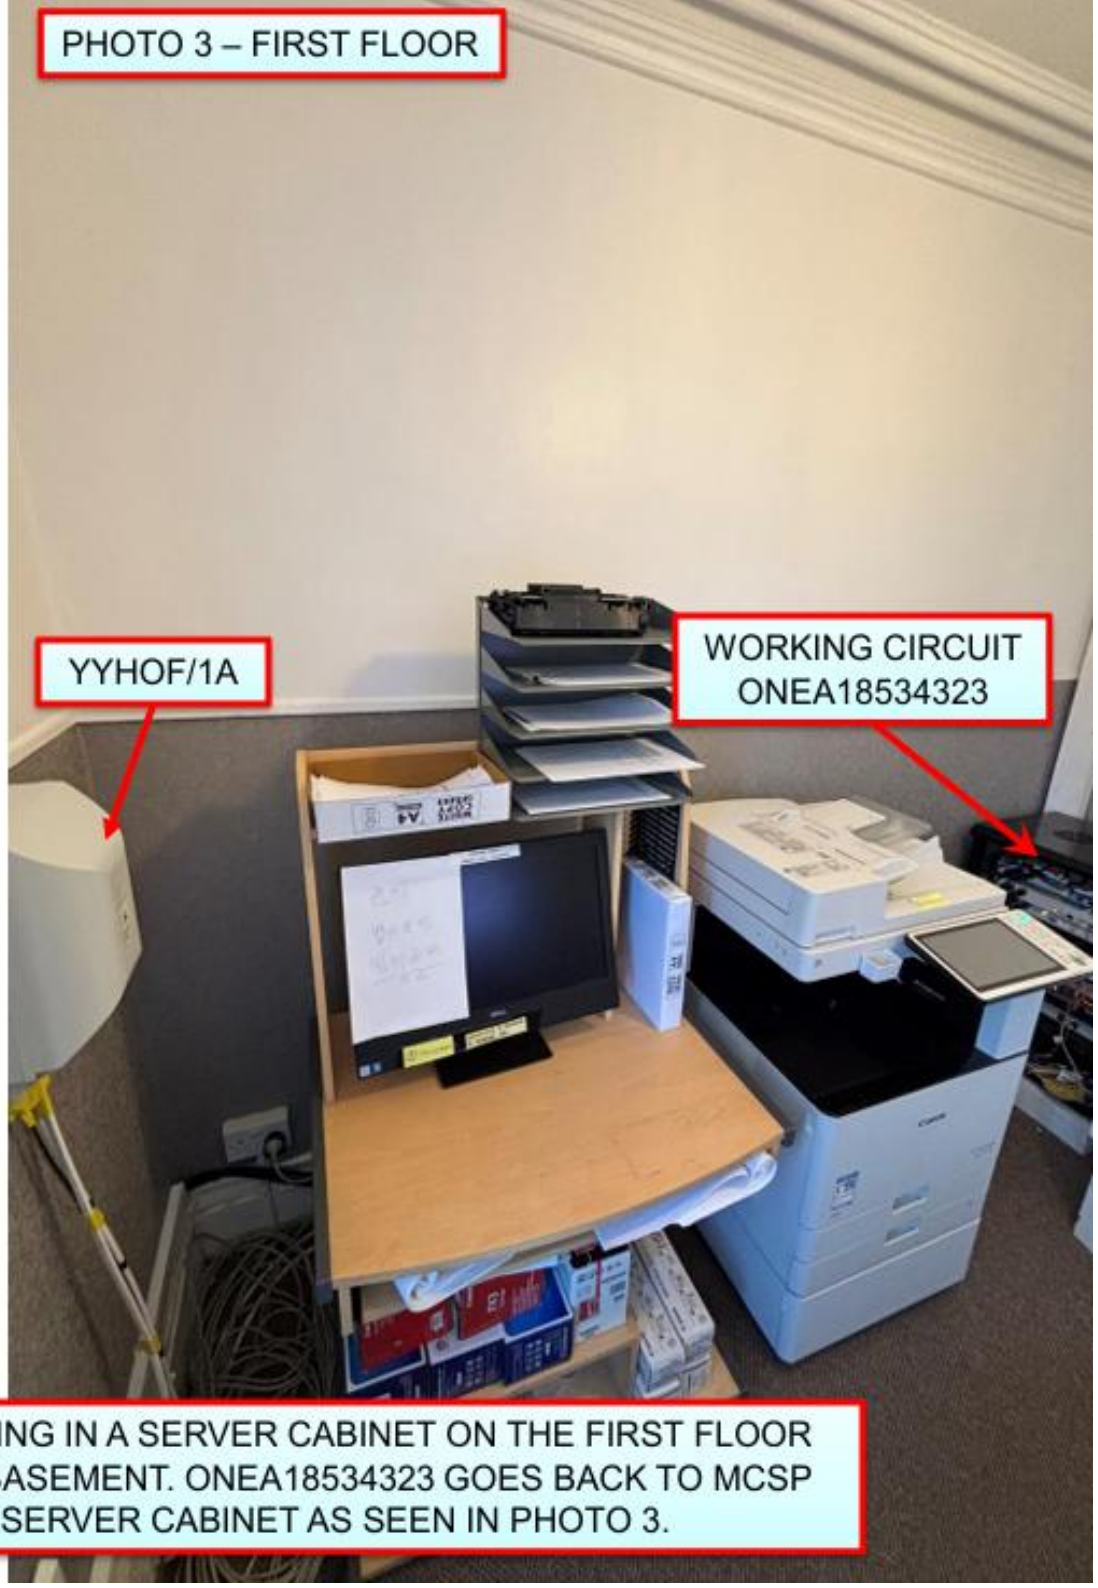
PHOTO 3 – FIRST FLOOR

CIRCUIT ONEA18534323 IS CURRENTLY WORKING IN A SERVER CABINET ON THE FIRST FLOOR AND WILL REQUIRE DOWNTIME TO SHIFT TO BASEMENT. ONEA18534323 GOES BACK TO MCSP ON THE WALL IN THE SAME ROOM AS SERVER CABINET AS SEEN IN PHOTO 3.
