Chimney oversail - stonework repairs

Murrays Mill, Manchester | Rev A | Sheet 1/1

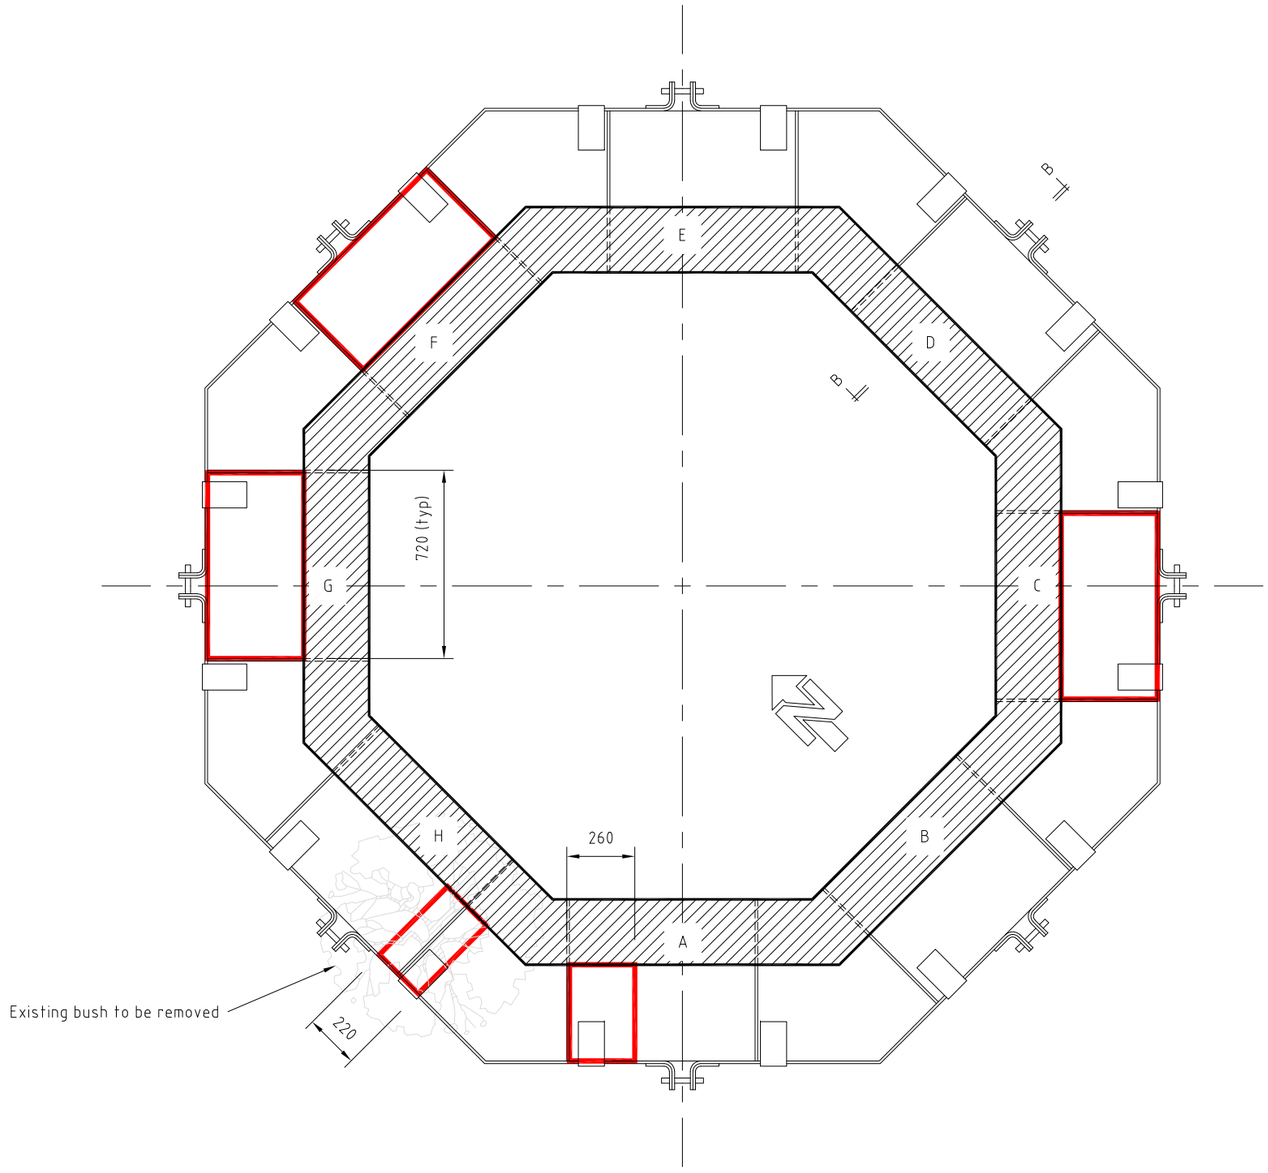
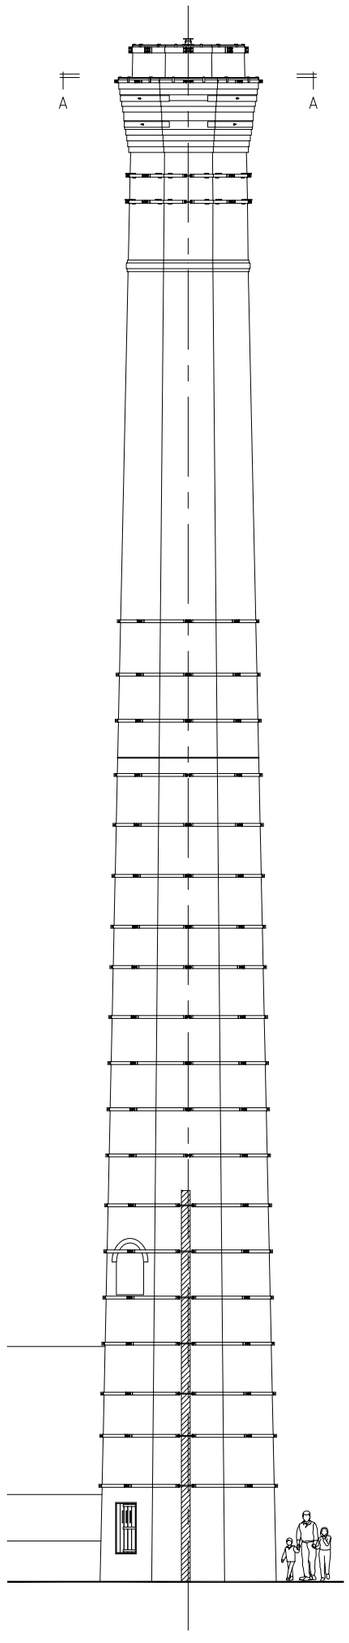
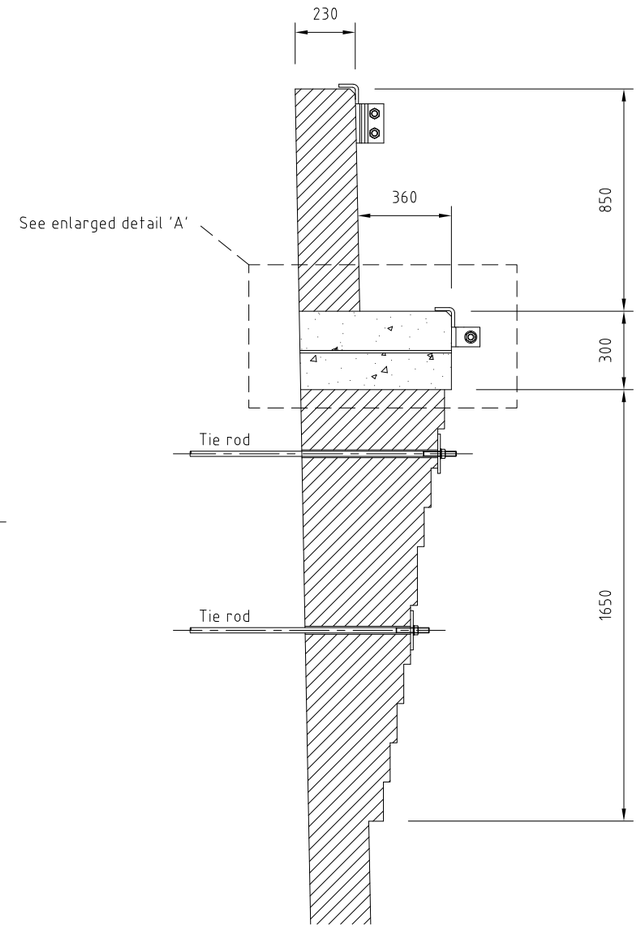
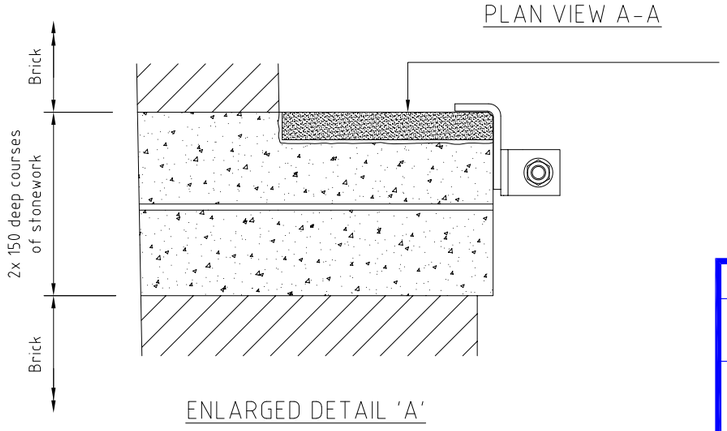
ENLARGED DETAIL 'A'

Defective stonework to be cut out to a depth of 60mm and new 50mm deep sandstone inlay panel inserted. See note 2 for inlay panel H.

New stone inlay panels to be set on a full bed of NHL 3.5 lime mortar.

Surface profile to be aligned with surrounding stones.
