castlefield Viaduct delapidation survey

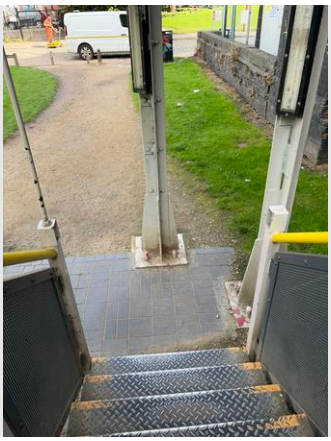
Photo 129 - Showing pedestrian footpath route from the public highway leading to the pedestrian access staircase.

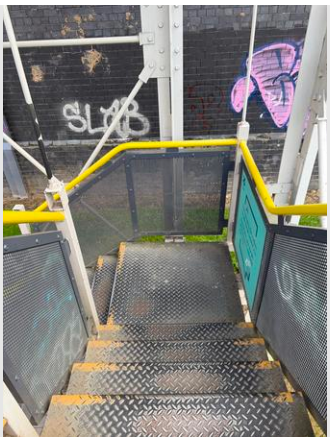
Photo 128- 12th landing to flight of stairs, paint damage to several areas and graffiti as shown in photos.

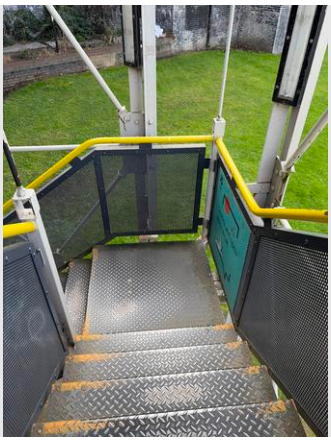
Photo 127- 11th landing to flight of stairs, paint damage to several areas and graffiti as shown in photos.

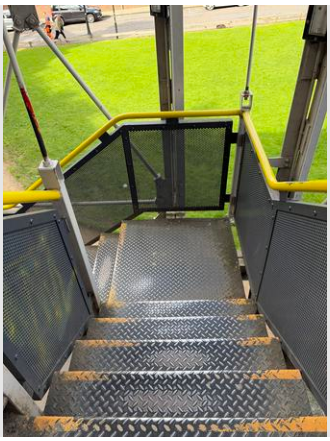
Photo 126- 10th landing to flight of stairs, paint damage to several areas and graffiti as shown in photos.

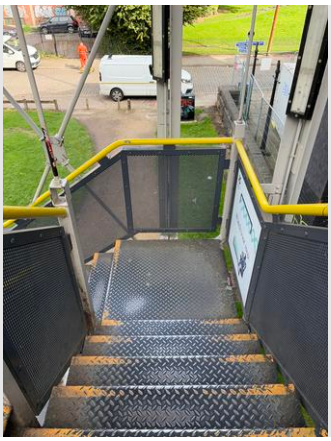
Photo 125- 9th landing to flight of stairs, paint damage to several areas and graffiti as shown in photos.

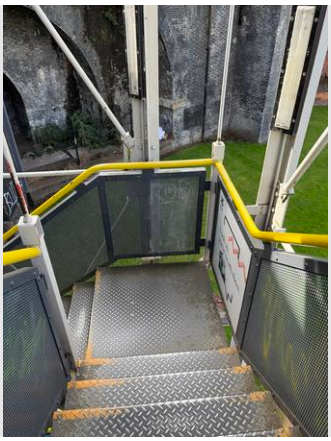
Photo 123- 7th landing to flight of stairs, paint damage to several areas as shown in photos.

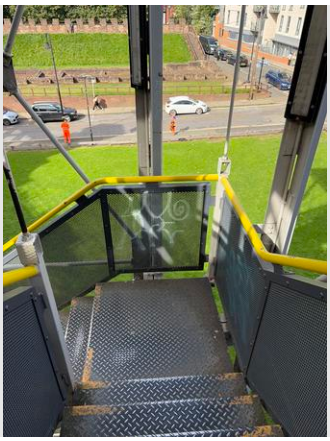
Photo 122- 6th landing to flight of stairs, paint damage to several areas and graffiti as shown in photos.

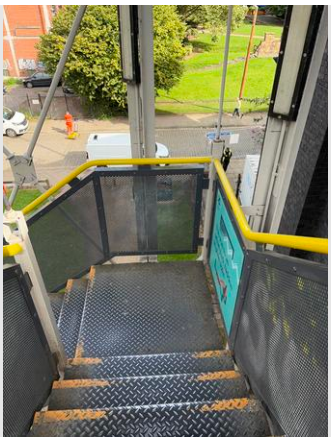
Photo 121- 5th landing to flight of stairs, paint damage to several areas and graffiti as shown in photos.

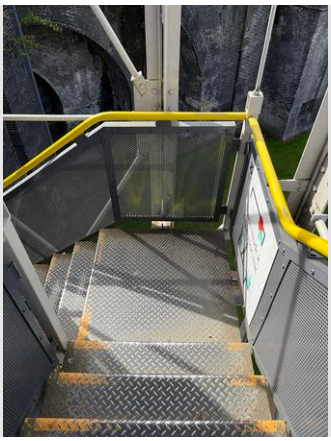
Photo 119- 3rd landing to flight of stairs, paint damage to several areas and graffiti present as shown in photos.

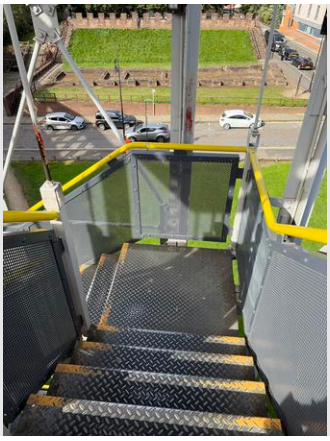
Photo 118- 2nd landing to flight of stairs, paint damage to several areas as shown in photos.

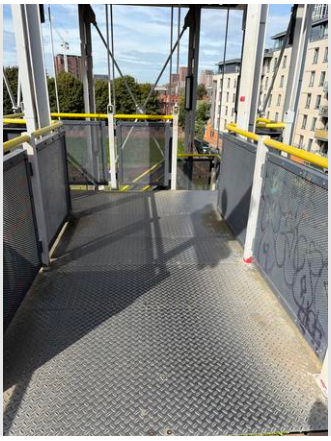
Photo 117 - Top flight of stairs, paint damage to several areas as shown in photos.

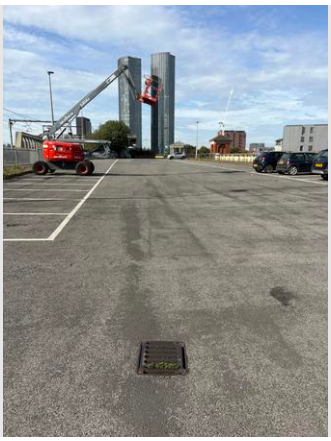
Photo 85 - Iron works in centre of road has vegetation growth. General photo of gully condition.

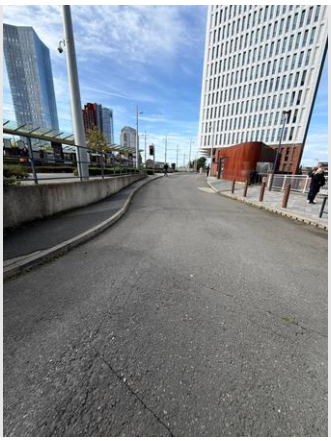
Photo 34 - MH cover to centre of the road sunken. Road surfacing to perimeter is deteriorating.

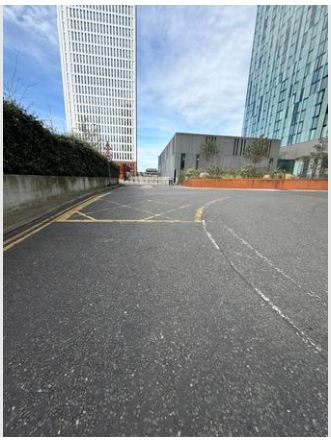
Photo 31 - General condition of the road surfacing is poor in front of the barrier system. Looks like a central island may have been remo...

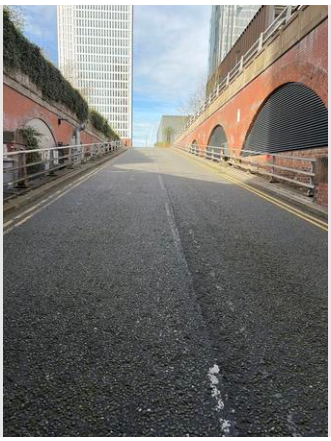
Photo 24 - No parking sign damaged on RH side of the ramp, viewed from photo 23 direction.

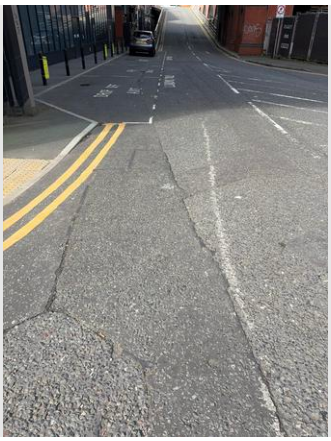
Photo 6 - Exit side of the service road onto junction with main carriage way on Albion street. General condition shows vegetation to kerb...

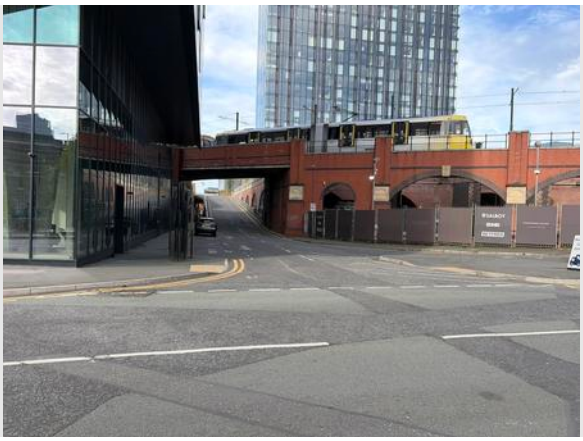
Photo 2 - Tactile paving damage to crossing point, LHS viewed from direction of photo 1
