DOMIS CONSTRUCTION LTD

BRWRY, Manchester

Remediation Validation Report

JEM/C5313/12304 Rev H

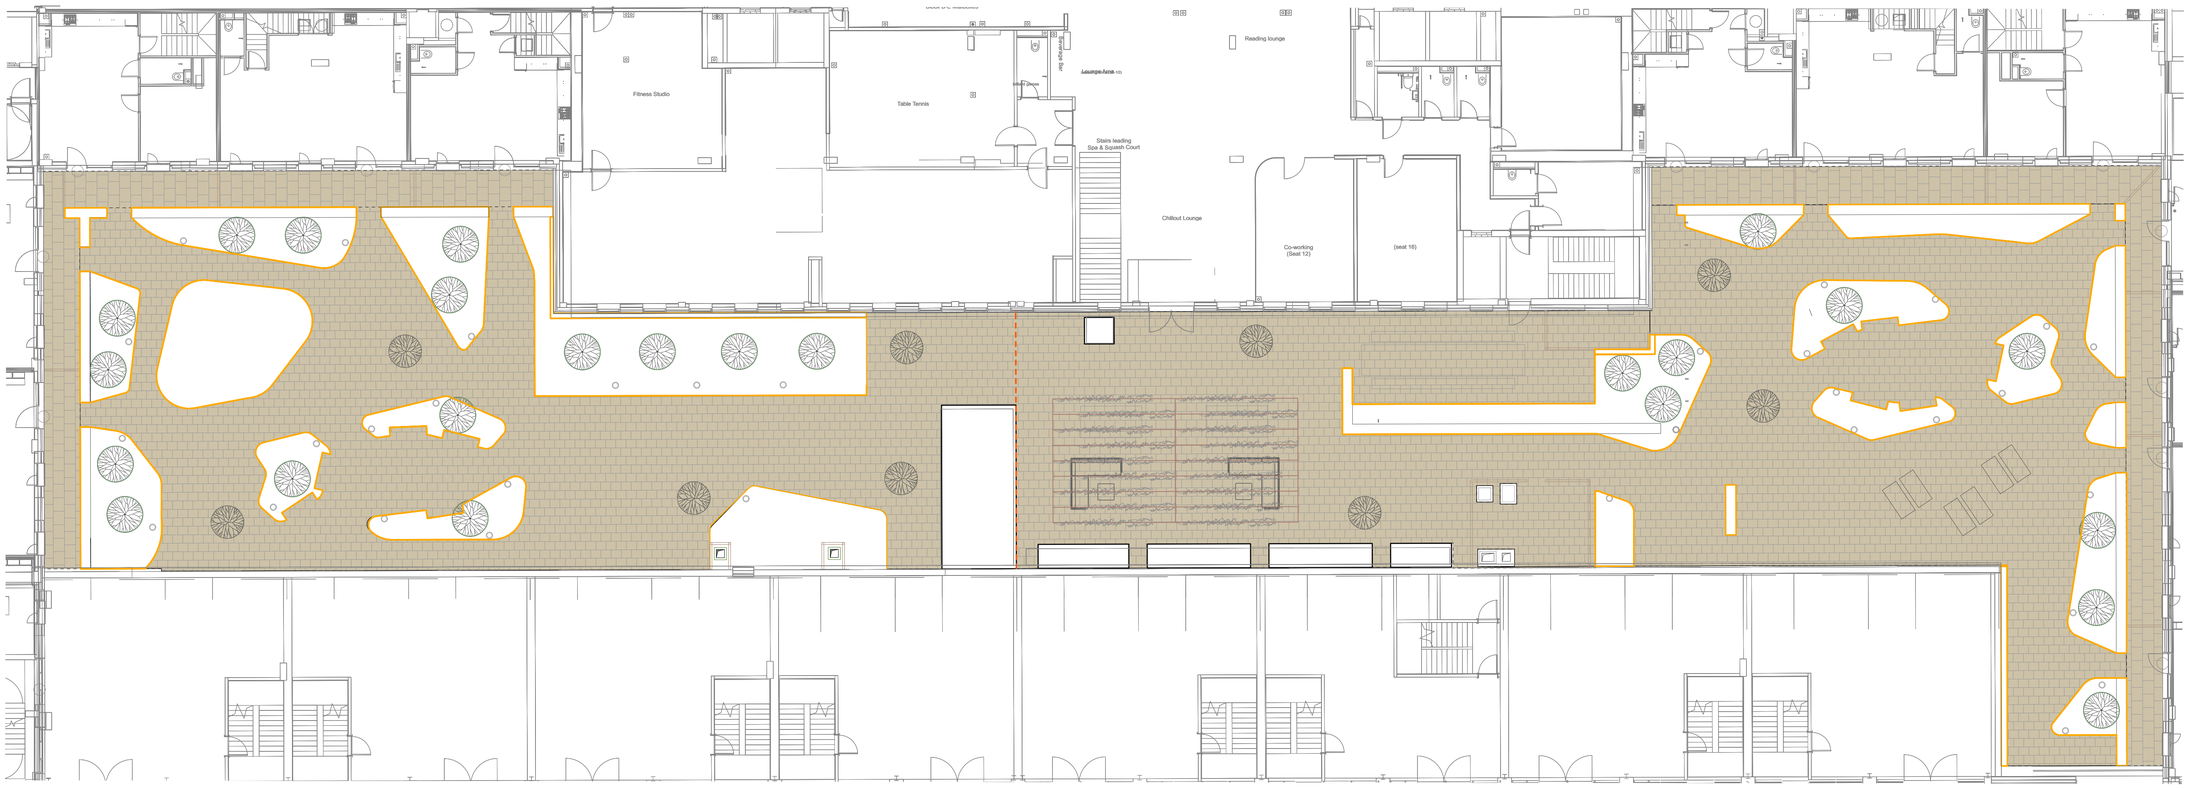
1 Podium Hardworks
Scale: 1:150

Blocks C & D
As presented in the Podium Hardworks drawing (ref. 1174-WRI-XX-XX-DR-L-0004) and as shown in the wider development landscaping plans, no ground-level soft landscaping is proposed in Blocks C & D as the building footprints for these blocks are across the entirety. As such, depth validation of the planters installed on the podium level of these blocks is not required as no risk from the made ground underlying the site exists.

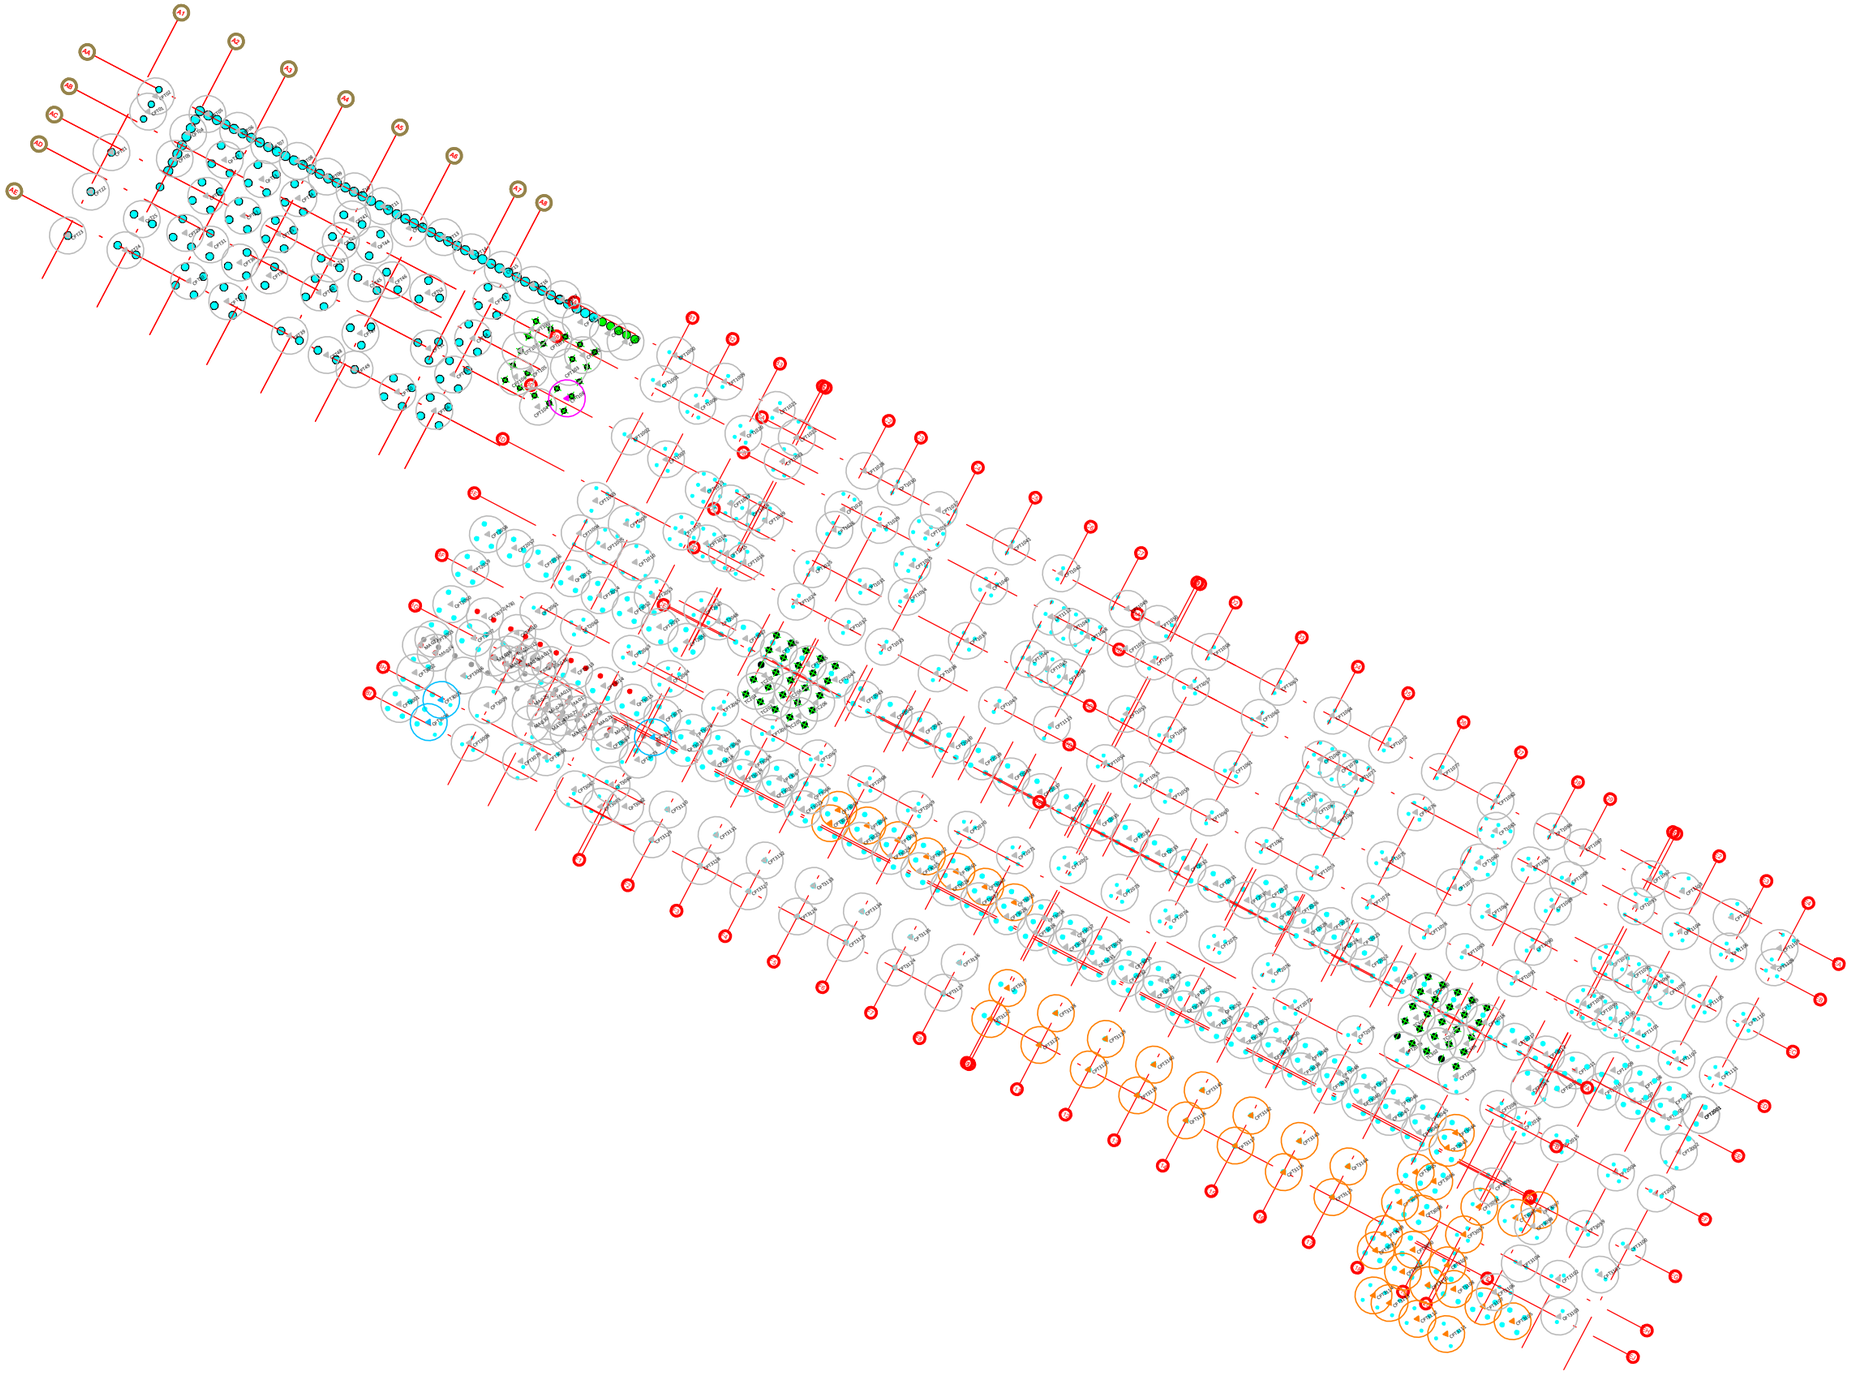
DRAWING No.	REVISION	SCALE	DATE
C5313/10	H	NTS	12/09/23

Hazard	Status
Excavation of asbestos impacted soils from the site-wide proof dig down to natural strata and subsequent stockpiling of material.	Completed.
Material will be sorted and re-engineered to 6F5 to be utilised as general fill and a piling mat across the majority of the development, in accordance with a declared MMP.	Completed.
Materials from BH102 where asbestos was encountered at 0.097% will be treated as anomalous from the general made ground and re-used as general fill below 1.00m bgl as one of the initial stages of works, in accordance with a declared MMP.	Completed. Movement demonstrated between Asbestos Work Area Plan Revision B and C (ref. C5313/10 Rev B and C5313/10 Rev C. HSE Notification Number: EEB31128E9. Submitted Date: 27/07/2023.
Materials from ASB203 where asbestos was encountered at 0.098% will also be treated as anomalous from the general made ground. Additional testing was undertaken in proximity to ASB203 to assist in confirming an appropriate work area and volume for notifiable asbestos	Completed. Movement demonstrated between Asbestos Work Area Plan Revision H and I (ref. C5313/10 Rev H and C5313/10 Rev I.

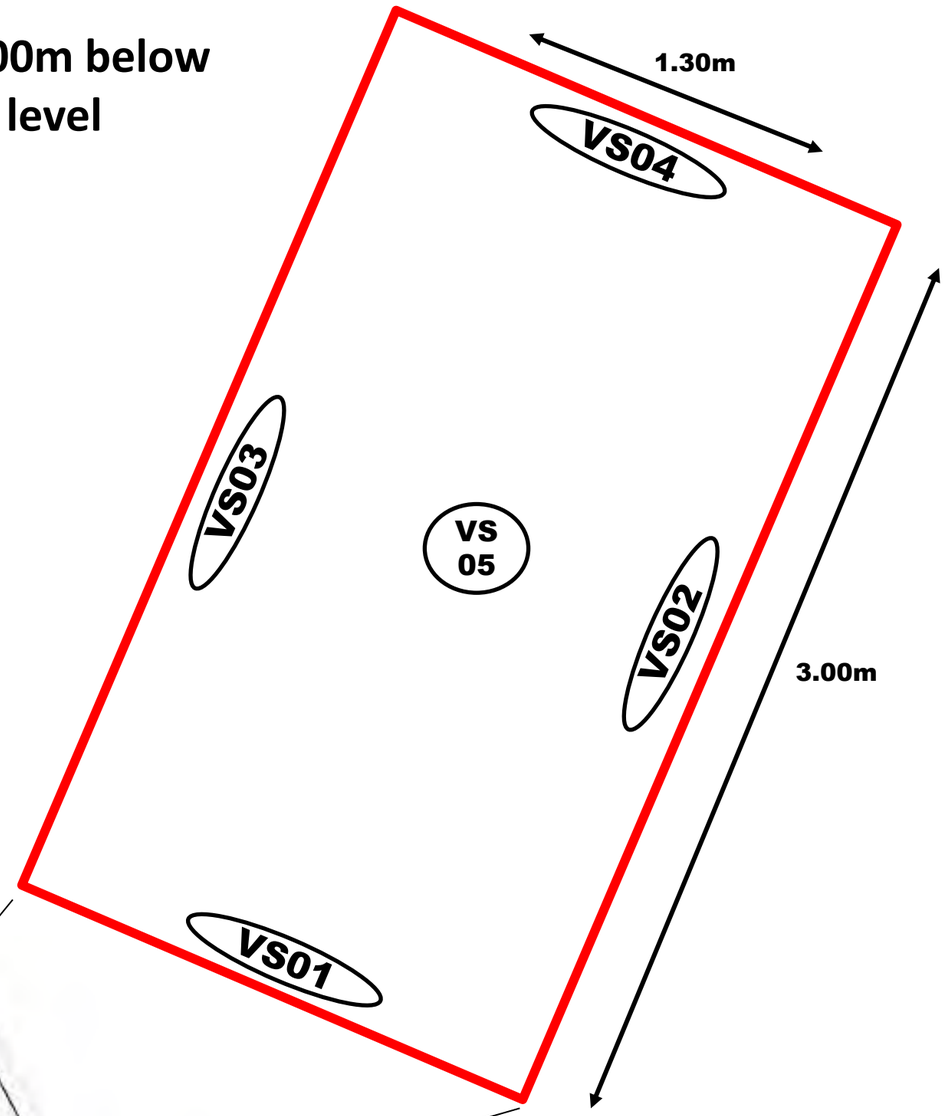
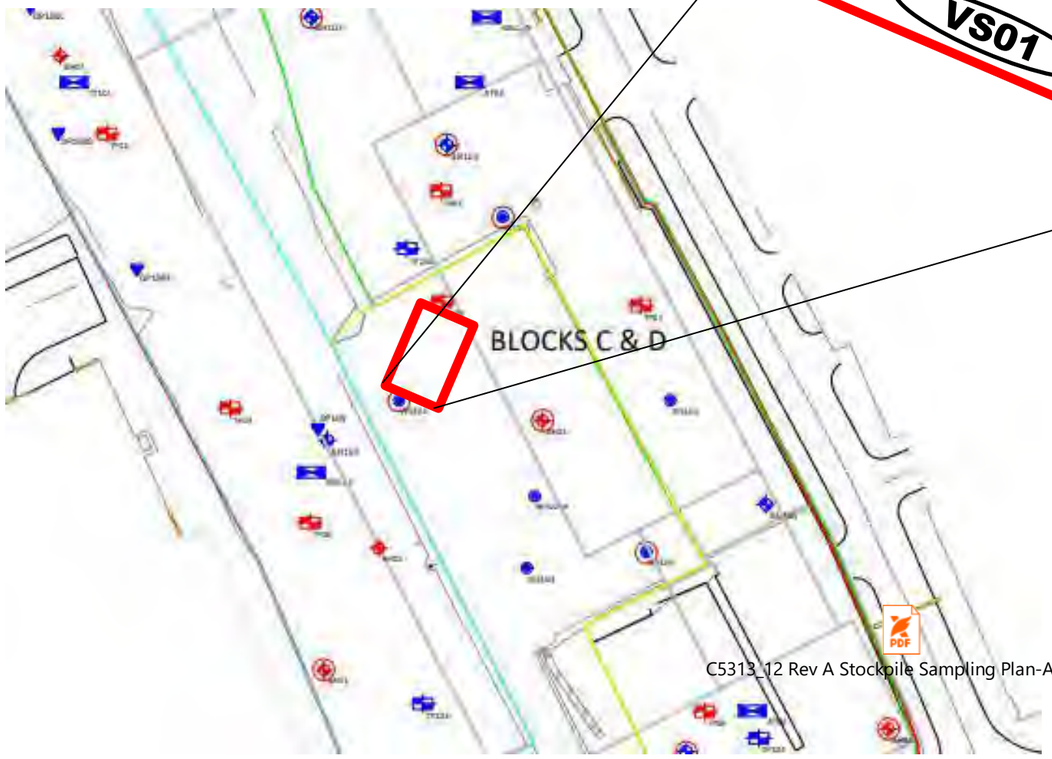
5th July 2023 – Previously Unrecorded UST (Excavation 1)
BSL attended site on 5th July 2023 to validate the removal of a tank found in Block C & D. BSL were not requested to attend site during the removal of the unrecorded UST. The area surrounding the UST was subsequently reduced in level to the same level of the base of the excavation with the excavated material re-used elsewhere onsite. No contamination was reported to BSL from the material excavated from this area. The locations and dimensions of the tank excavations and sampling locations are shown on the Tank Excavation Plan, drawing C5313/11.

Top of tank found 2.00m below original ground level

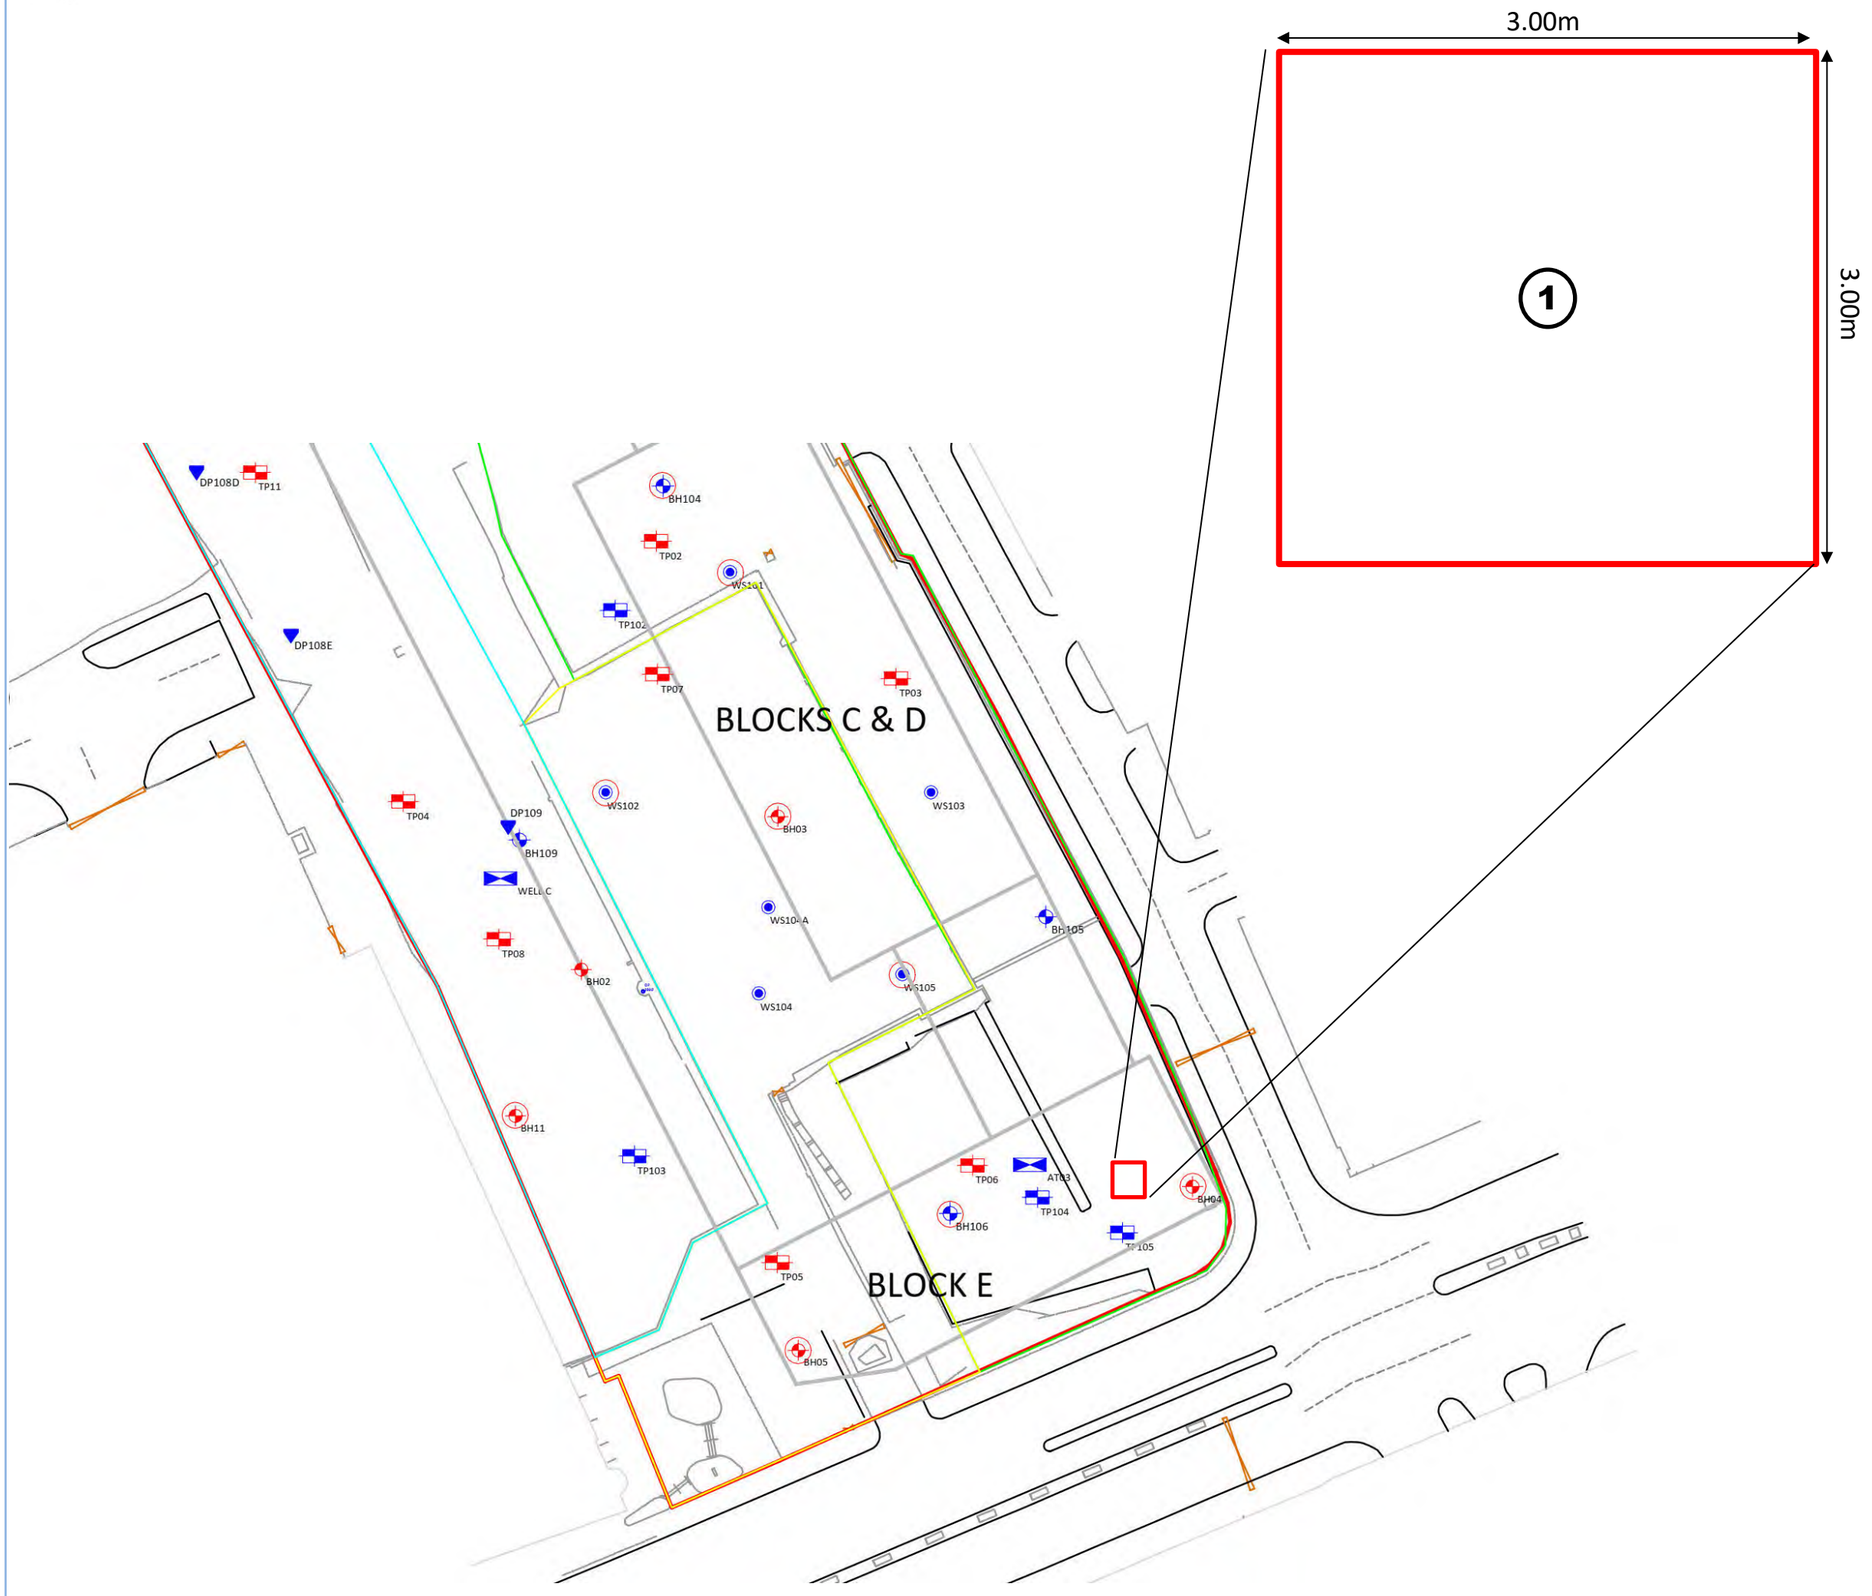
DRAWING No.	REVISION	SCALE	DATE
C5313/12	A	NTS	26/07/23

On 14th July 2023, BSL attended the site to obtain samples of stockpiled 6F5 generated during the earthworks at the site for asbestos which was being crushed and screened ready for re-use across the site. Based on an approximate volume of 4,000m^3 and a sample frequency of 1 per 1,000m^3, a total of 4No. samples were collected and named SP01, SP02, SP05 and SP06. It was noted onsite, that a smaller stockpile of approximately 2,000m^3 was present which comprised material excavated and stockpiled from the area around and including BH102. Two samples of this material were obtained and named SP03 and SP04. The location of these samples and the materials stockpiled is shown on drawing ref. C5313/12 Rev A. The results recorded trace asbestos in SP01 and SP02, and asbestos at 0.001% in SP03.
