## BS5837:2012 TREE SURVEY / Arboricultural Impact Assessment

Customer No: MBHDE05  
Document No: 800717  
26/01/2022

Site Address:  
FS408 MFG RUSHOLME SERVICE STATION  
10 WILMSLOW ROAD  
MANCHESTER. M14 5TQ

Version 2 Jan 2022

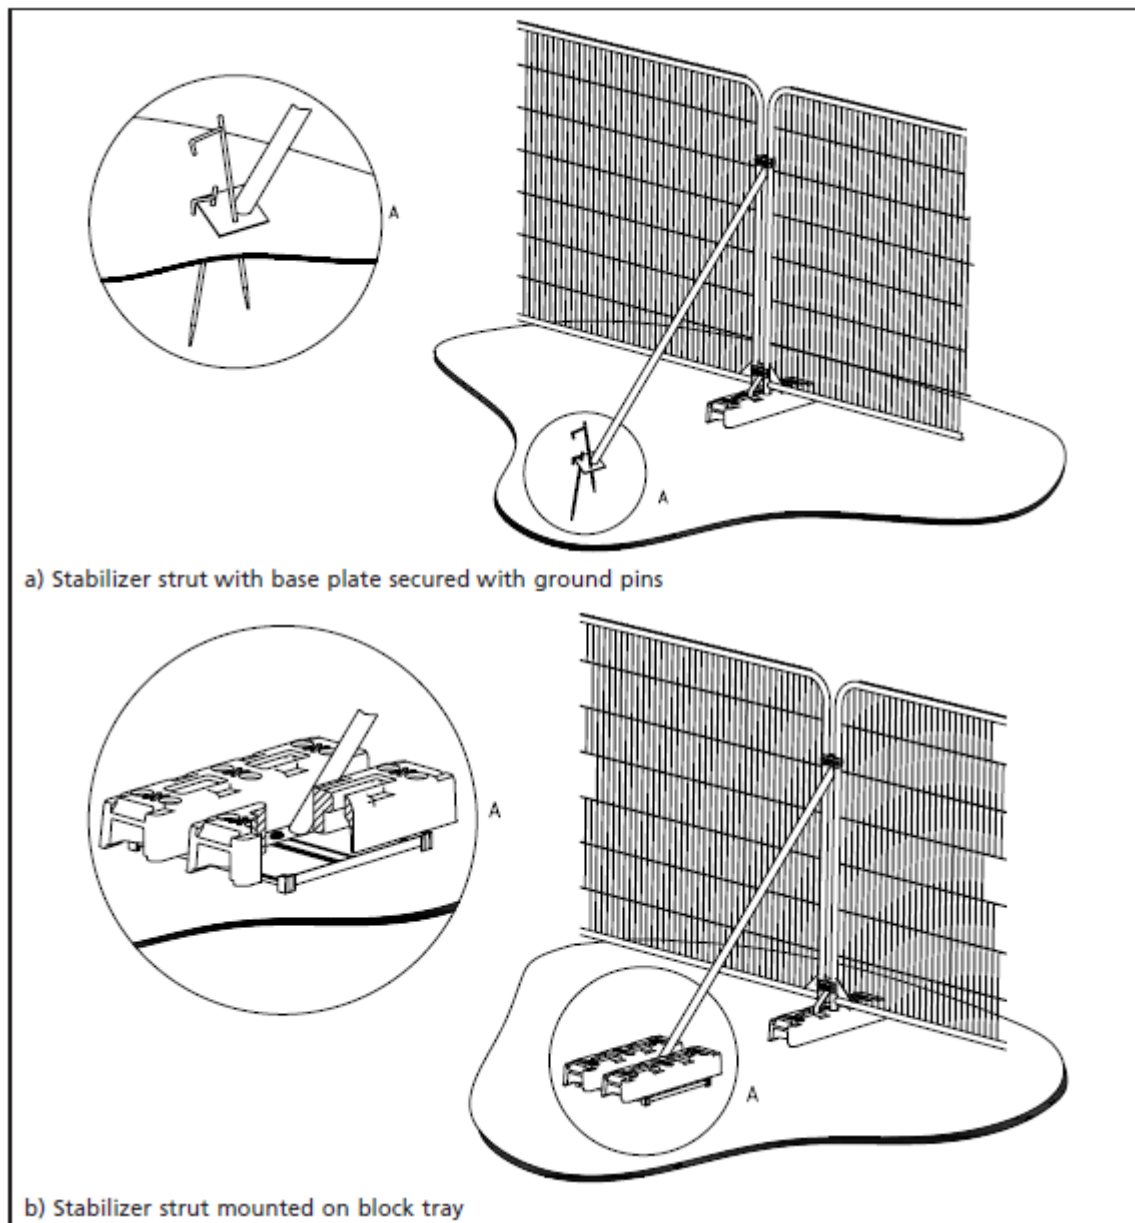
**Figure 3 Examples of above-ground stabilizing systems**

Specific Tree Protection is not required, except in a limited way for T2 to either keep the existing fence temporarily or replace it with an alternative, eg Harris Fencing, for the duration of the works.

The extract below from BS5837:2021 gives an indication of the screen required, to be positioned in place of the existing fence if required.

The Tree Protection shall be erected before any plant or equipment is brought onto site.

The integrity of the fencing shall be maintained throughout the construction period.

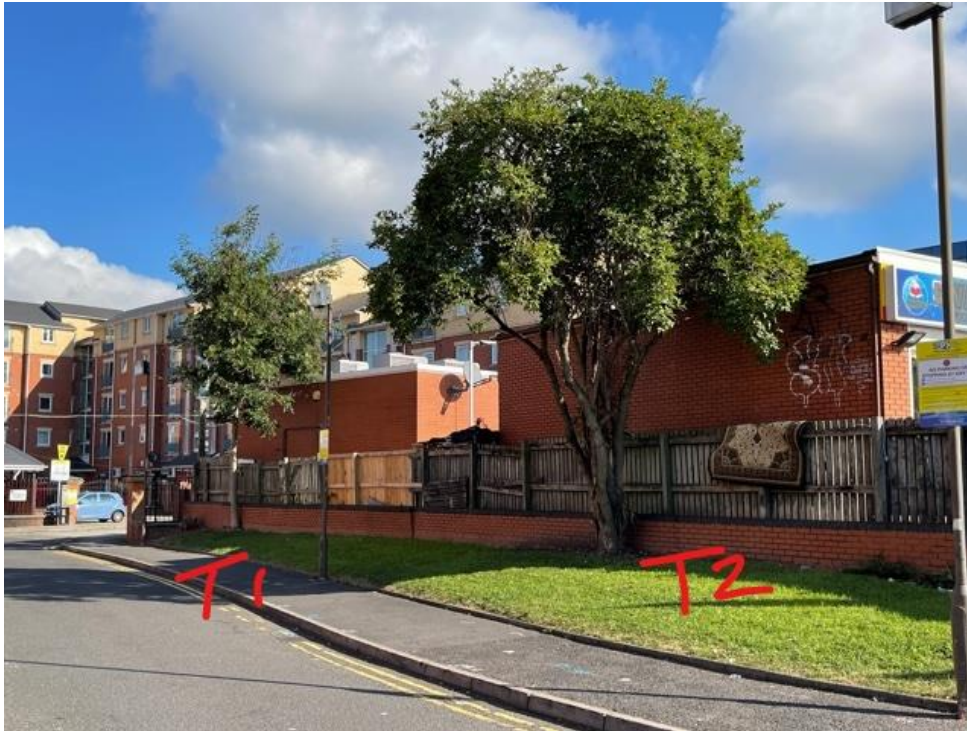
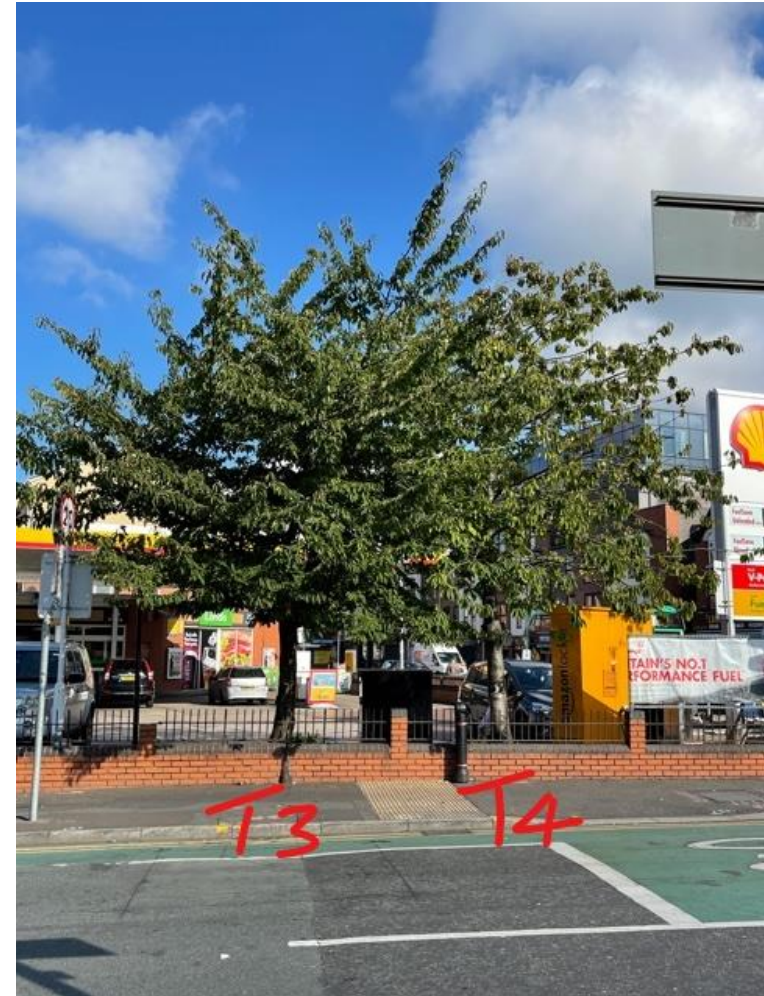
## Photos

Condition: Early indications of Ash Dieback (*Hymenoscyphus fraxineus*) a fungal disease of recent distribution in the UK, causing leaf and stem dieback, leading to death of the tree.

Condition: Mature, Fair condition, Surgery, crown raising and removal of dead wood has been carried out in the past. The fence appears to have a rotten base and is tied to the tree for support.

Condition: Good. Crown height is just below statutory height over the pavement and tips just over the road, below the 5m height requirement. One main root has grown through the wall expansion gap and down to the pavement, protruding a little over the edge of the pavement. At present there appears to be no damage to the wall or obstruction / danger to the pavement and its users.

Condition: Fair. Crown canopy density is a little sparse. Crown height over the road is as T3. Exudate marks on the trunk hint at a potentially compromised vascular system. Longer term there is likely to be limited safe useful life with

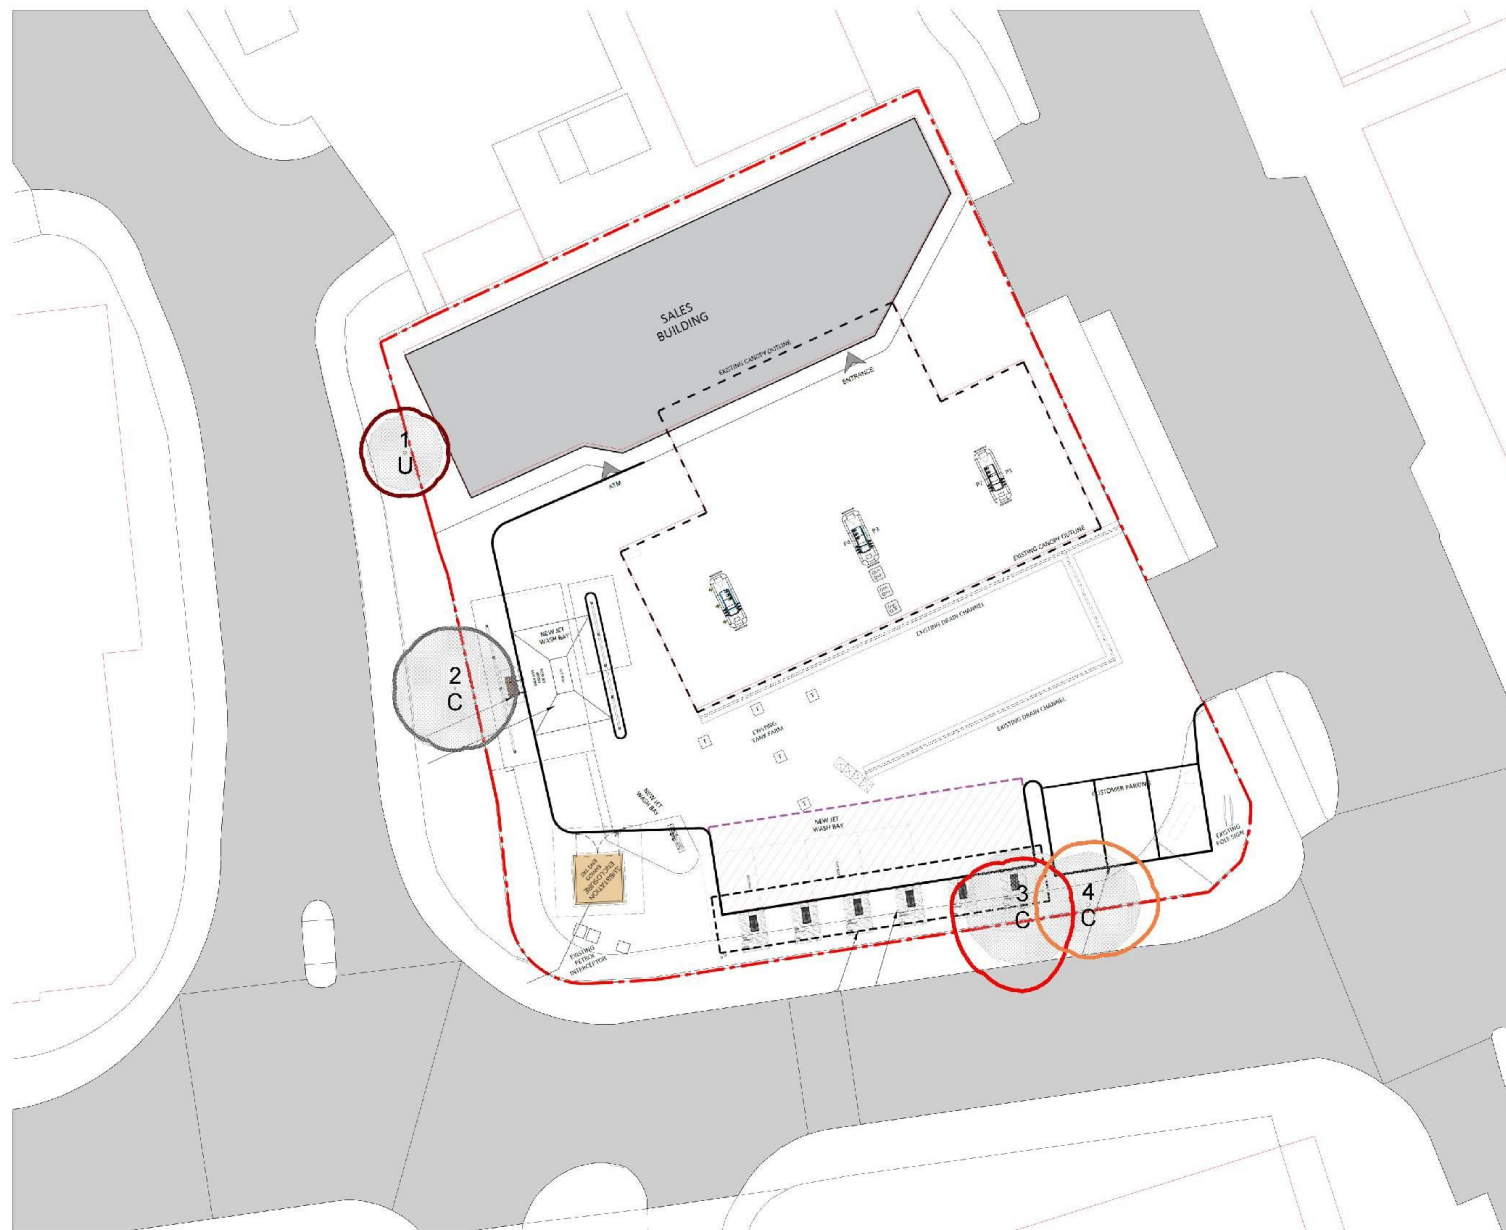
### Tree Removal and Pruning

T3 as previously noted has a main root that is forcing its way between the wall in the wall joint and through to the pavement. Removing the tree will also therefore prevent the incursion of the root expansion into the pavement.
