# **HISTORIC BUILDING RECORDING (LEVEL 3)**

**BELLE VUE STADIUM  
GORTON, MANCHESTER**

**PREPARED BY LANPRO SERVICES  
ON BEHALF OF  
COUNTRYSIDE PROPERTIES AND  
SCP INVESTMENTS**

March 2022

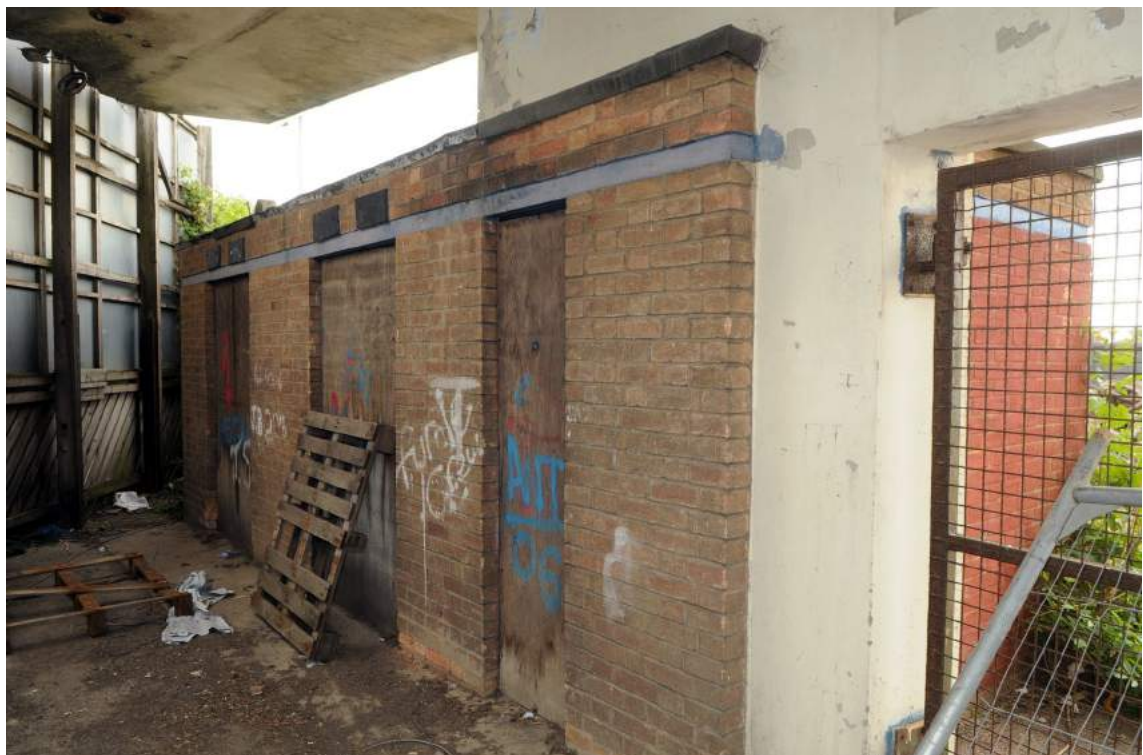
- 8.24 The north-east elevation had boarded openings (Plate 10). There was no evidence to indicate why these openings were boarded up rather than bricked-in as was the case in the west booth.

Plate 10. Structure A, north-east elevation of the east booth (Facing south)

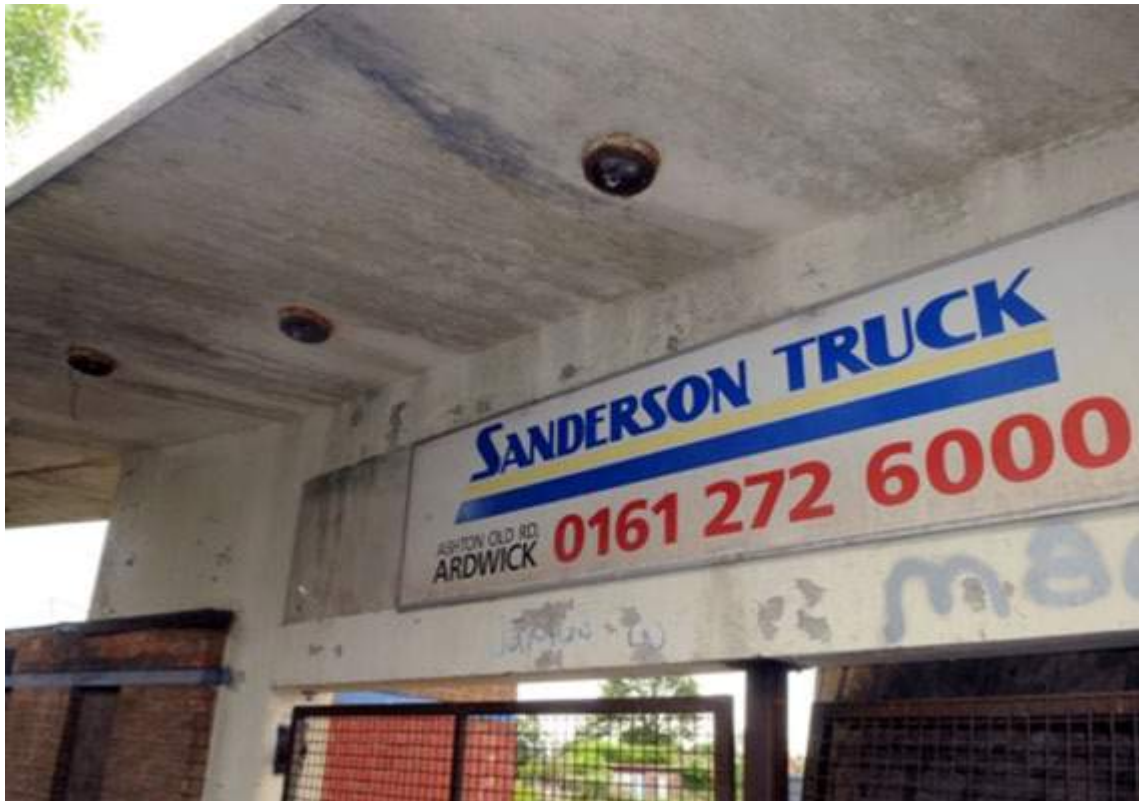
- 8.25 The canopy of Structure A was a poured concrete construction forming a portal into the stadium. Although there was no outwardly visible evidence, the concrete was probably reinforced. Essentially, it was designed with two large piers and a massive lintel supporting a roof with a slender pier in the middle. It is not clear if this was a structural requirement or a means of subdividing the large opening between the large piers in to two. These lower structural elements supported the canopy roof that in plan resembled a slightly sweptback wing 'flying' into the stadium (Plate 2). As with the roof, there was no evidence for the structural makeup of the elements but it is highly likely they were reinforced with steel. The canopy roof was slightly cantilevered, the outer slender part being supported by integral braces from a central east-west spine (Plates 11, 12 and 13). Several details survive such as electric down lights (Plate 13) and fixings for the original signage.

Plate 13. Structure A, location of original Belle Vue sign to the left of modern advertisement (facing south-west)

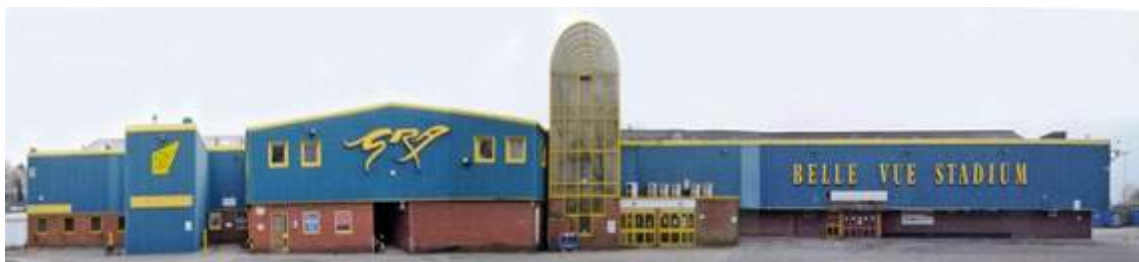
- 8.28 The north elevation had stretcher bond brickwork to the ground floor with box-section cladding to the upper elevations along with a large steel framed glazed stair tower (Plates 14 and 15). Visible sections of the roof were a mix of box section and corrugated asbestos cement sheeting. The doors and windows were powder-coated aluminium. All visible construction materials were modern and associated with later extensions except corrugated asbestos sheeting covering the roof at the west end.

Plate 14. Structure B, north elevation (facing south)

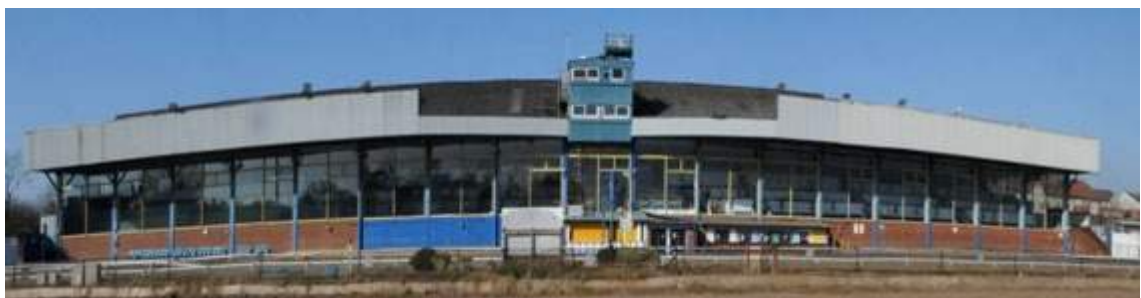
- 8.29 All visible materials in the south elevation were modern coherent and there was no visible evidence for any of the previous phases (Plate 16). The outward appearance of this elevation is considered most likely to be Phase III at ground floor level and Phase IV for the blue box section cladding to the second-floor commentating box (formerly the 'Stewards Box) and grey box section cladding of the 'cornice'.

Plate 16. Structure B, south elevation (facing north)

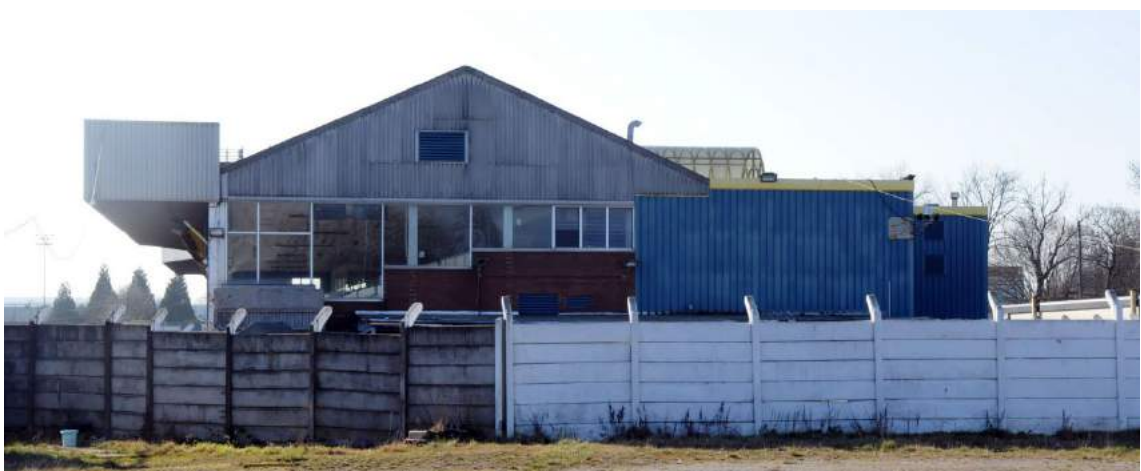
- 8.30 The east elevation has stepped brickwork with glazing above defining the first-floor stands. Blue box section cladding to the right of this is the east elevation of the Phase IV extension (Plate 17). The gable was clad in asbestos cement sheeting that was not banned until 1999. The grey box section 'cornice' is likely to be Phase IV.

Plate 17. Structure B, east elevation (facing west)

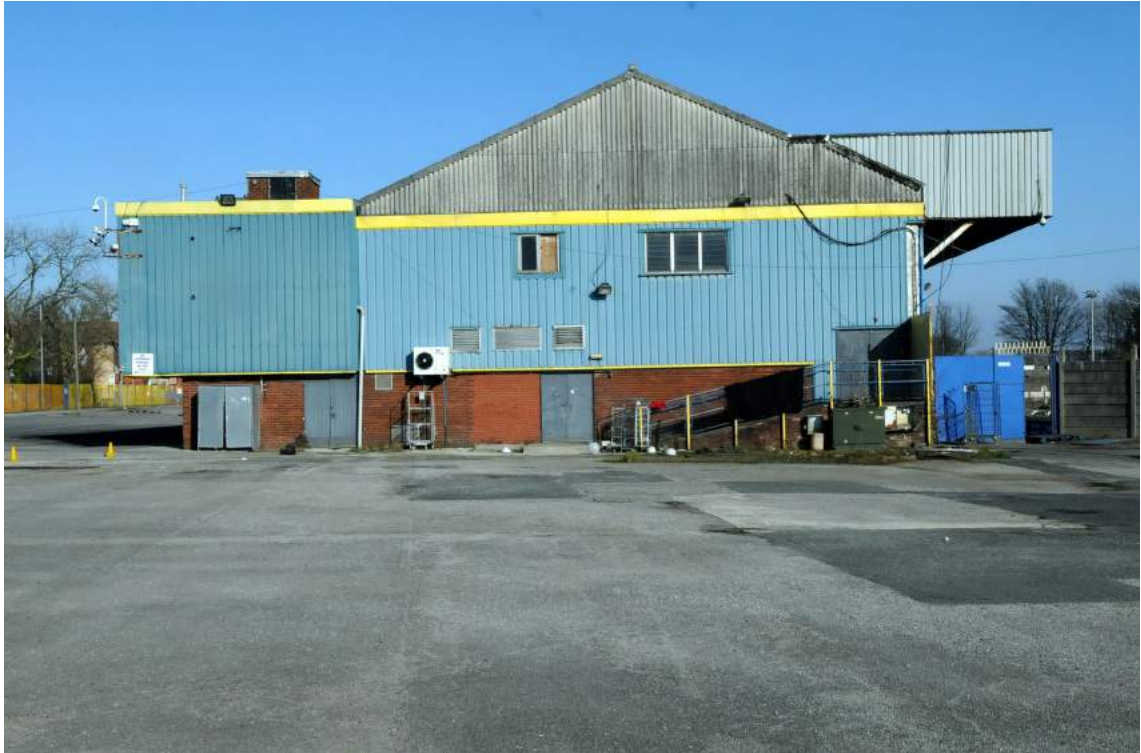
- 8.31 The west elevation gable was clad in corrugated asbestos cement sheeting with brickwork to the ground floor. The Phase IV north extension can clearly be seen (Plate 18). Unlike the glazing that characterised the first floor stands of the east elevation, the first floor had been clad in the familiar blue box-section sheeting presumably during the Phase IV redevelopment. At ground floor level, there was rare evidence for adaptation in the form of a blocked doorway.

Plate 18. Structure B, west elevation (facing east)

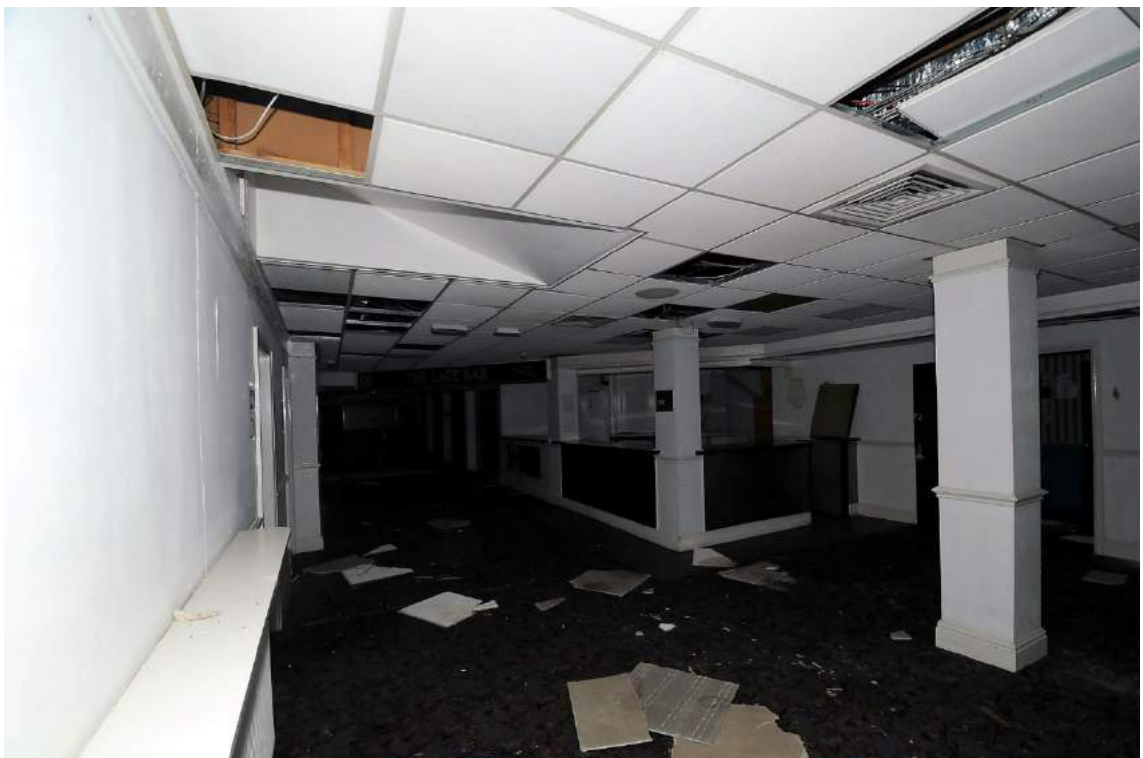
- 8.36 The central section of the building consisted of the Phase I element that was largely characterised by a large open area housing a Tote, bar with stairs down to the stadium and up to the covered stands at first floor level. The Phase IV extension to the north provided a large main stair to the first and second floors (Plate 15 and 36), with the main entrance, offices and WC facilities to the ground floor. There had been multiple wall removals resulting in the original floor plan of the main Phase I element being completely lost resulting in a main open space located with columns supporting the first floor stands. This area was the principal public area after punters had gained access through the main entrance, the area contained a Tote in addition to the external one noted above; a coffee bar and an alcohol bar (Plates 25 – 30).

Plate 25. Structure B central, large open area (facing west)

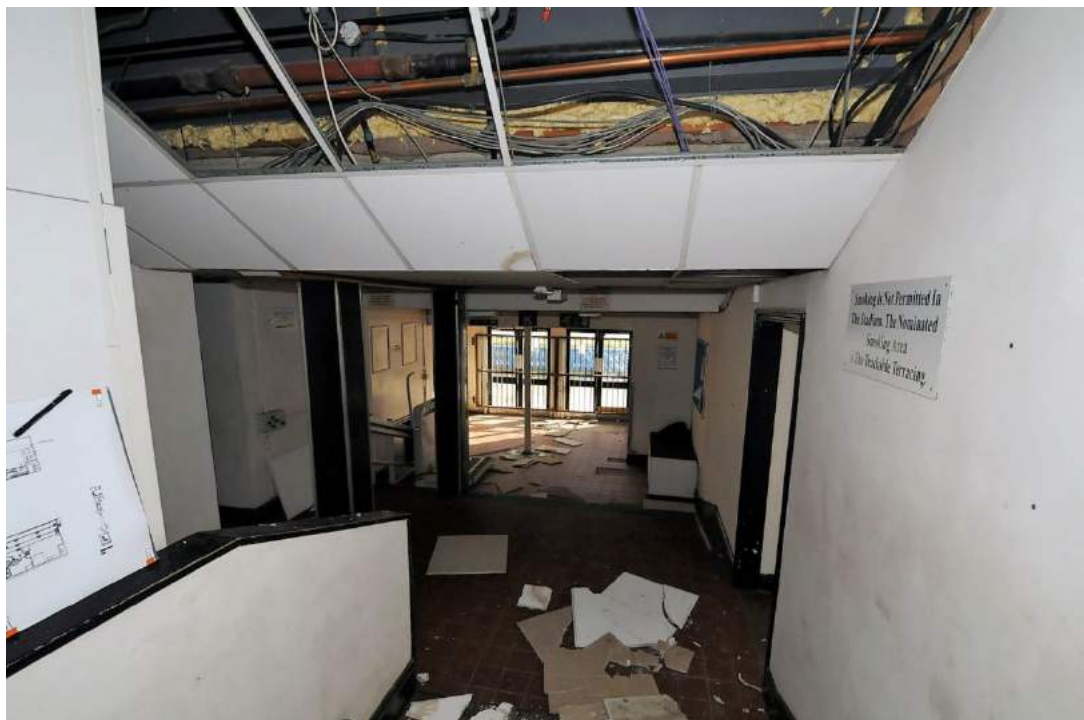
- 8.37 Multiple staircases provided access from the main public area to internal and external viewing areas (Plates 31 and 32). A short flight of steps led to a lower-ground floor area with WC facilities (Plates 31 and 33). The main staircase within the Phase I area provided

Plate 31. Structure B central, steps (facing north)

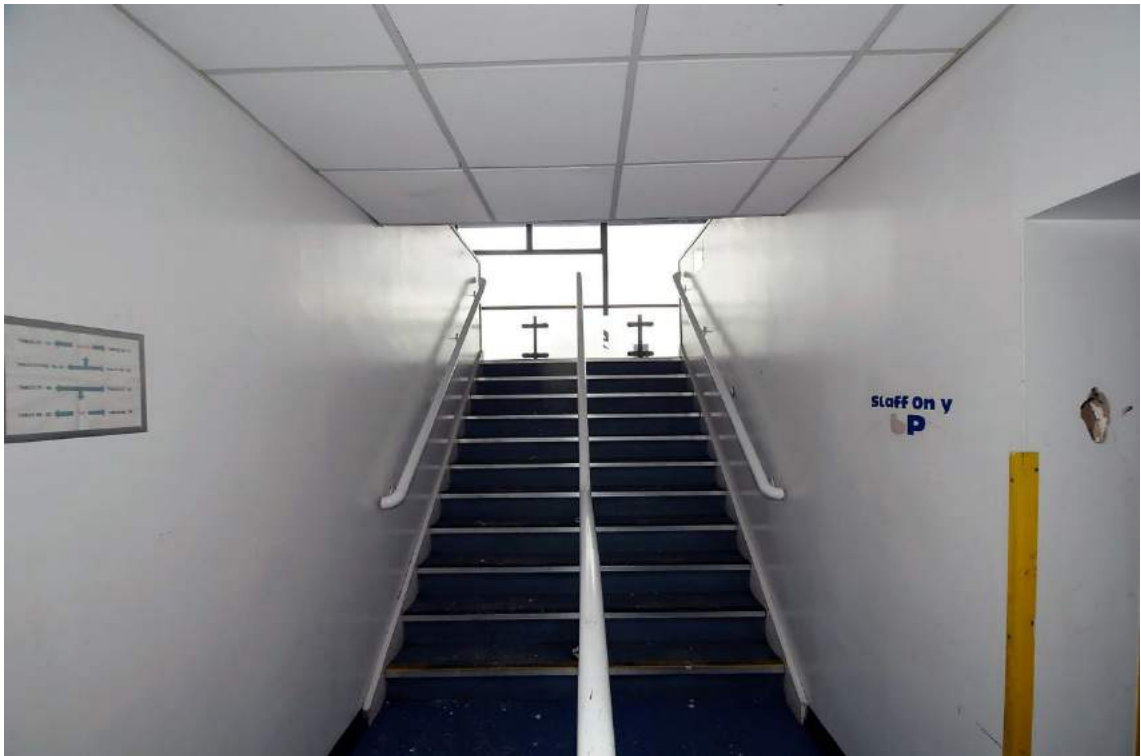
Plate 32. Structure B central, stair access to the track (facing south)

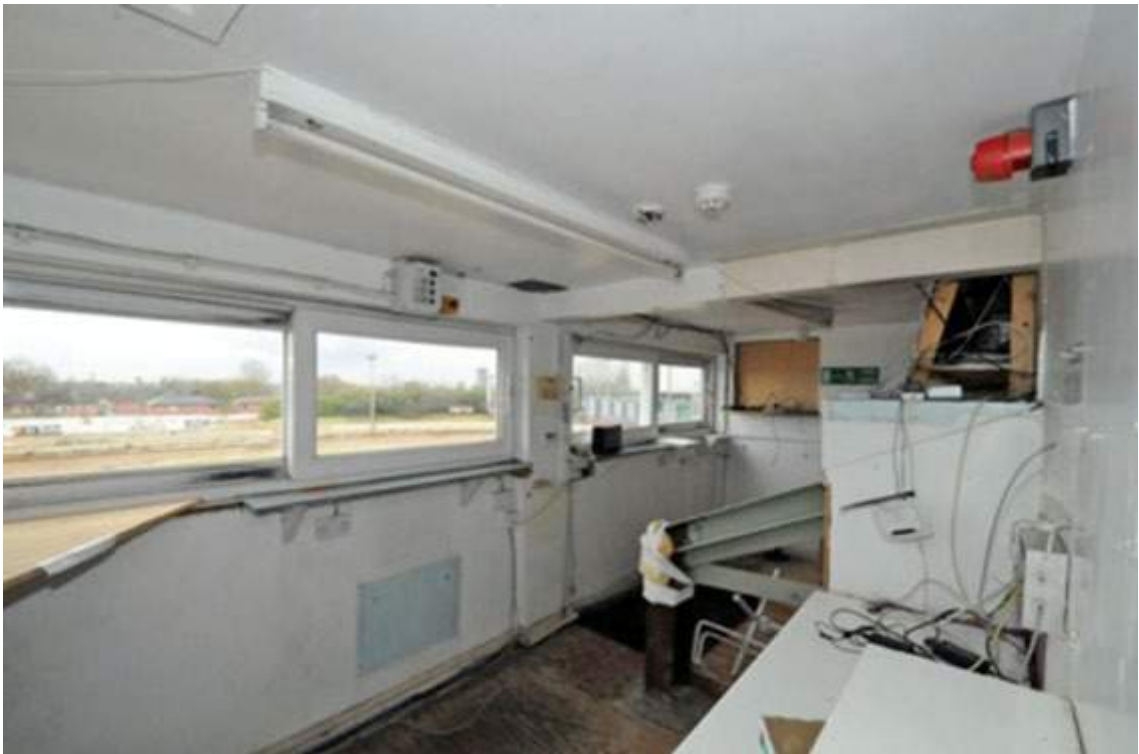
hare control room (for the electronic hare that the greyhounds chased) (Plate 47), the other up to a similarly cramped commentary room (Plate 48).

Plate 47. Structure B second floor, hare control room (facing south-east)

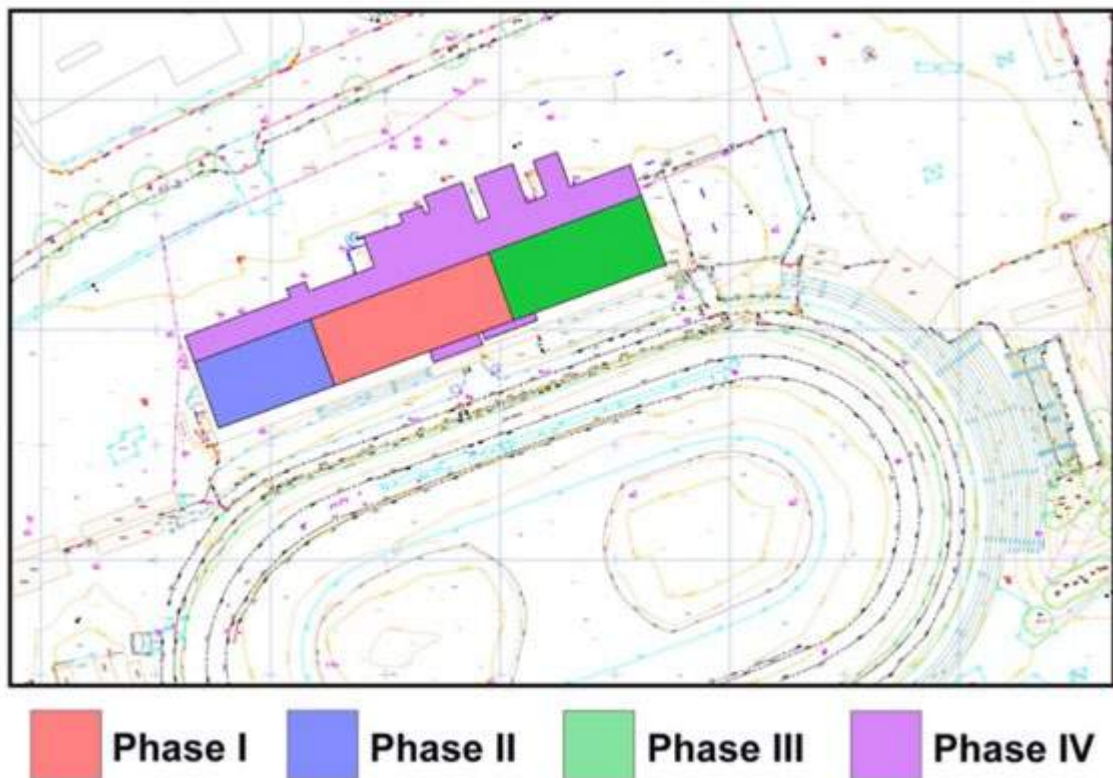
Plate 48. Structure B second floor, Commentator's room (facing south-west)

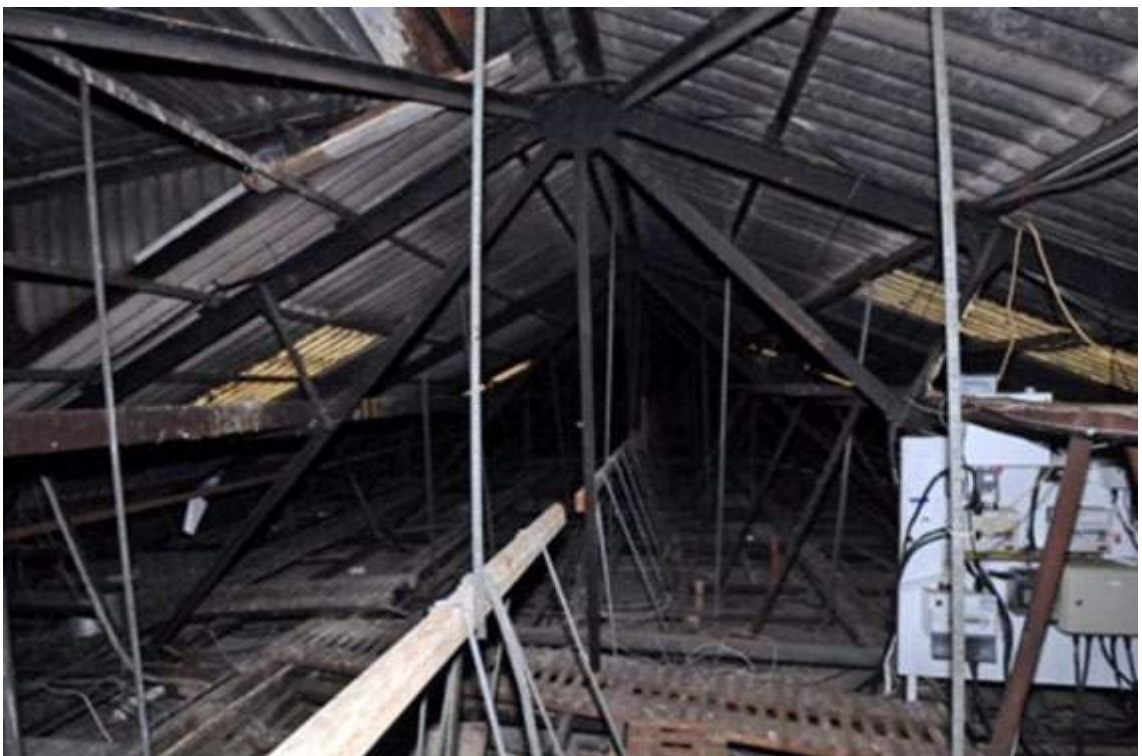
- 8.55 This phase was characterised by triangulated steel trusses manufactured from flat bar and angle-section bolted together with fitch plates at high stress or complex joints (Plate 58).

Plate 58. Structure B roof, Phase I roof trusses (facing west)

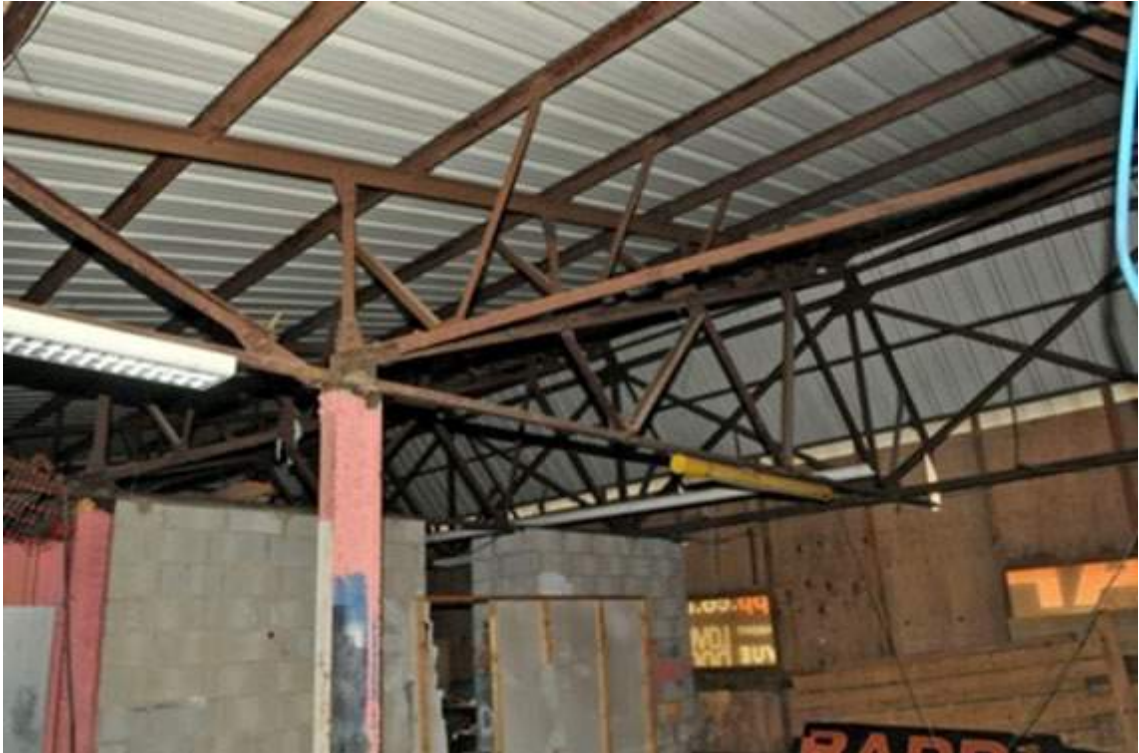
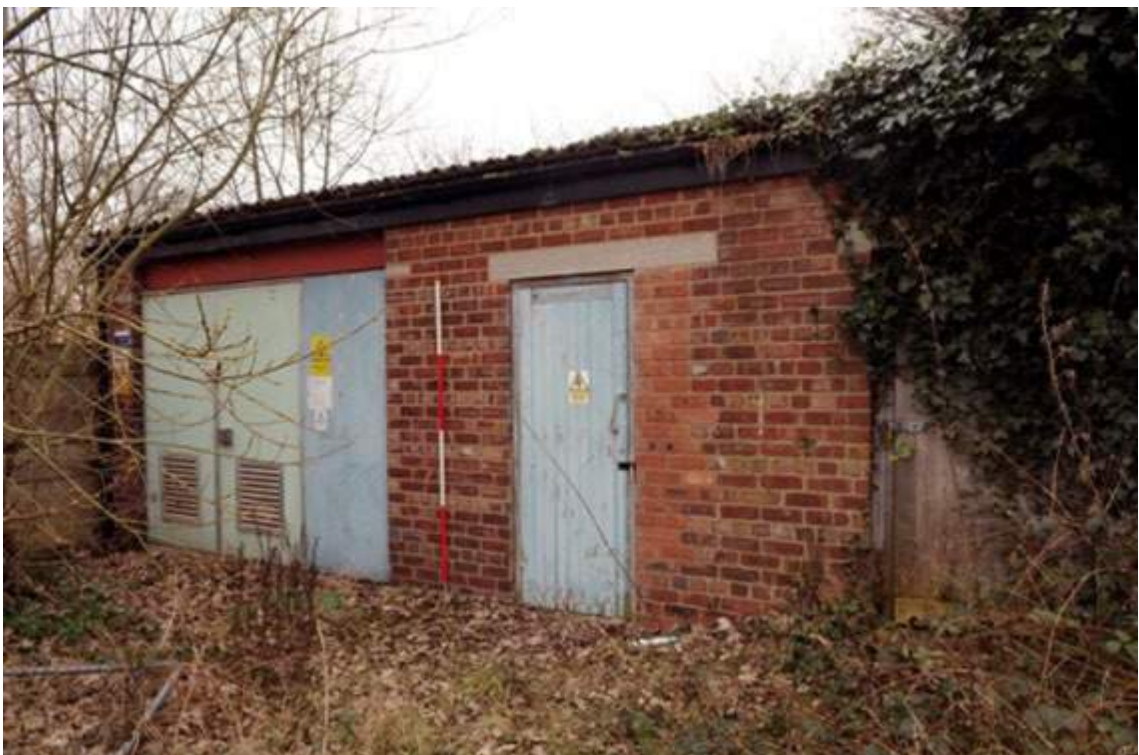
- 8.70 Triangulated roof trusses typical of 1930s light industrial/commercial buildings were visible internally. These are effectively TRADA roof trusses executed in steel rather than wood (Plates 67 and 68). The narrow flanged I-Beam RSJs used for vertical support are also typical of the period since the only wide-flanged beams then available had to be imported. It took until 1957 for wide-flanged beams to be manufactured in the United Kingdom.

Plate 67. Structure D, interior aspect (facing south-west)

Plate 68. Structure D, example of trusses (facing north-east)

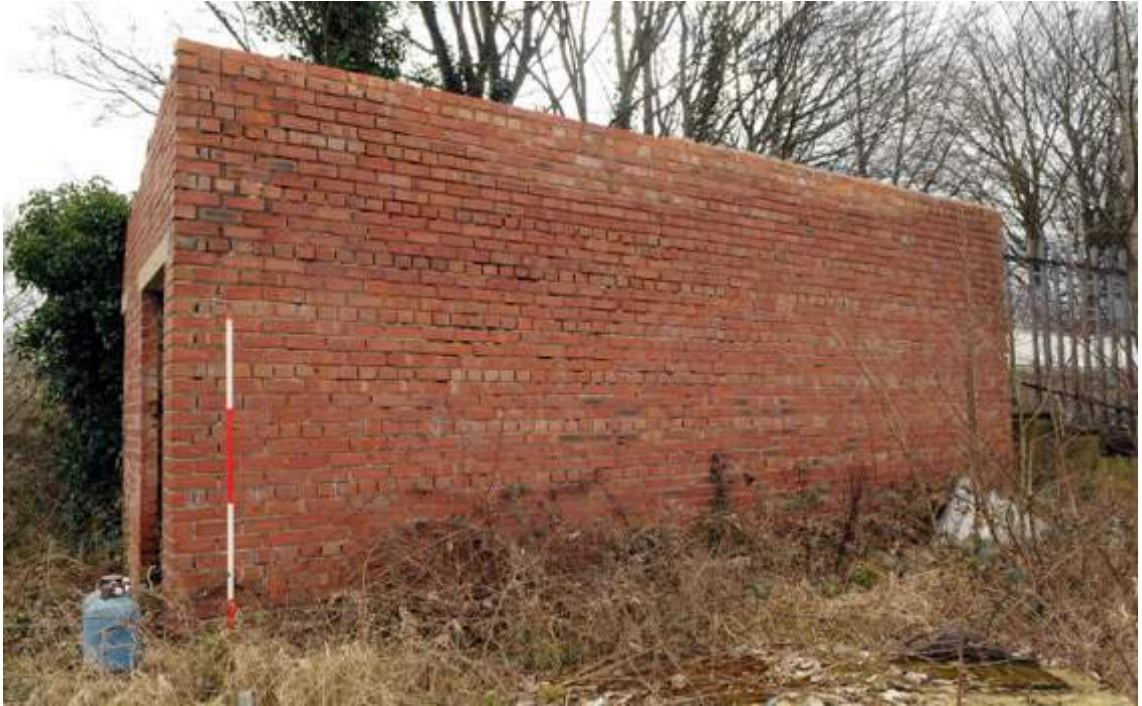
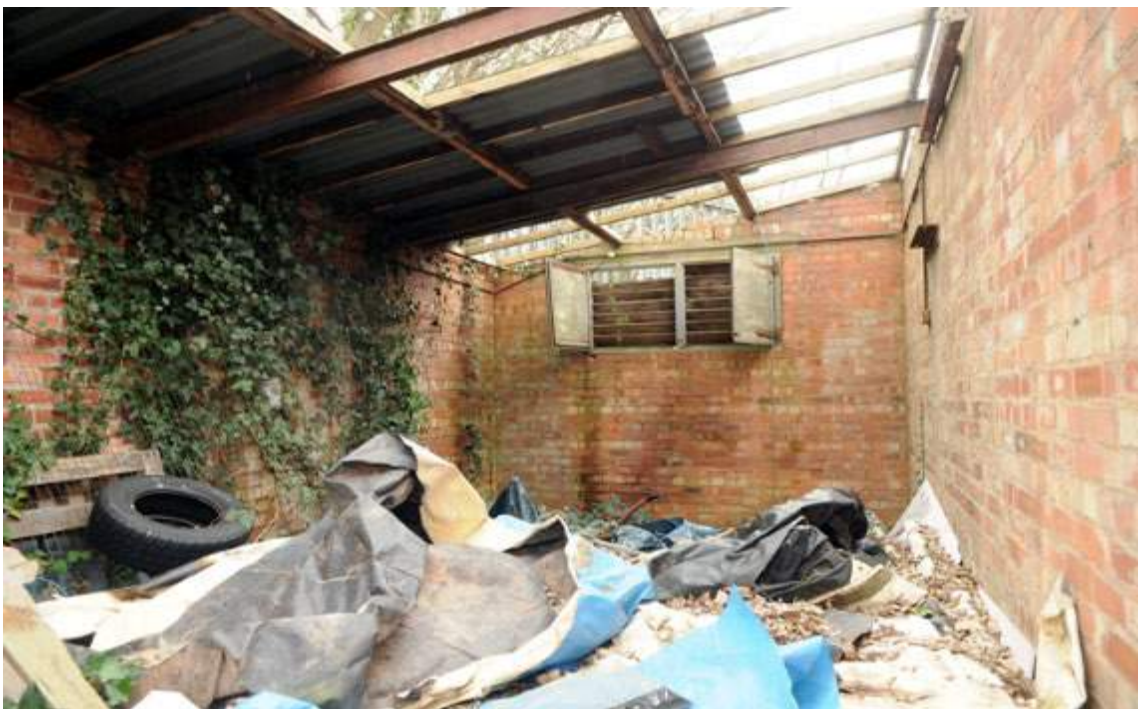
- 8.74 This building was located to the southeast of Structure D (Maintenance Building) (Figure 2). It could not be entered and dense undergrowth and mature sycamore trees only allowed the north-west and west elevations to be photographed (Plates 69 and 70). The building was constructed sometime prior to 1953 and it appears upon an aerial photograph of that date (Manchester History 2022)
- 8.75 It was constructed in red stock bricks (9" by 4½" by 3") laid to a gauge of 13" in English garden wall bond. The doorway to the store/office on the south side of the building had been reduced and a new door fitted. The plant room on the north side was fitted with modern steel doors.

Plate 69. Structure E, north-west elevation (facing south-east)

Plate 70. Structure F, west elevation (facing south-east)

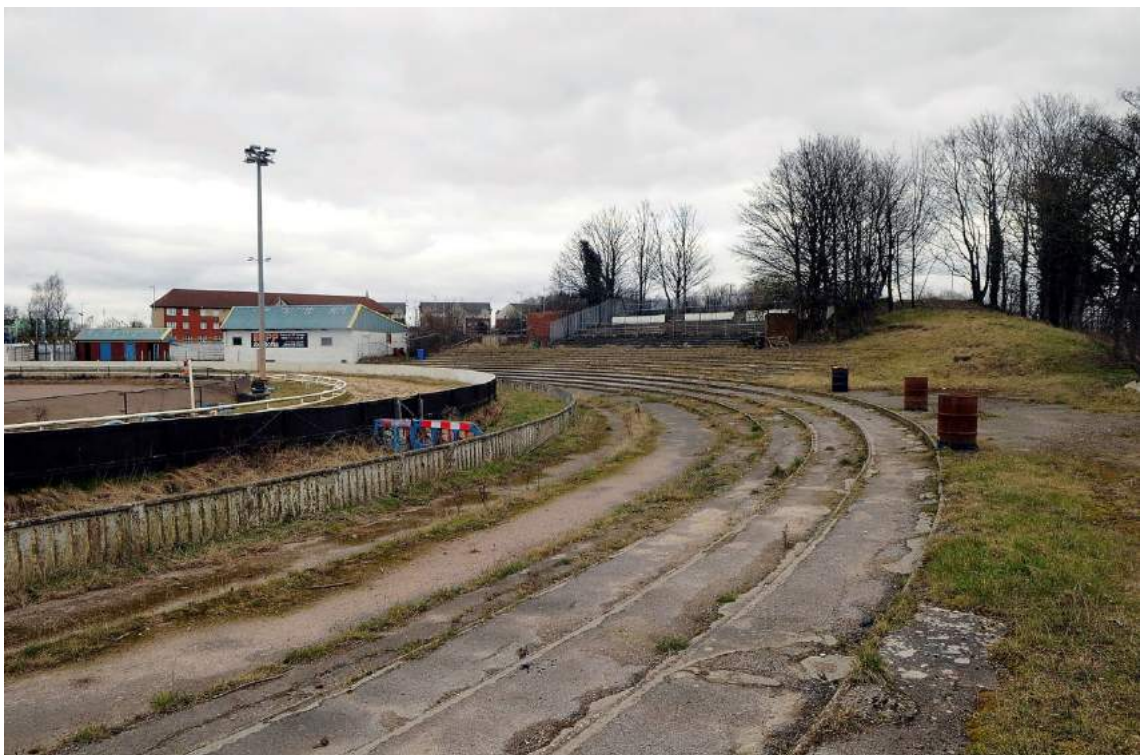
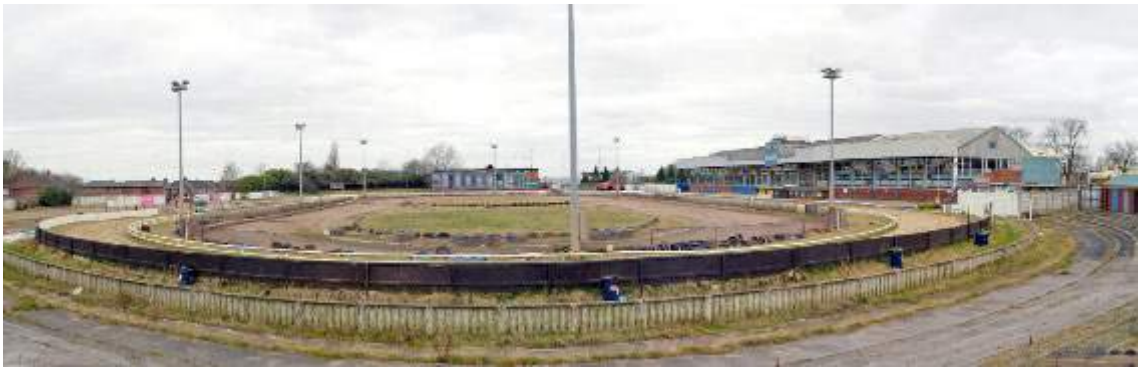
- 8.81 The east stand was constructed with poured concrete, cast concrete edgings and tarmac on a terraced artificial bank (Plates 72 - 74). The East Stand was originally two separate stands (described as the north and south fingers for the purposes of this survey) and until relatively recently, it was contained to an essentially square section since the two north and south fingers that extended out from the central area were historically part of covered stands.
- 8.82 Cartographic evidence suggests the covered stands survived until the 1980s but it is not known if this is an actuality or reflects a lack of revision in Ordnance Survey mapping of the stadium.

Plate 72. Structure G, The East Stand from the north (facing south)

Plate 73. Structure G, The East Stand from the end of the south finger

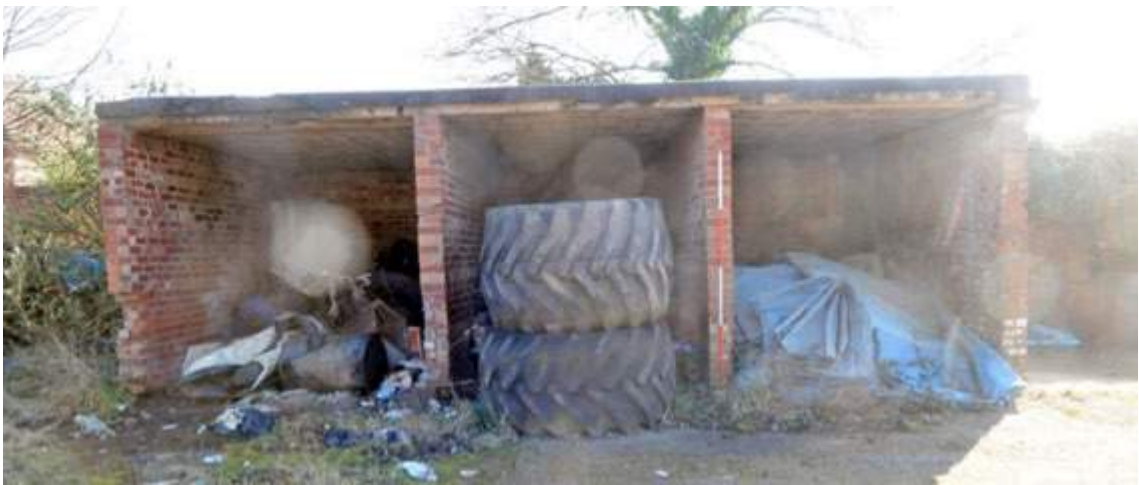
Plate 75. Structure H, north elevation (Facing south)

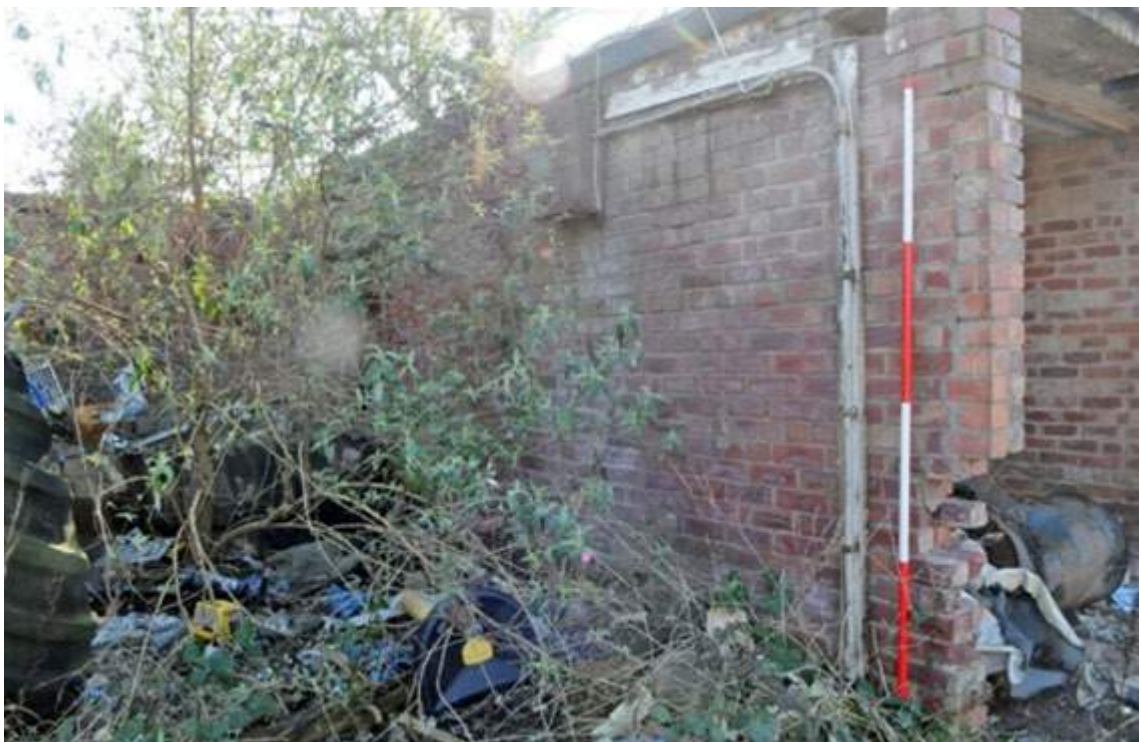
Plate 76. Structure H, west elevation (facing south-west)

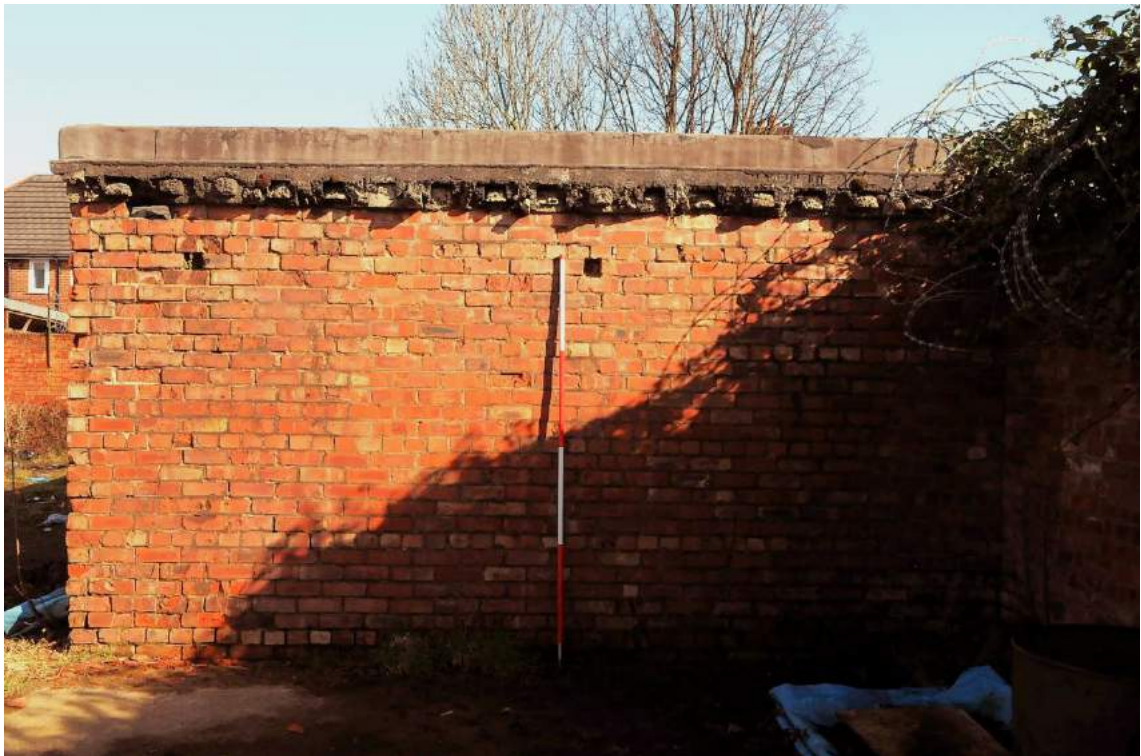
Plate 77. Structure H, east elevation, showing roof construction (facing west)

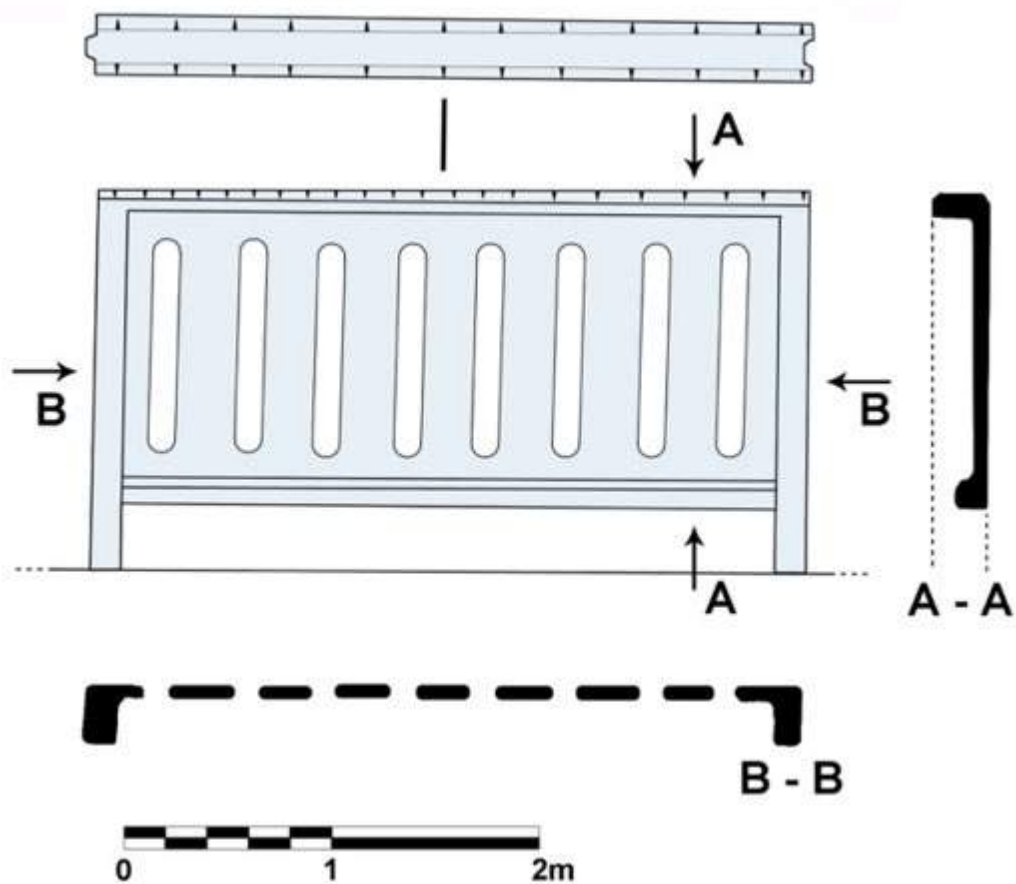
Plate 80. Structure I, elevation and cross-sections

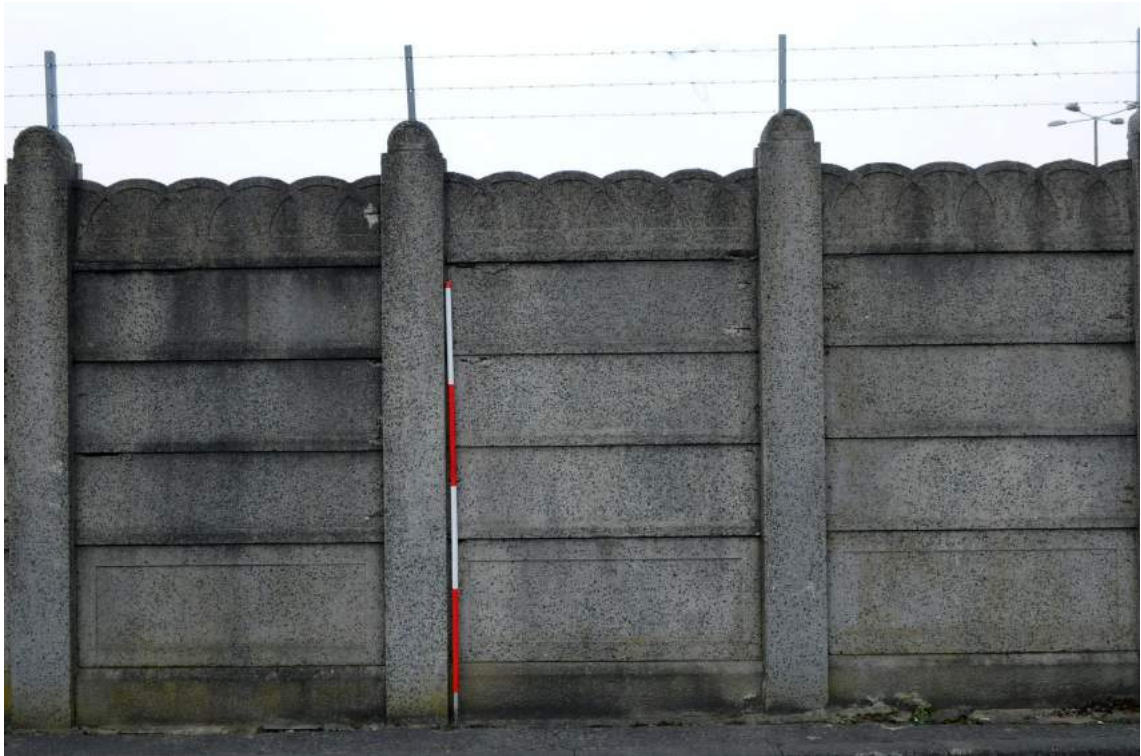
Plate 81. 1950s Perimeter fencing

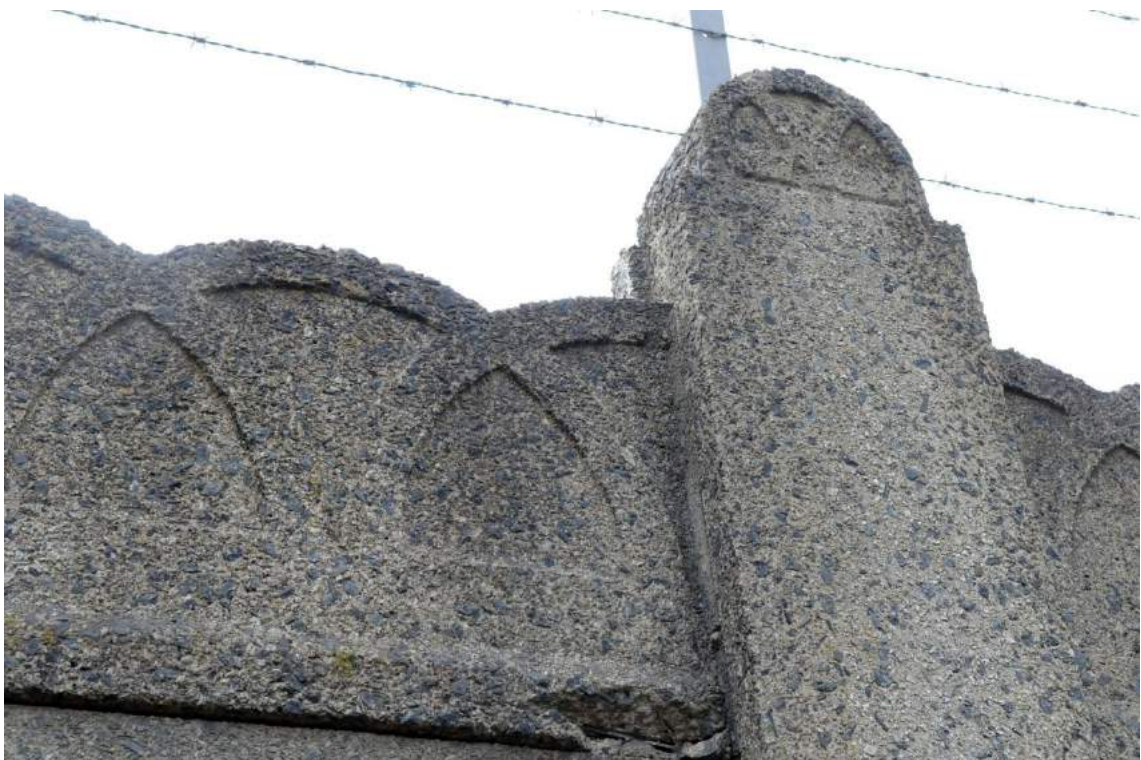
Plate 82. 1950s Perimeter fencing, detail

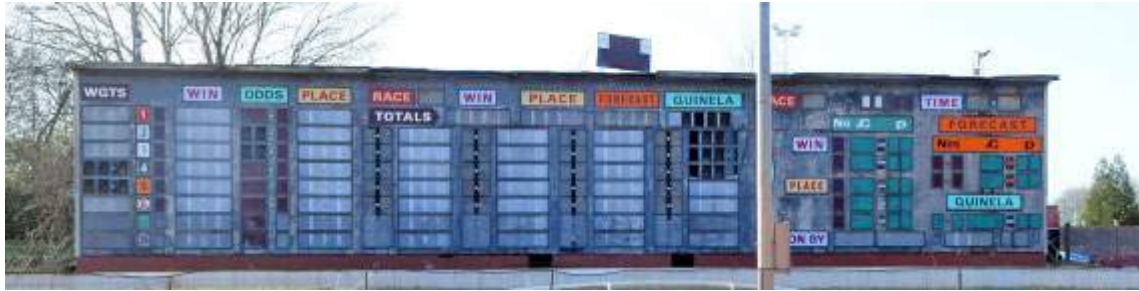
- 8.91 When constructed in the early 1920s, the west side of the track was characterised by terraces and a stand. These were lost during the 1980s upgrading of the site to be replaced in part by a large scoreboard (Plate 83 - 84).

Plate 83. Structure J, east elevation (facing west),

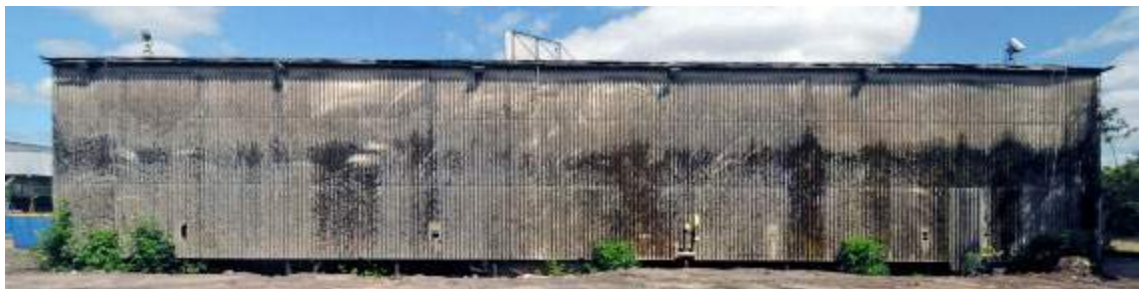
Plate 84. Structure J, west elevation, (facing east)

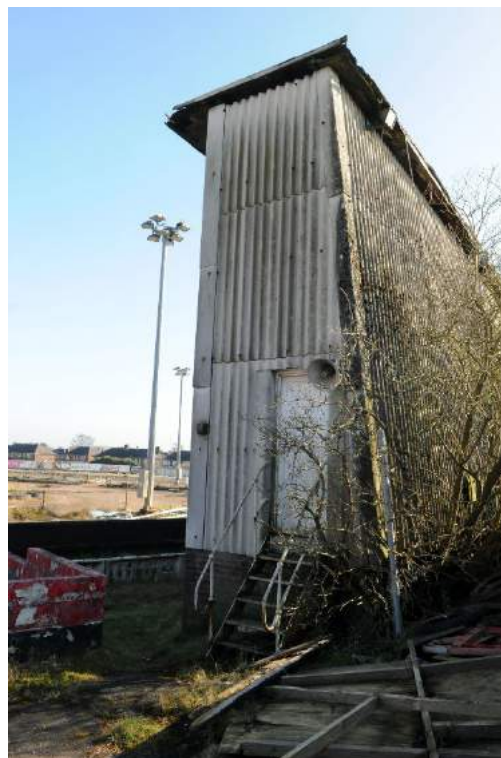
- 8.93 The north and south elevations were similar to the west, other than they had short flights of steps leading to access doors (Plates 85 - 86).
- 8.94 The interior was recorded following licenced asbestos and the interior was an empty shell with all the electronics stripped out (Plates 87 and 88)

Plate 85. Structure J, north elevation (facing south)

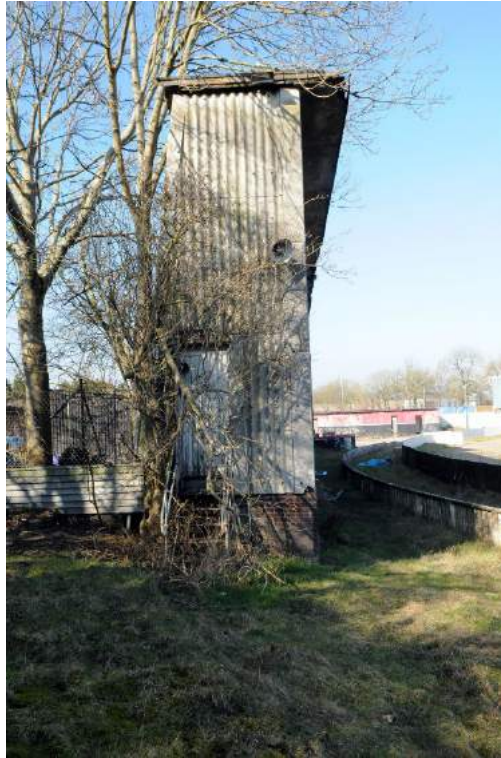
Plate 86. Structure J, south elevation (facing north)

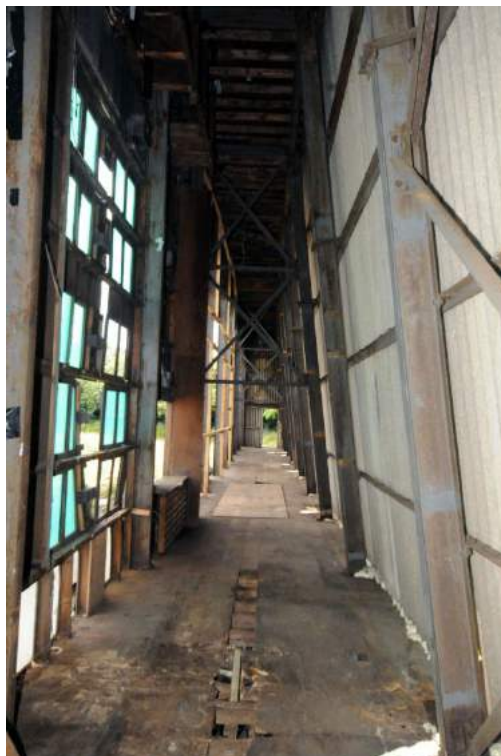
Plate 87. Structure J, interior (facing south)

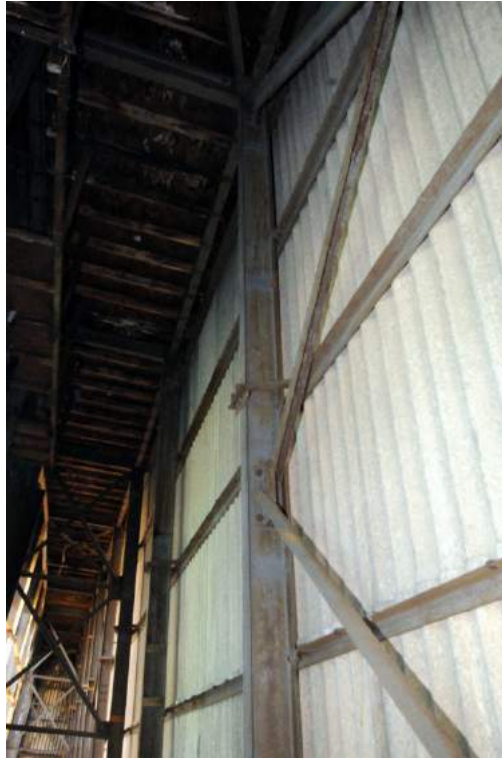
Plate 88. Structure J, internal frame (facing south-west)
