# **HISTORIC BUILDING RECORDING (LEVEL 3)**

**BELLE VUE STADIUM  
GORTON, MANCHESTER**

**PREPARED BY LANPRO SERVICES  
ON BEHALF OF  
COUNTRYSIDE PROPERTIES AND  
SCP INVESTMENTS**

March 2022

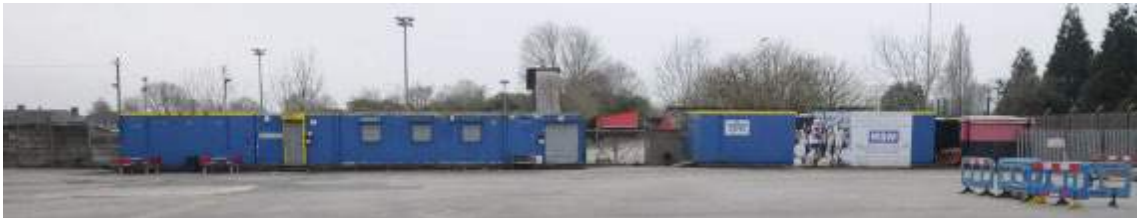
- 8.98 Situated to the north of a fence separating the track from the car park, there was a row of modern site accommodation type buildings used by a motorcycle business. These were not recorded in detail (Plate 89).

Plate 89. Structure L, motorcycle business temporary buildings (facing south)

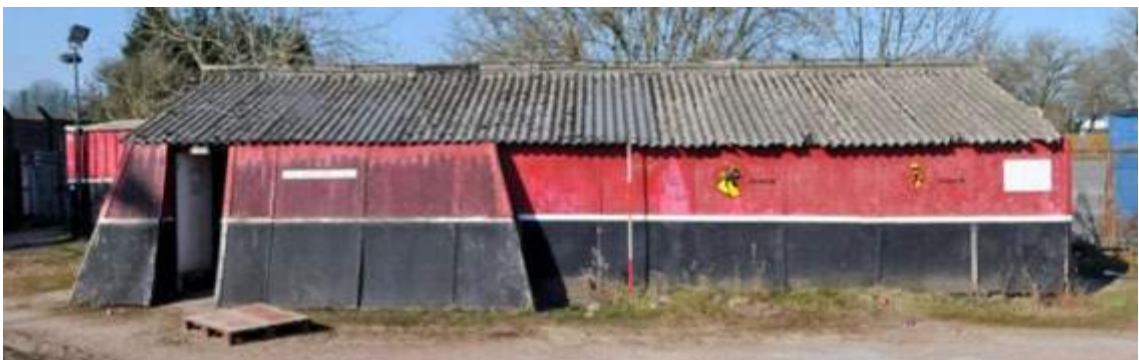
- 8.99 On the south side of the fence, two timber buildings of mixed vintages appeared to have been associated with the speedway and/or stock car and banger use of the track. These were all of conventional construction consisting of sheeted framed panels. One, a workshop, had king post roof trusses indicating that it was almost certainly of pre-war construction whilst the other had a thin Tyrolean finish typical of temporary buildings and residential caravans of the late 1970s to 1990s (Plates 90 - 92). This building close to the west boundary was divided into two functional spaces. To the west was a welfare facility and to the east a workshop.

Plate 90. Structure L, possible speedway building, south elevation (facing north)

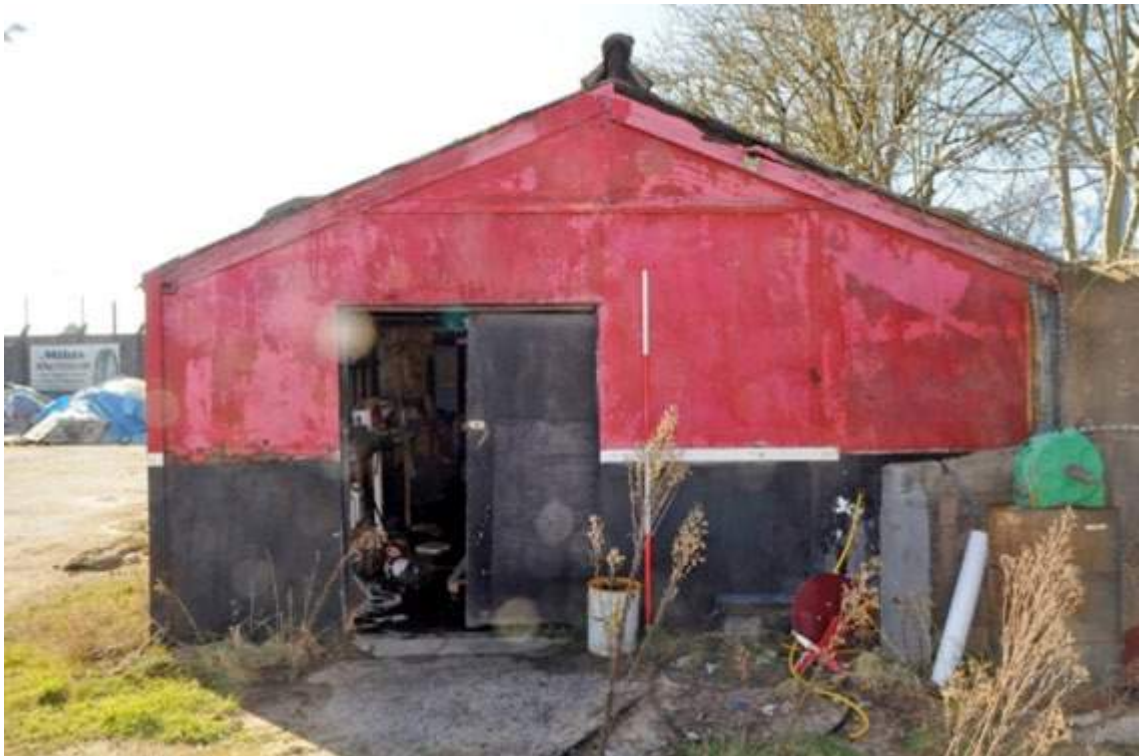
Plate 91. Structure L, possible speedway building, east elevation (facing west)

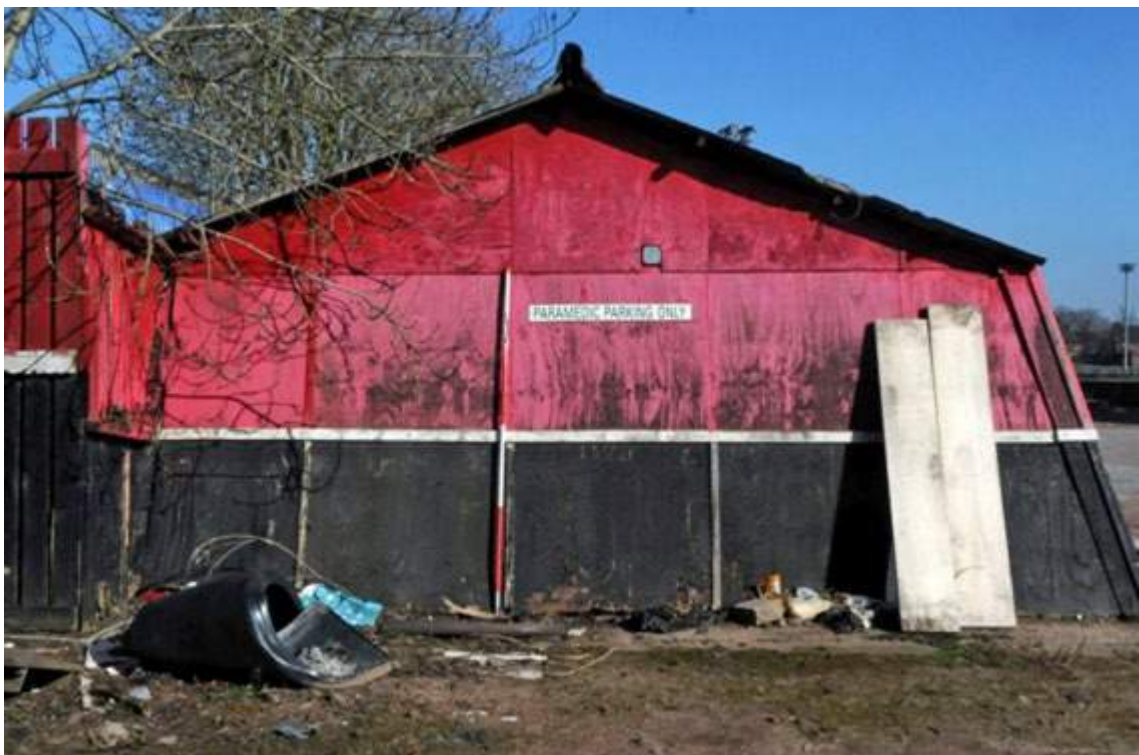
Plate 92. Structure L, possible speedway building, west elevation (facing east)

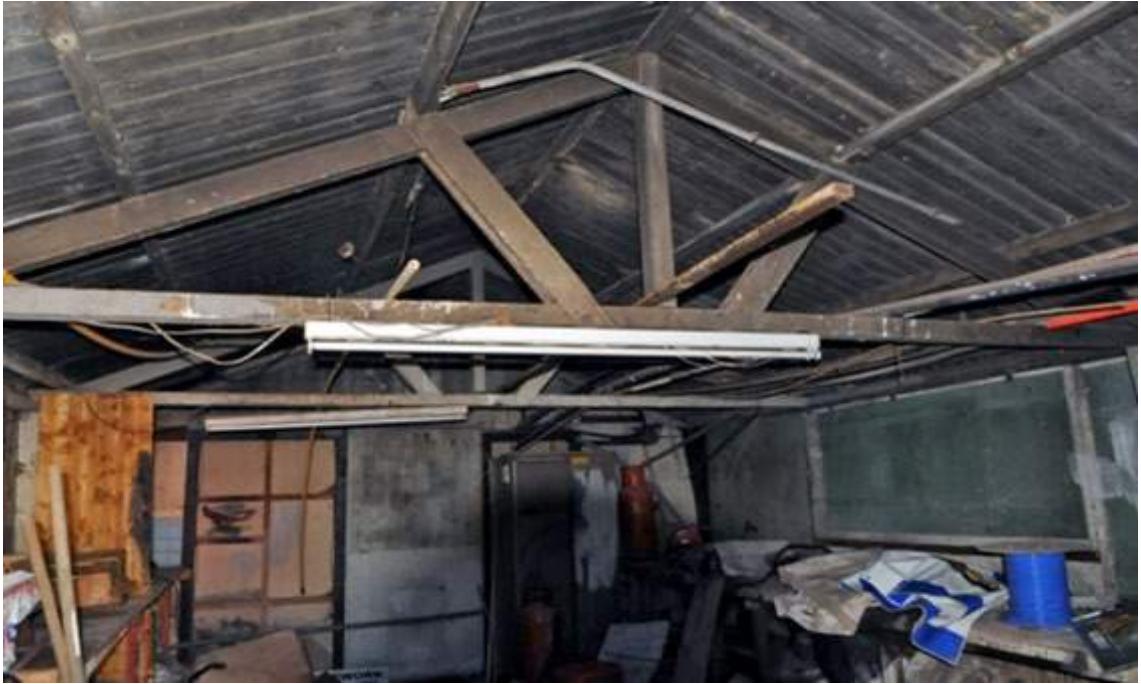
- 8.100 Internally, the king post roof truss is clearly seen (Plate 93). Though modern as evidenced by its centre-point carpentry construction. The right-hand side of the room was defined by a long work bench with vices, grease guns and miscellaneous abandoned tools indicative of its use as a mechanics workshop.

Plate 93. Structure L, possible speedway building, interior view (facing west)

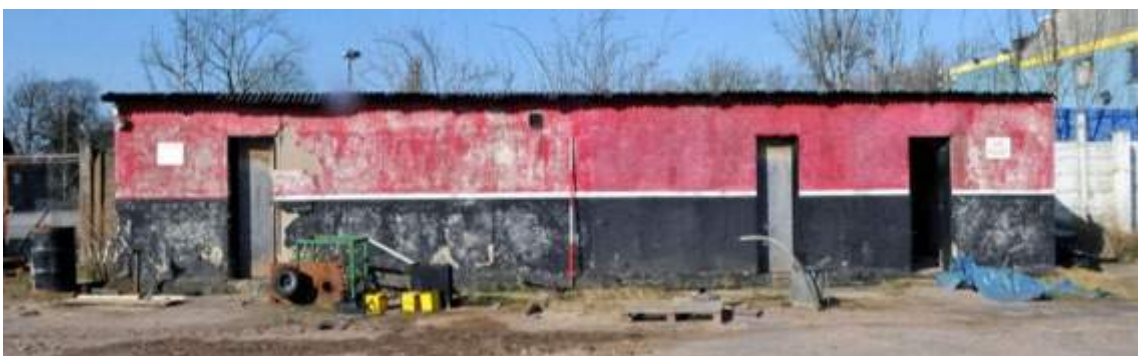
- 8.101 To the east of the workshop, another non-permanent building (Plate 94 - 95) was of unclear function as only one room (WC) could be accessed (Plate 96). The WC was located at the east end of the building. Clearly a 'Gents' it may be that the bay to the west was a 'Ladies', but there was no indication of the use made of the west end bay.

Plate 94. Structure L, building of unknown use, south elevation (facing north)

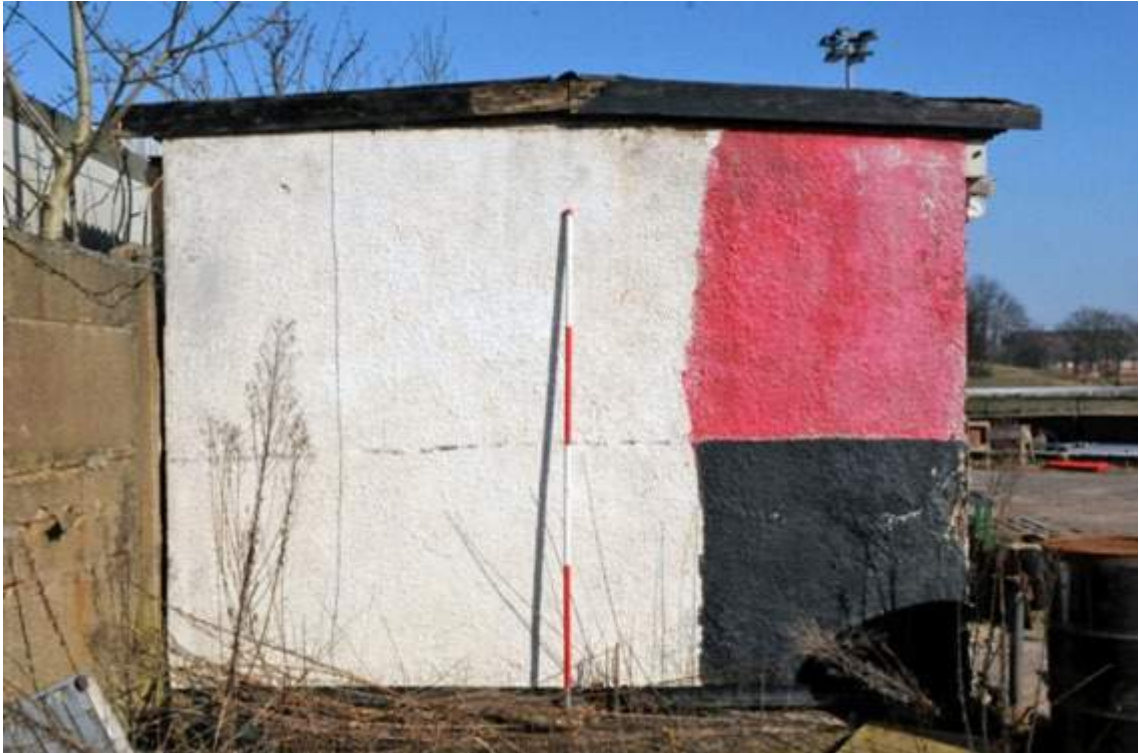
Plate 95. Structure L, building of unknown use, west elevation (facing east)

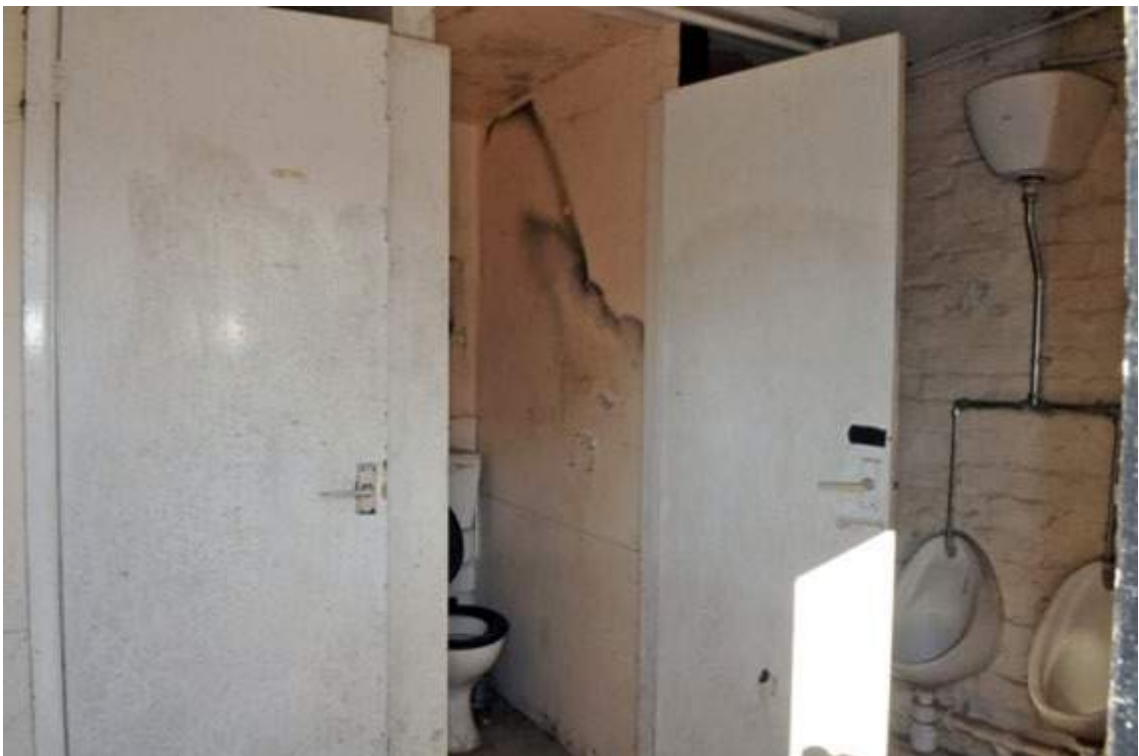
Plate 96. Structure L, interior view of WCs (facing north-east)
