10 Minshull Street and 11 Bloom Street

**TANKING DETAILS PROPOSALS**

PLANNING CONDITIONS RELEASE 11(e)

Planning Permission 119374/FO/2018 – BOTH BUILDINGS

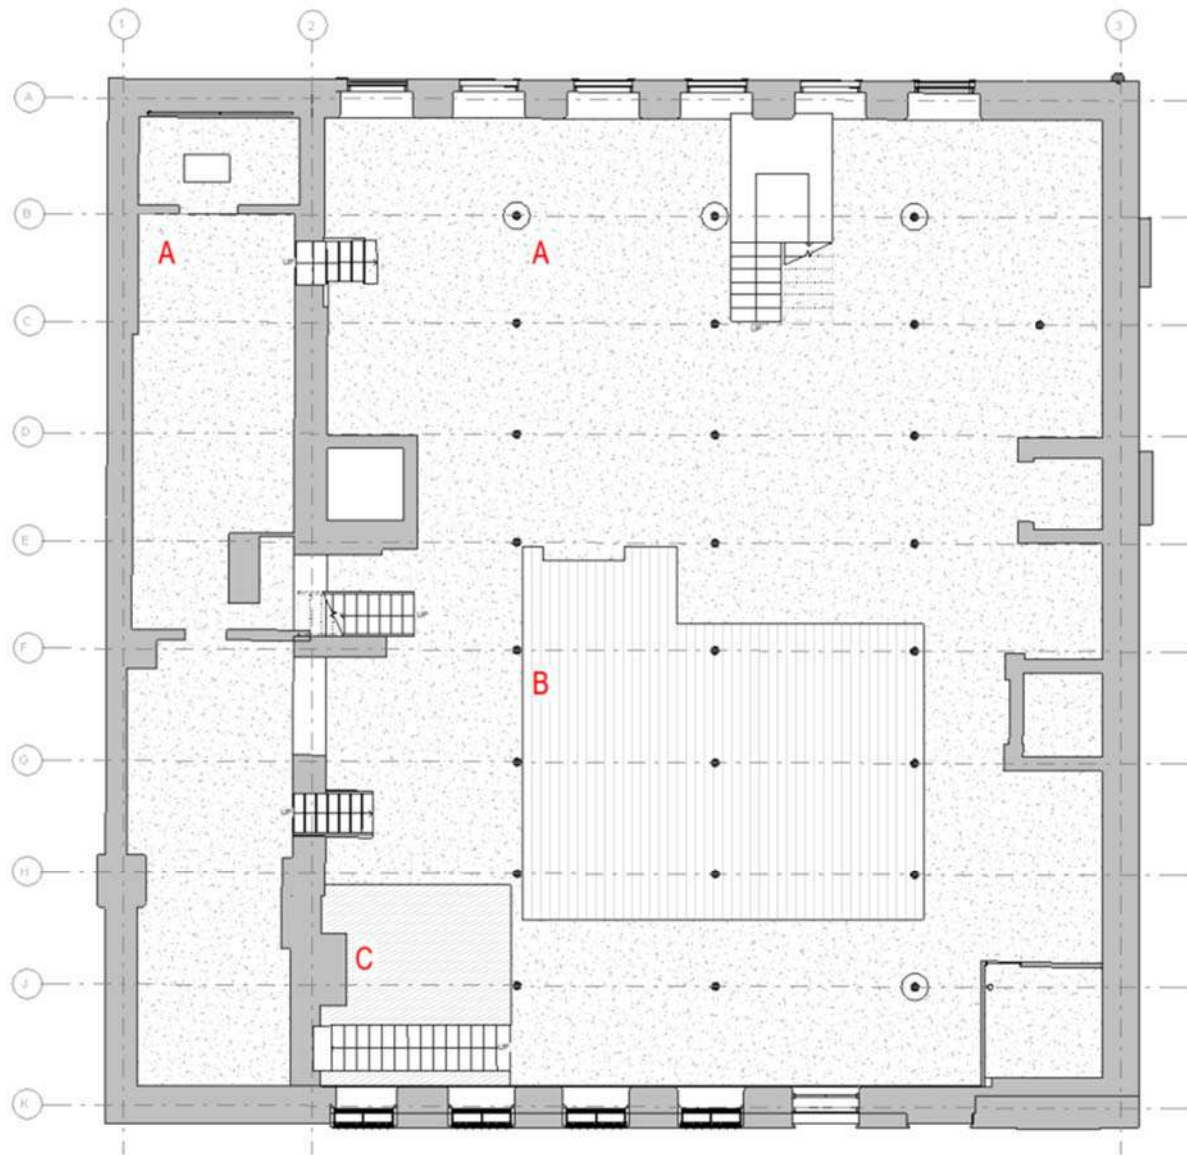
**Fig.1:** BLOOM STREET - EXISTING BASEMENT & SUB-BASEMENT FLOOR PLAN

As outlined above the existing slab make-up of the Bloom Building basement floor consists of timber mill boards, varying screed materials which are poured to a range of depths, as well as concrete in other places. This slab arrangement is supported and spanning between historic brick dwarf walls which are decaying, evident from the blown mortar joints, blown brickwork and extensive cracking (**Appendix C**). After further investigation around existing columns and dwarf walls it has also been highlighted that the depths the dwarf walls reach is limited in comparison to the existing column foundations. The SE is not satisfied with the soils the dwarf wall strip footings are founded on.

The existing timber mill boards have been surveyed (**Appendix E**) with the outcome showing there is infestation of the board by wood boring weevils, along with wet rot. The boards are of a high moisture content and require a specialist drying treatment along with extensive re-milling of the boards. The result of this would be a board that is of non-original size to the existing and a departure from the other existing timber millboards in the building. For this reason and with the recommendation of the conservation lead timber surveyor it is viewed as impractical to use the existing boards in the new floor build up.

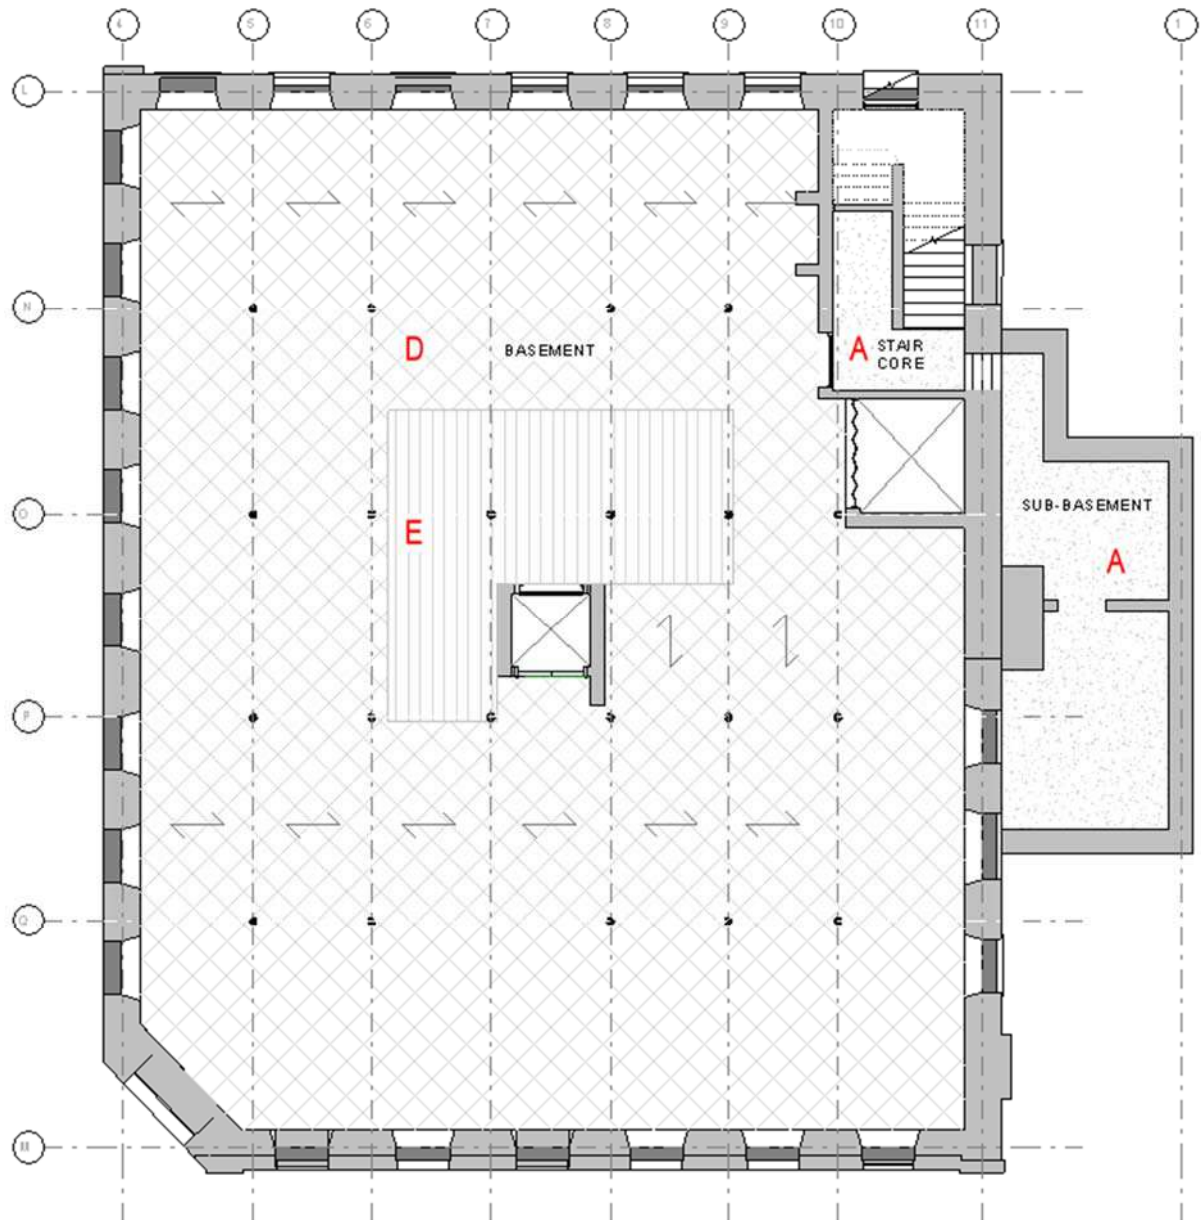
**Fig.2:** MINDEL HOUSE - EXISTING BASEMENT & SUB-BASEMENT FLOOR PLAN

Mindel House experiences a different floor build-up, upon investigation it has been found that the majority of the floor consists of an uninsulated sand cement type screed above a suspended beam & block floor spanning and between supporting brick dwarf walls. There is a small section of timber floor to the centre of the plan around the historic lift core.

Along with this, a report from the Timber specialist has argued that the few boards in Mindel House are of a later addition and do not match that found on the other floors of the building. Confirmation of infestation and rot in the existing floorboards, requiring wholesale removal as they have been deemed unsalvageable in some areas is also identified (**Appendix E**), a technical note from a heritage specialist supports this position also (**Appendix H**).

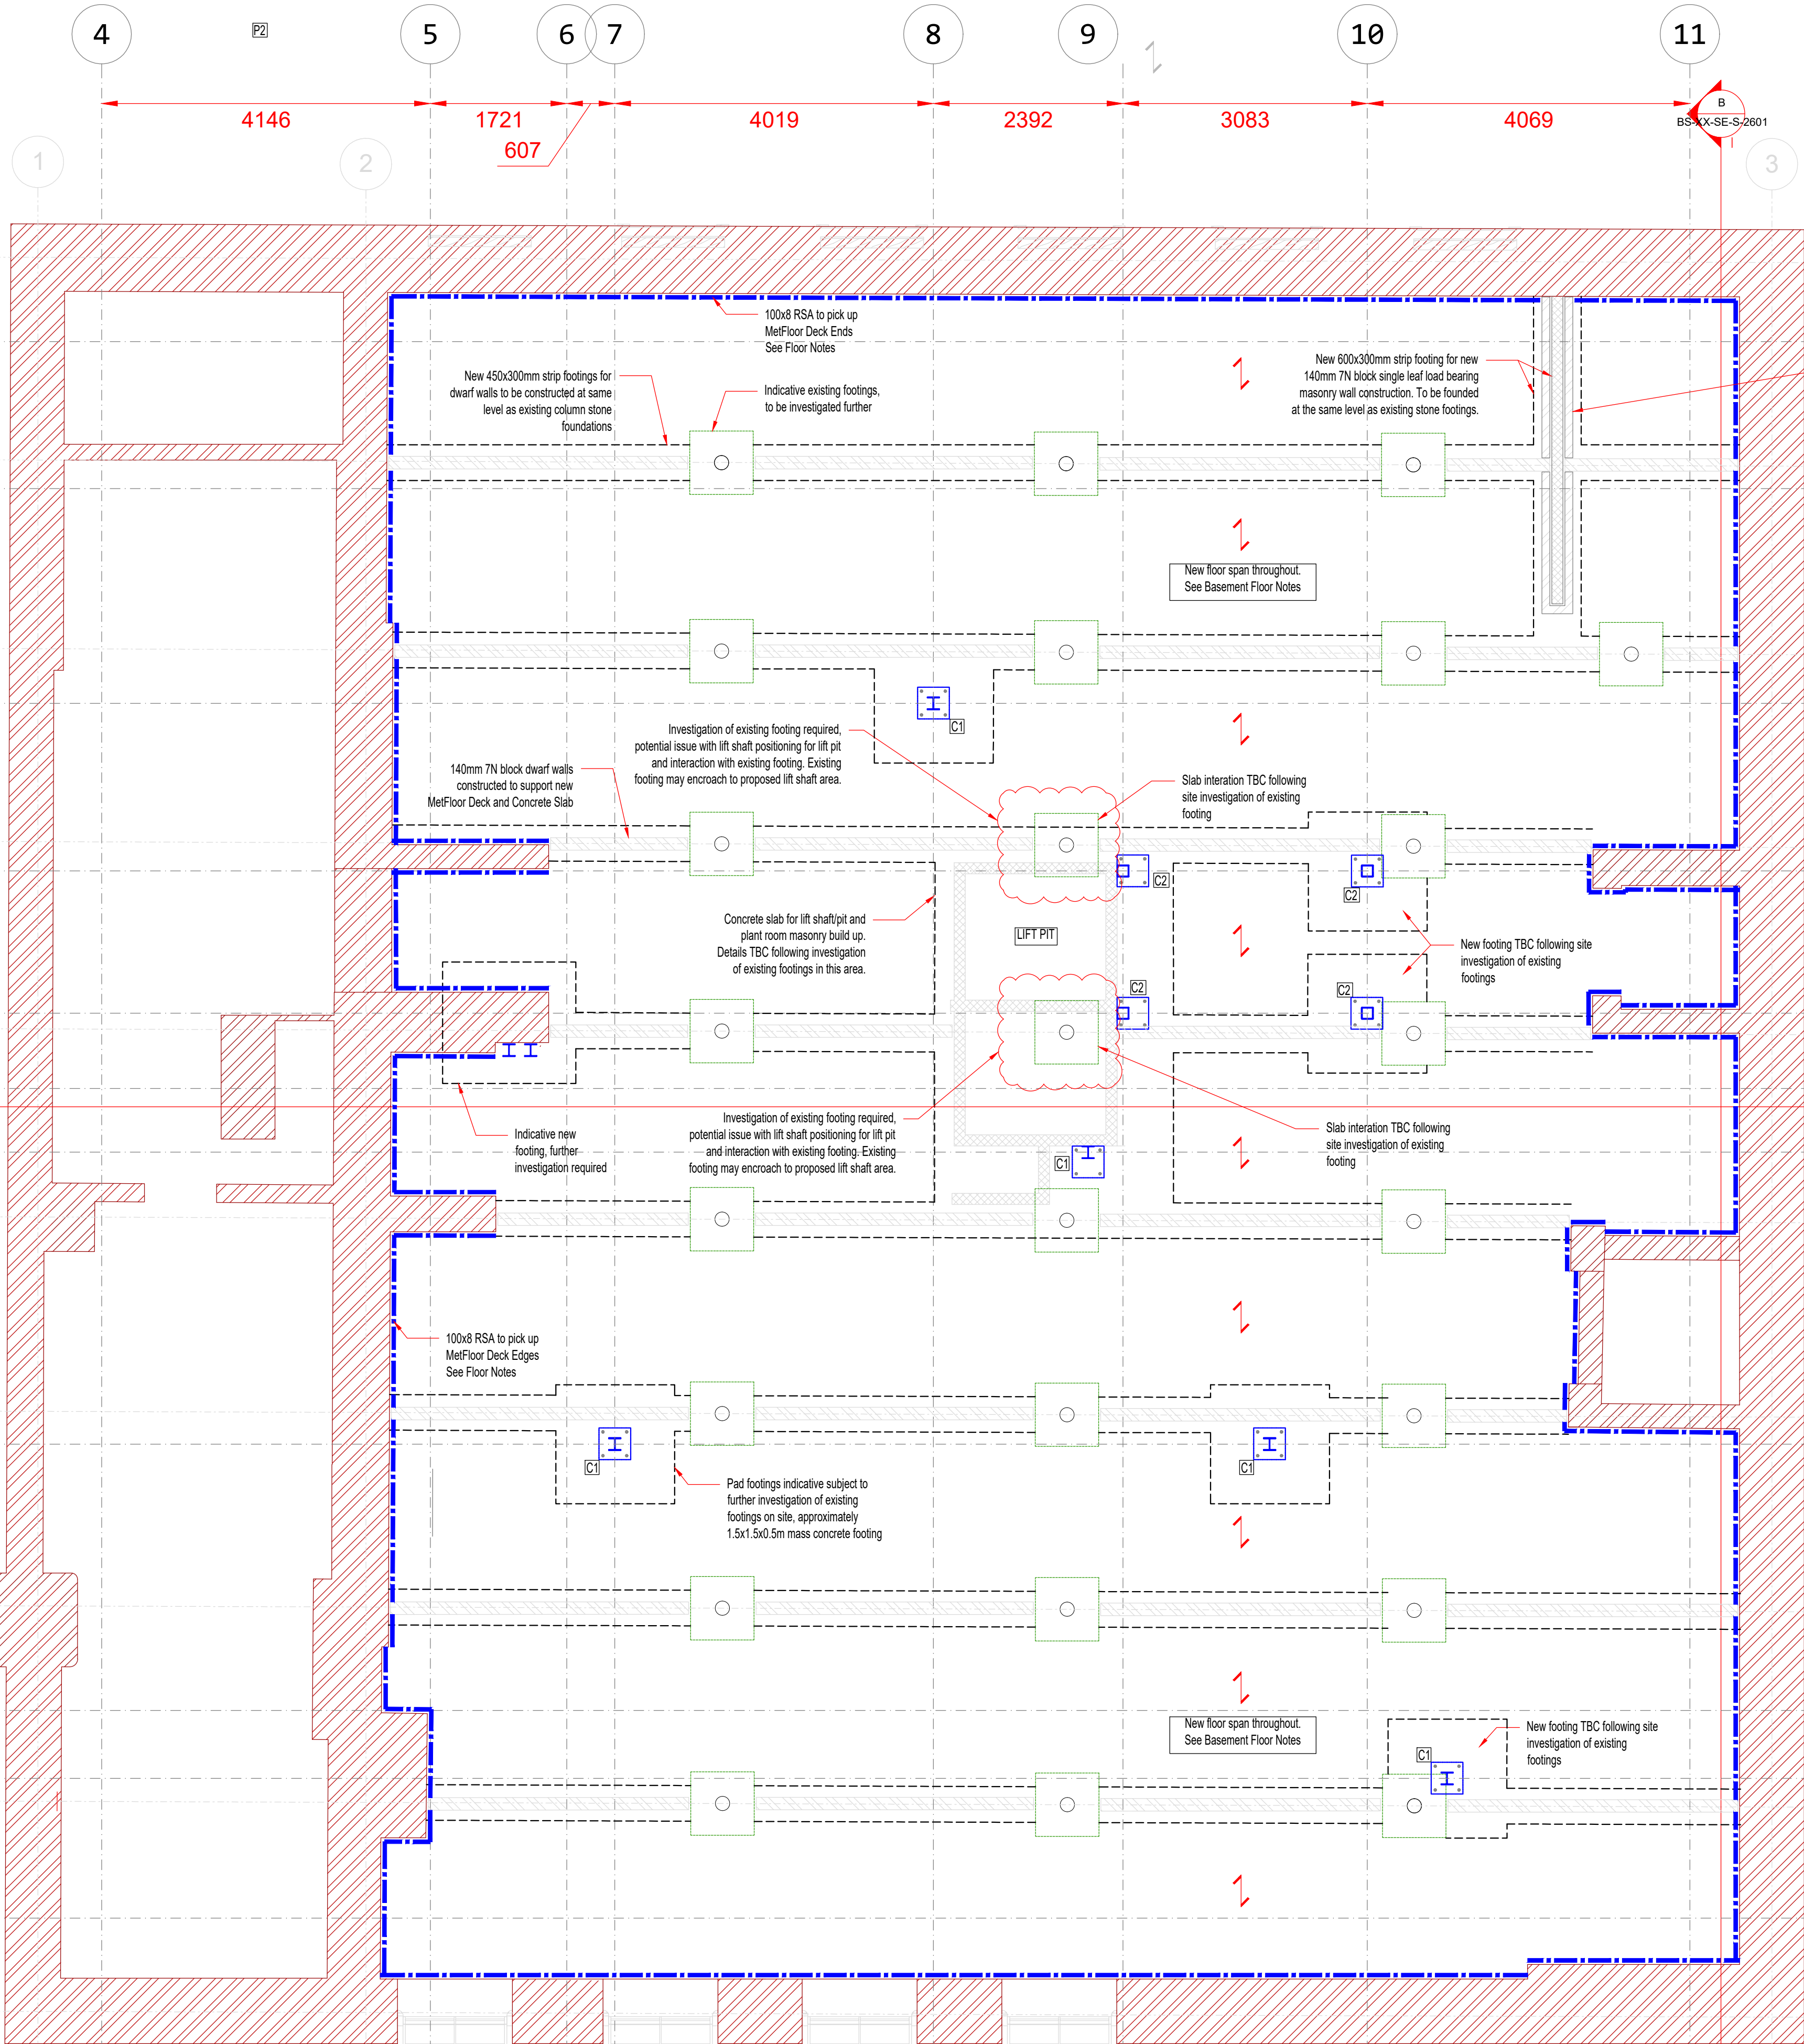
D - Structural Engineer – Bloom Building Proposed Floor Structure - A3516-GMS-  
BS-FL-PL-S-2600-A3

Existing dwarf walls exposed to date appear to be of poor quality and founded at varying levels. Demolition of all dwarf walls and rebuilding on new strip footings recommended

Existing foundation and substructure exposure required throughout. All existing timber and concrete flooring to be removed to allow investigation of all existing column and wall foundations. To allow for final design and layout of proposed new levels.

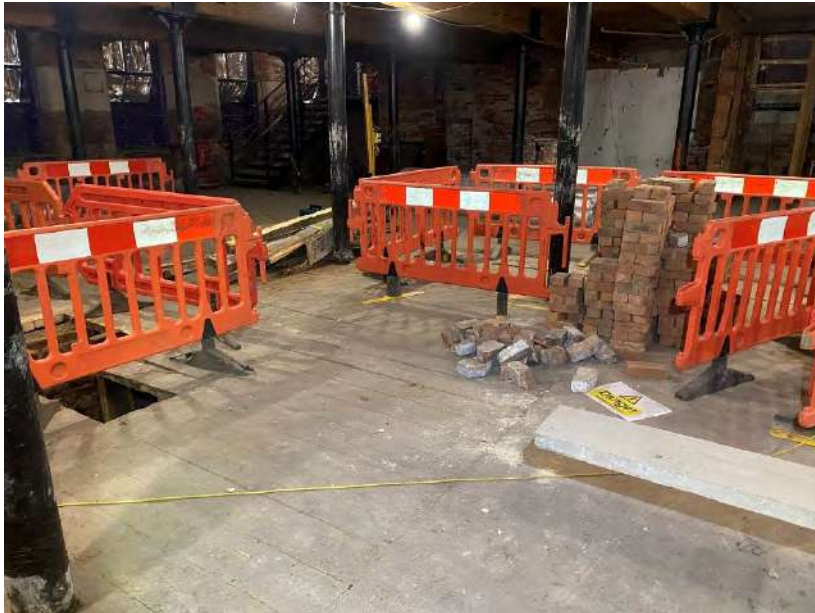
**Fig 1:**

Lower ground floor; showing a general view of the softwood suspended timber floor to the centre of the room

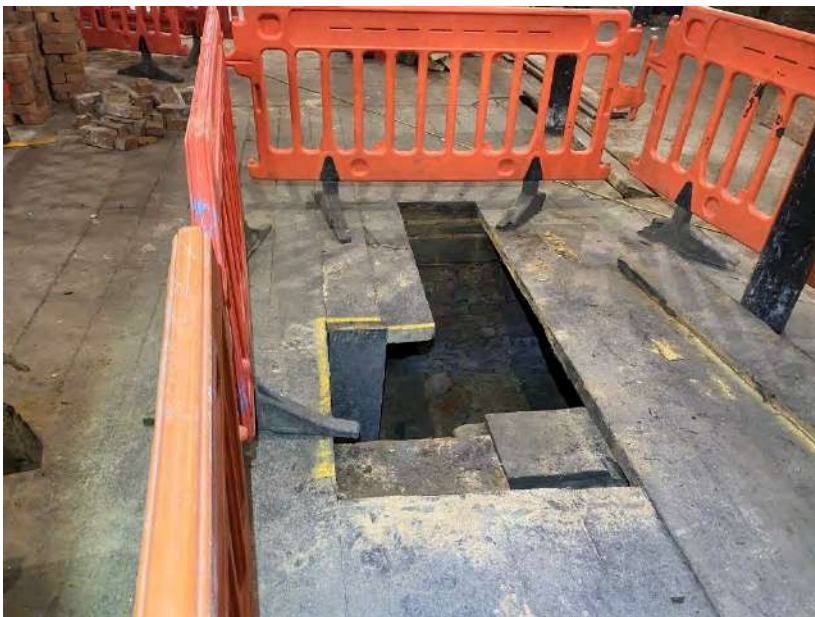
**Fig 2:**

Lower ground floor; showing an opening which provided access to inspect from within the floor void

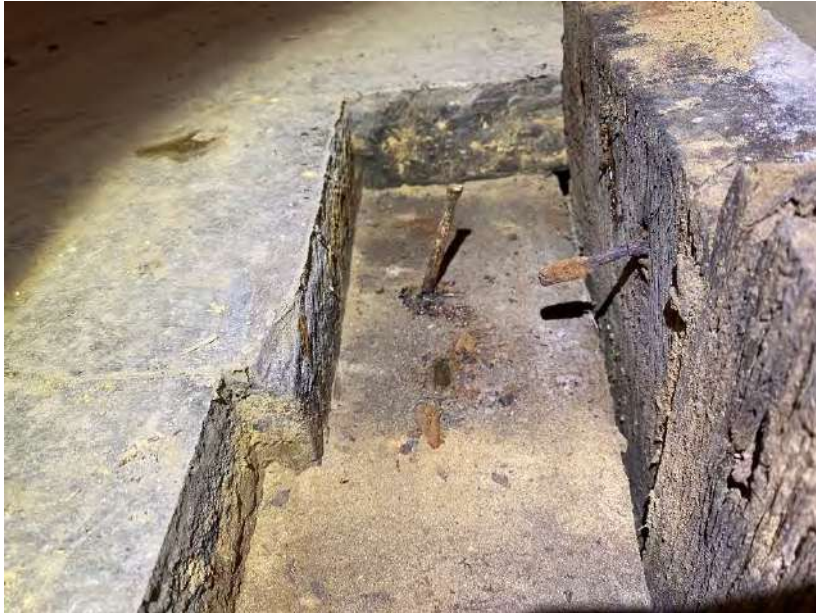
**Fig 7:**

Lower ground floor; showing the end of a floorboard where it is fixed with 2 no. nails into a lower wall plate with oval wire nails. Larger cut clasp nails were also used to fix the wall plate into supporting beams beneath

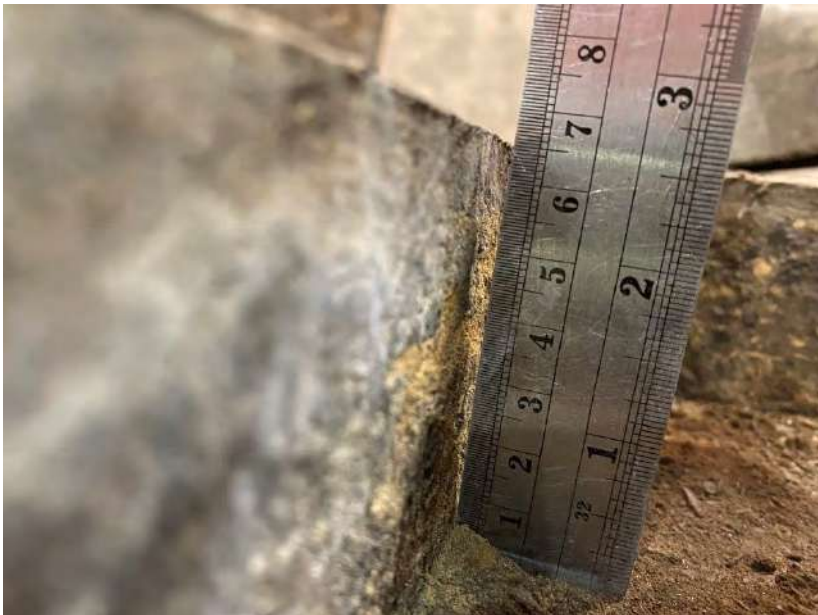
**Fig 12:**

Lower ground floor; showing the square-edge floorboards that measured 65mm in depth

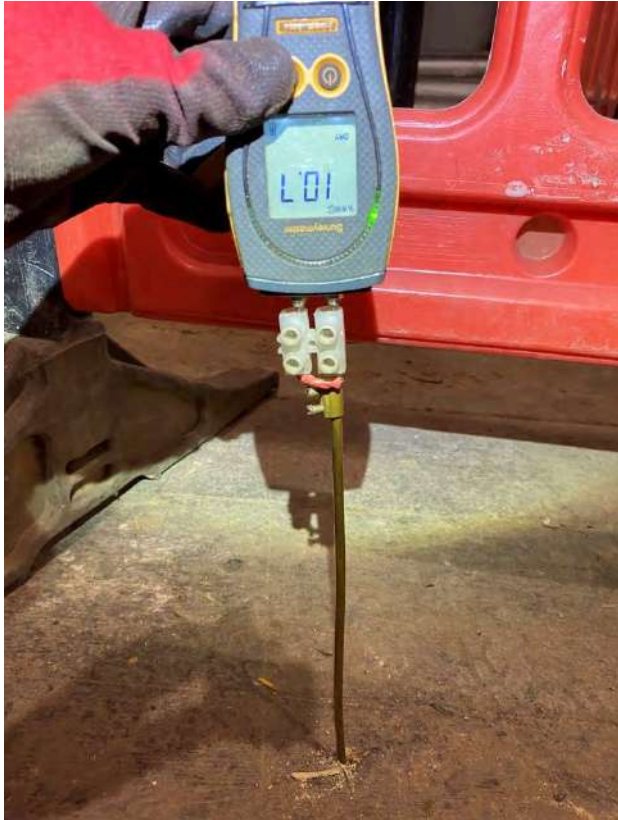
**Fig 13:**

Lower ground floor; showing a deep moisture content of 10.7 per cent w/w taken from the centre of a floorboard. This is a low reading which is unable to support fungal growth or wood-boring weevil infestation

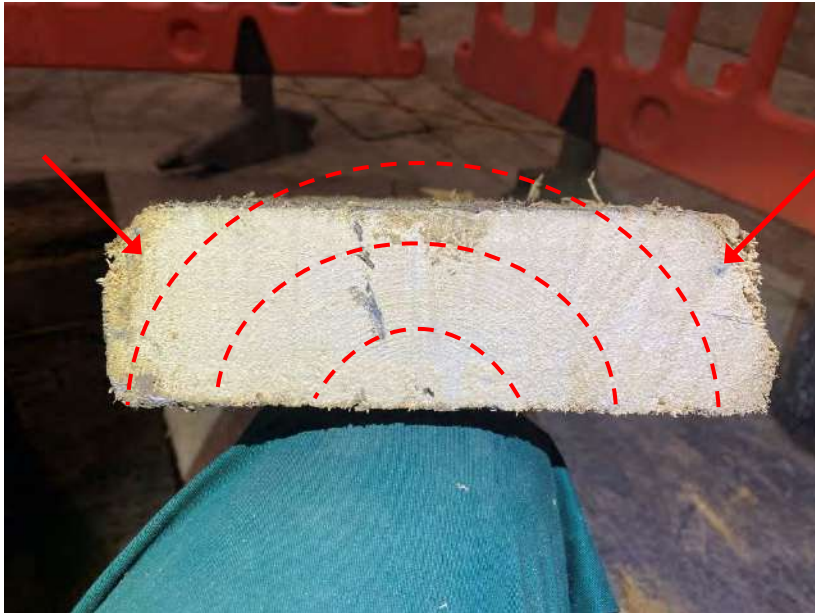
**Fig 15:**

Lower ground floor; showing a typical example of wood-boring weevil tunnelling concentrated in the sides of and underside of a floorboard

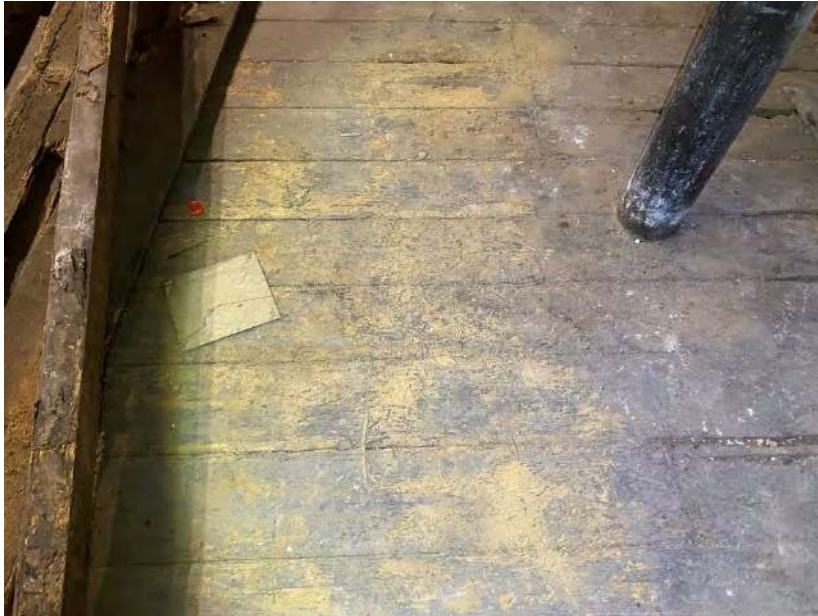
**Fig 17:**

Lower ground floor; showing an example of wood-boring weevil infestation on the top side of the floorboards. Tunnelling here was limited to the upper 3mm of the floorboards and can be considered superficial

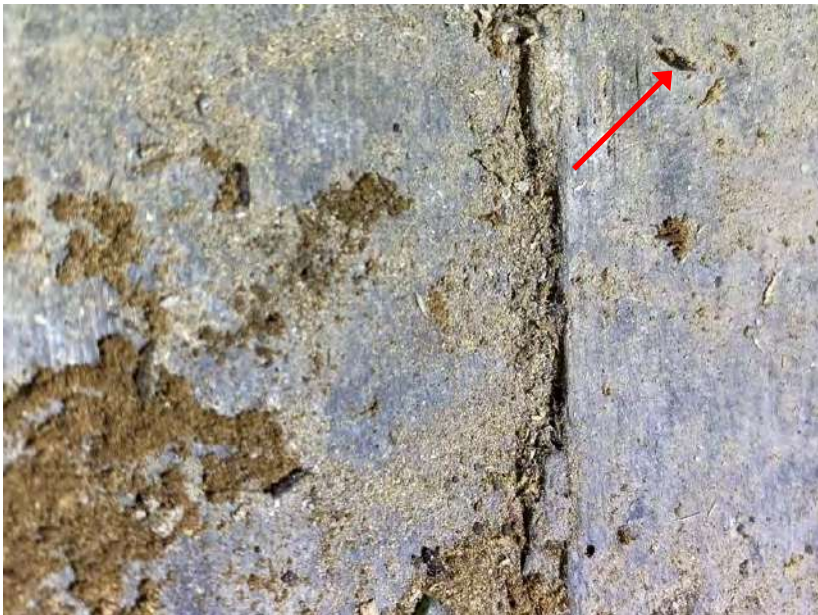
**Fig 18:**

Lower ground floor; showing a wood-boring weevil. Note the distinctive long 'snout'

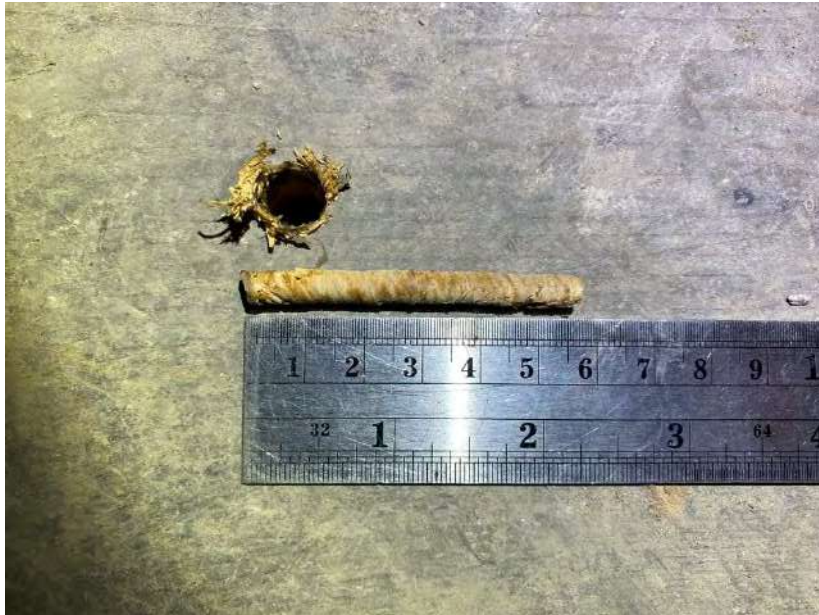
**Fig 25:**

Lower ground floor; showing floorboard core sample no.1 which measured approximately 57mm

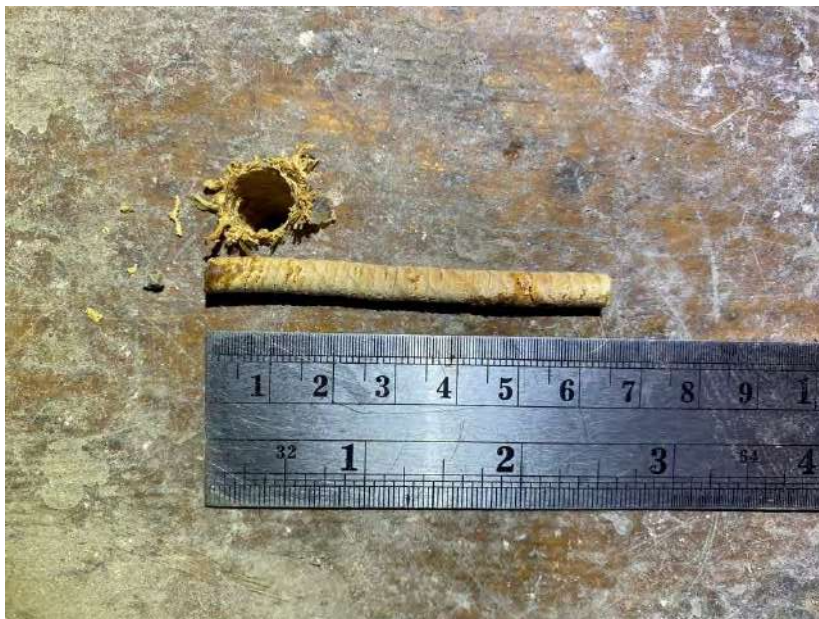
**Fig 26:**

Lower ground floor; showing floorboard core sample no.2 which measured approximately 64mm

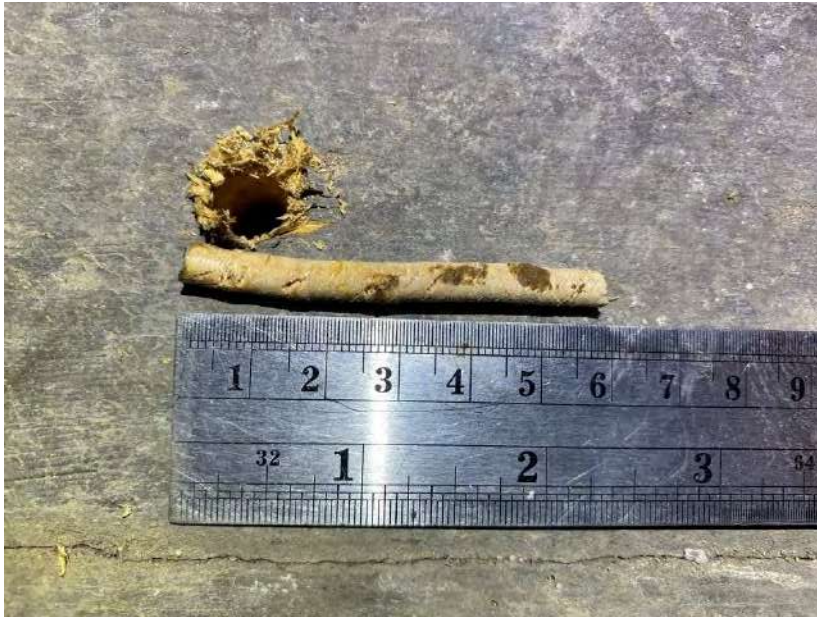
**Fig 27:**

Lower ground floor; showing floorboard core sample no.3 which measured approximately 59mm

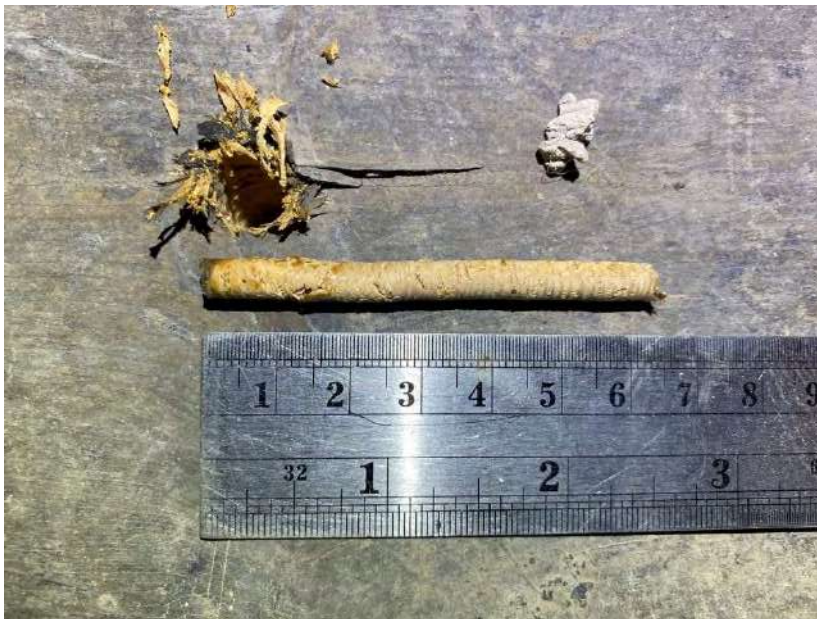
**Fig 28:**

Lower ground floor; showing floorboard core sample no.4 which measured approximately 64mm

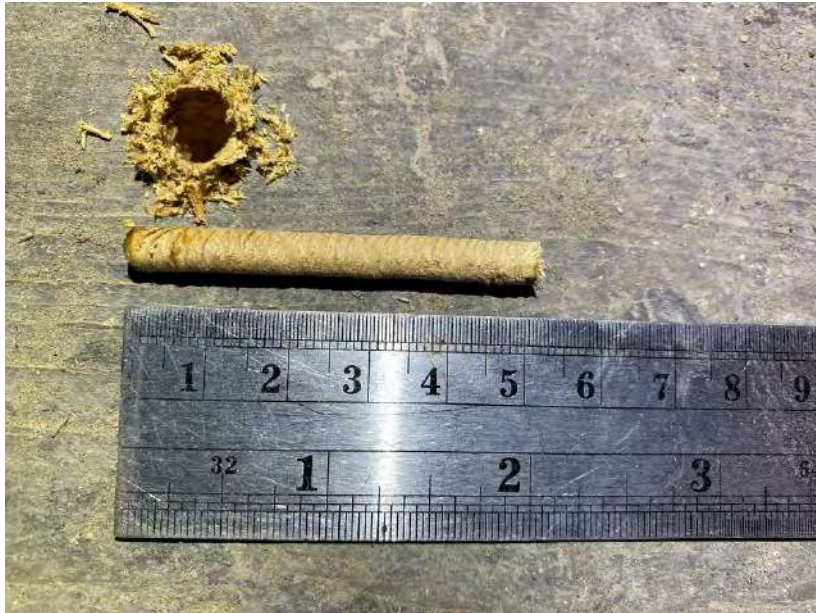
**Fig 29:**

Lower ground floor; showing floorboard core sample no.5 which measured approximately 52mm

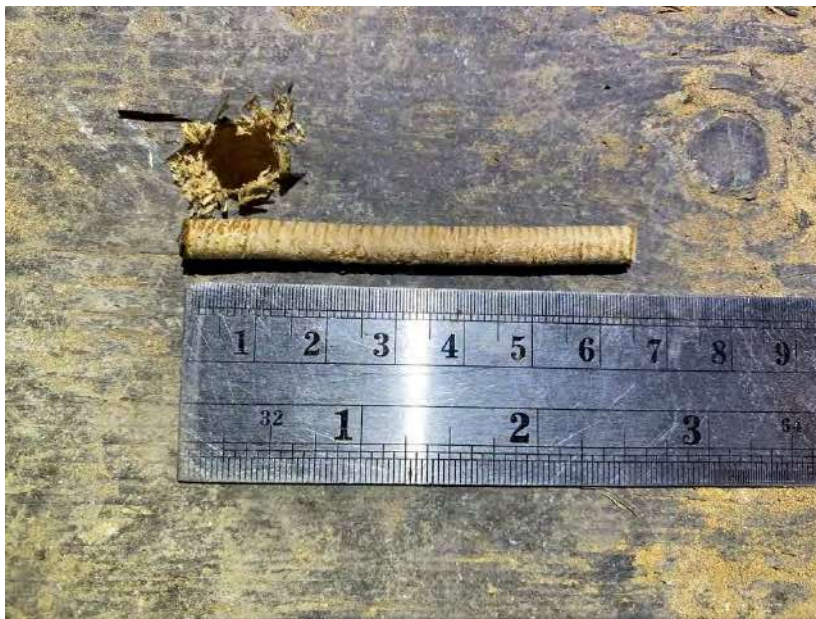
**Fig 30:**

Lower ground floor; showing floorboard core sample no.6 which measured approximately 65mm

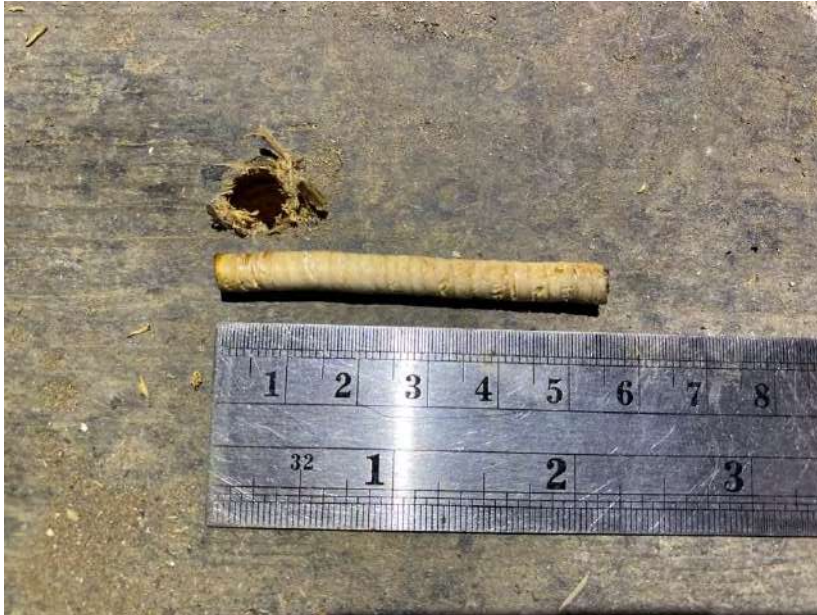
**Fig 31:**

Lower ground floor; showing floorboard core sample no.7 which measured approximately 55mm

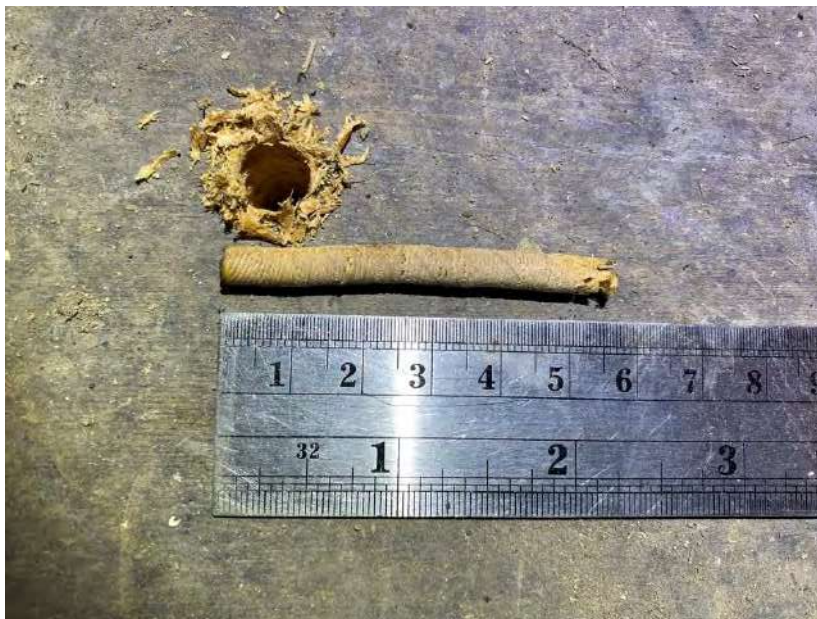
**Fig 32:**

Lower ground floor; showing floorboard core sample no.8 which measured approximately 55mm

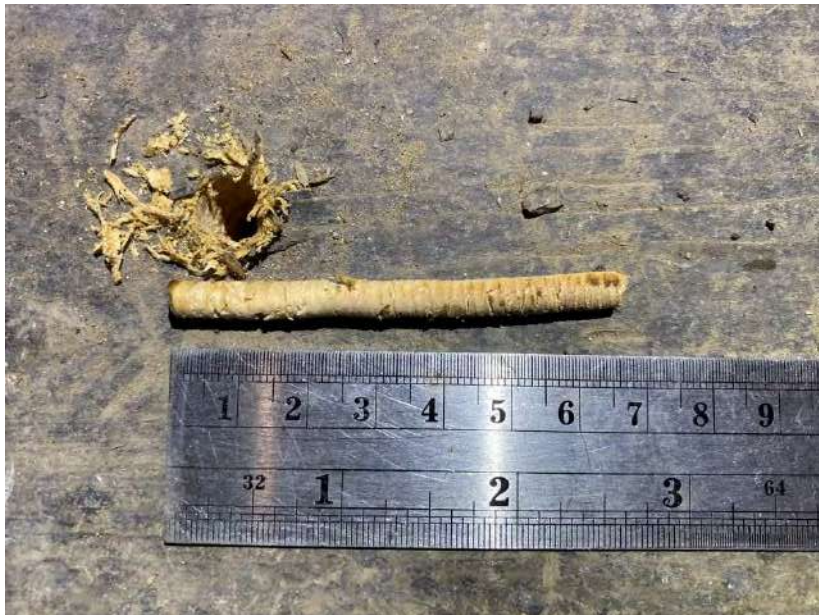
**Fig 33:**

Lower ground floor; showing floorboard core sample no.9 which measured approximately 65mm

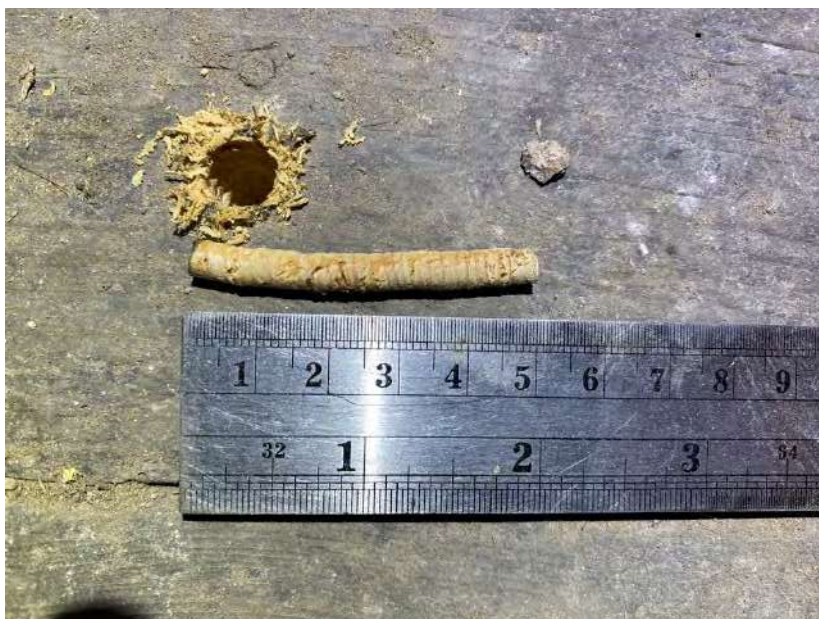
**Fig 34:**

Lower ground floor; showing floorboard core sample no.10 which measured approximately 50mm

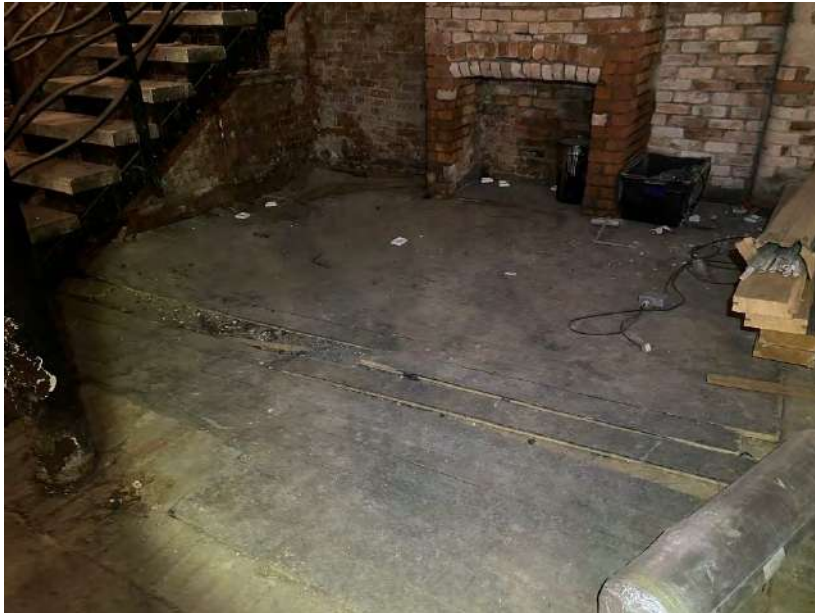
**Fig 35:**

Lower ground floor; showing the area of softwood suspended timber floor to the south-west corner of the room

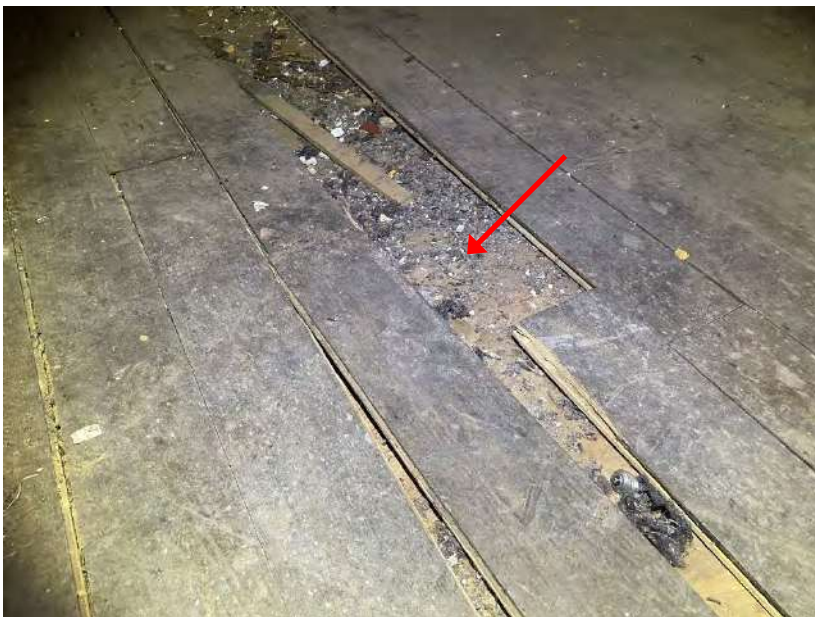
**Fig 36:**

Lower ground floor; showing tongue and groove floorboards applied over engineered oriented strand board (OSB). Note that OSB only dates from the 1960's

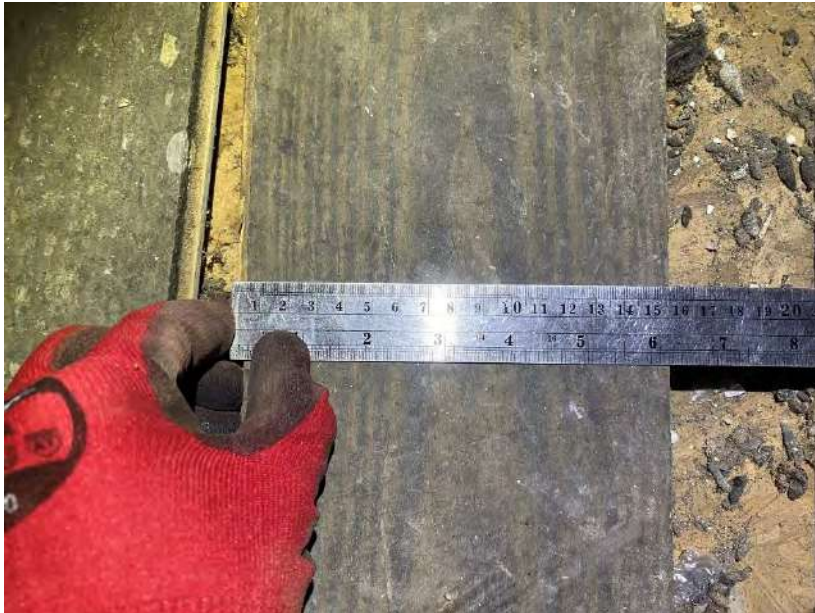
**Fig 37:**

Lower ground floor; showing t&g floorboards that measured approximately 155mm in width

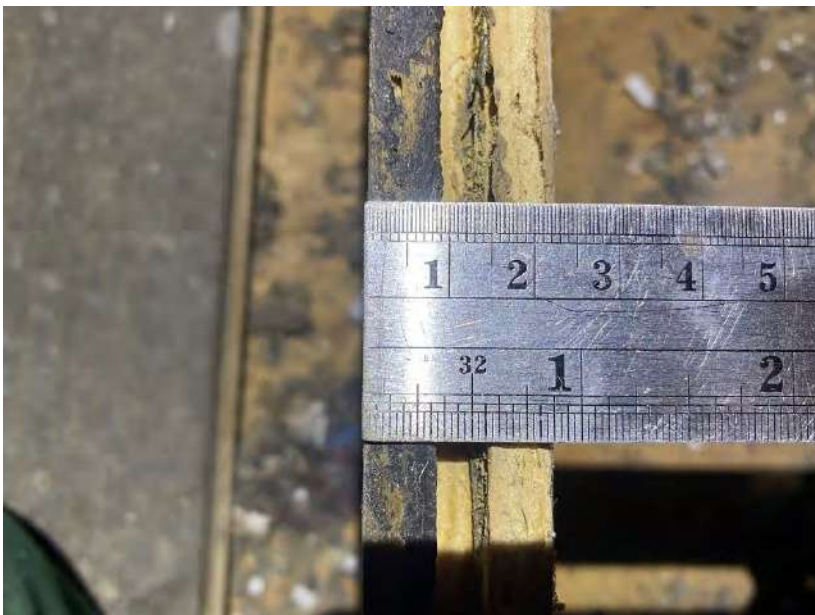
**Fig 38:**

Lower ground floor; showing t&g floorboards that measured approximately 22mm in depth

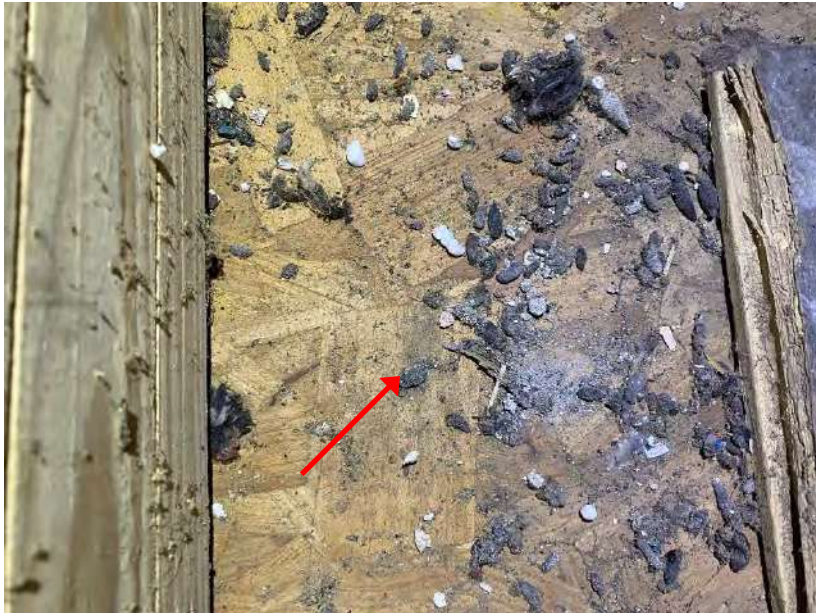
**Fig 39:**

Lower ground floor; showing rat droppings on the top of the OSB

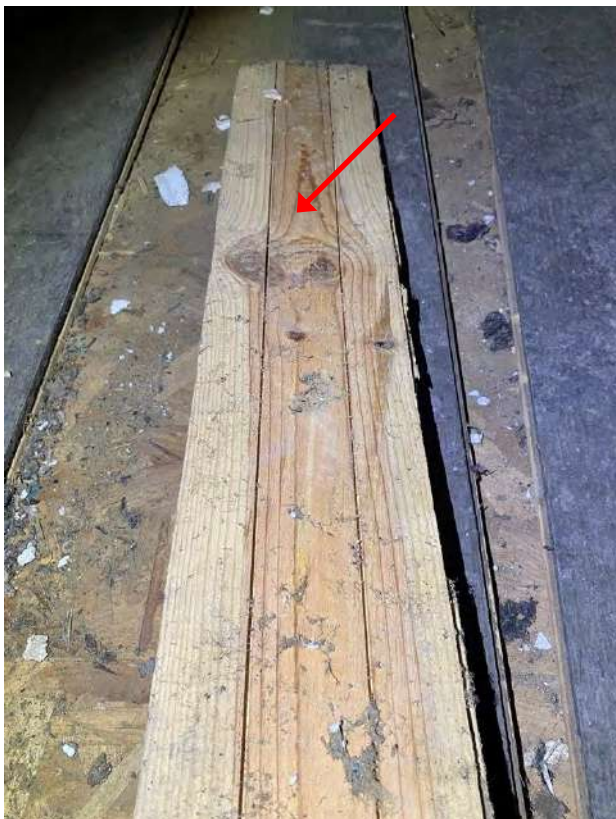
**Fig 40:**

Lower ground floor; showing a central groove milled into the underside of the t&g floorboard

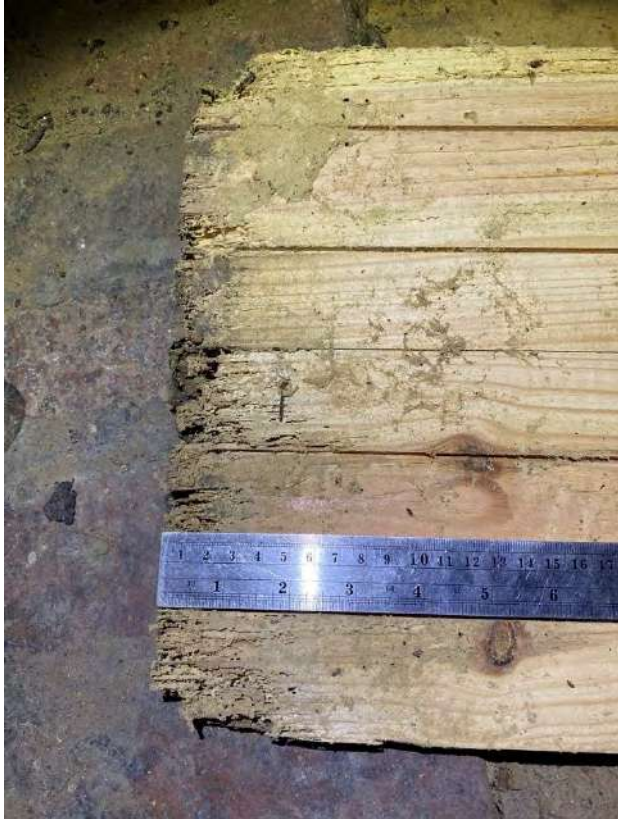
**Fig 41:**

Lower ground floor; showing an example of significant wood-boring weevil infestation and tunnelling concentrated in the end of a floorboard

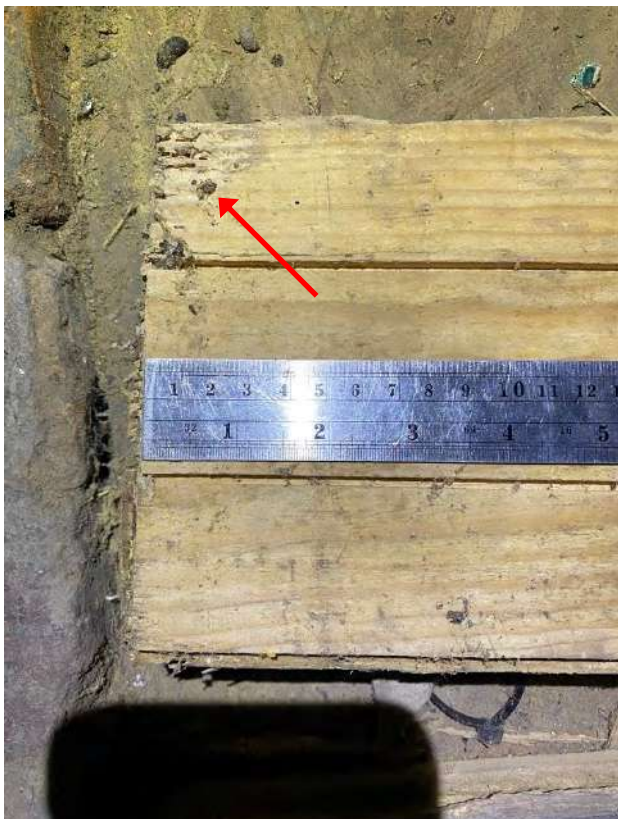
**Fig 42:**

Lower ground floor; showing an example of minor wood-boring weevil infestation and tunnelling concentrated in the end of a floorboard

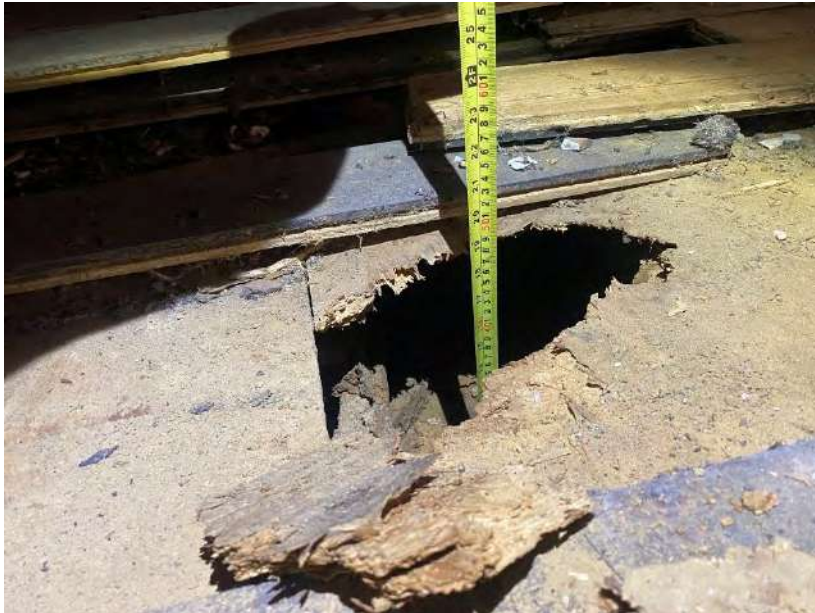
**Fig 43:**

Lower ground floor; showing a void of approximately 500mm between the floor level and earth beneath

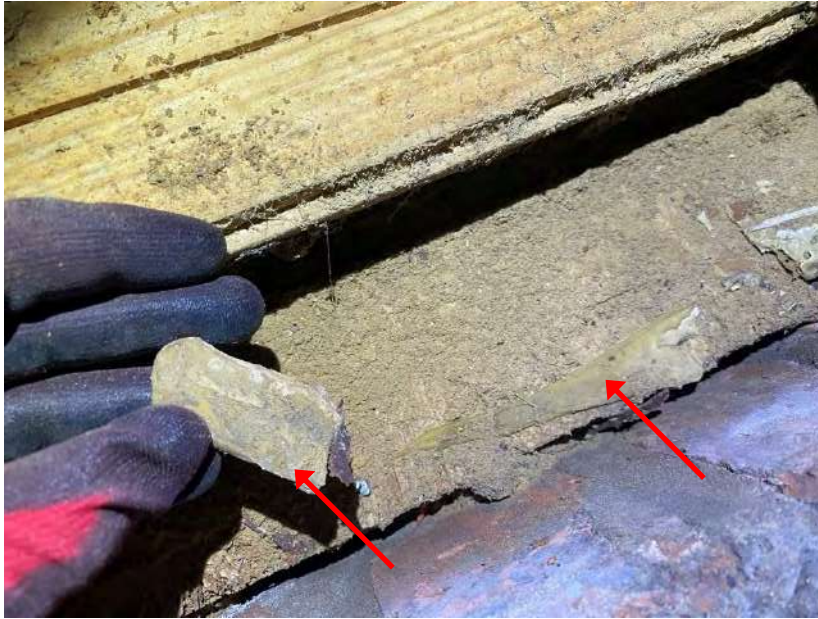
**Fig 45:**

Lower ground floor; showing the use of an adhesive to secure the t&g floorboards to the OSB

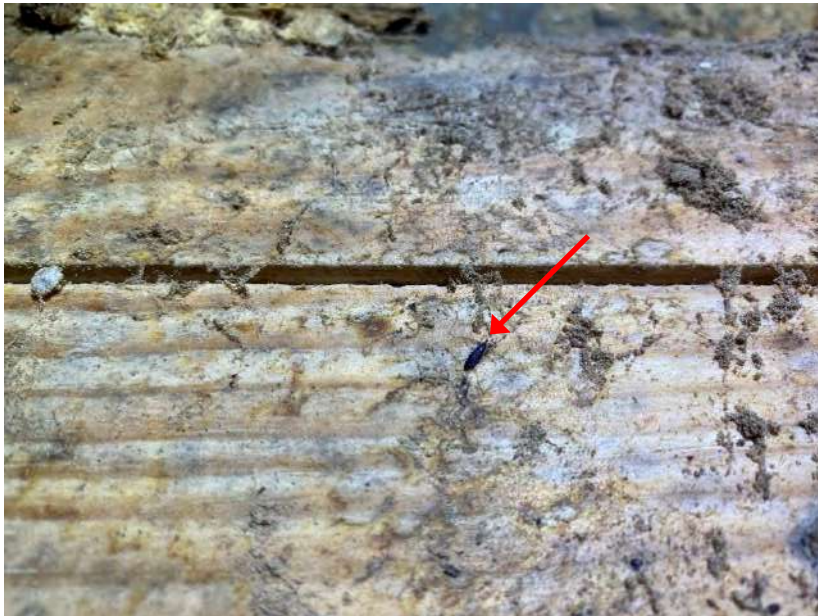
**Fig 46:**

Lower ground floor; showing a close-up of an adult wood-boring weevil
