10 Minshull Street and 11 Bloom Street

**TANKING DETAILS PROPOSALS**

PLANNING CONDITIONS RELEASE 11(e)

Planning Permission 119374/FO/2018 – BOTH BUILDINGS

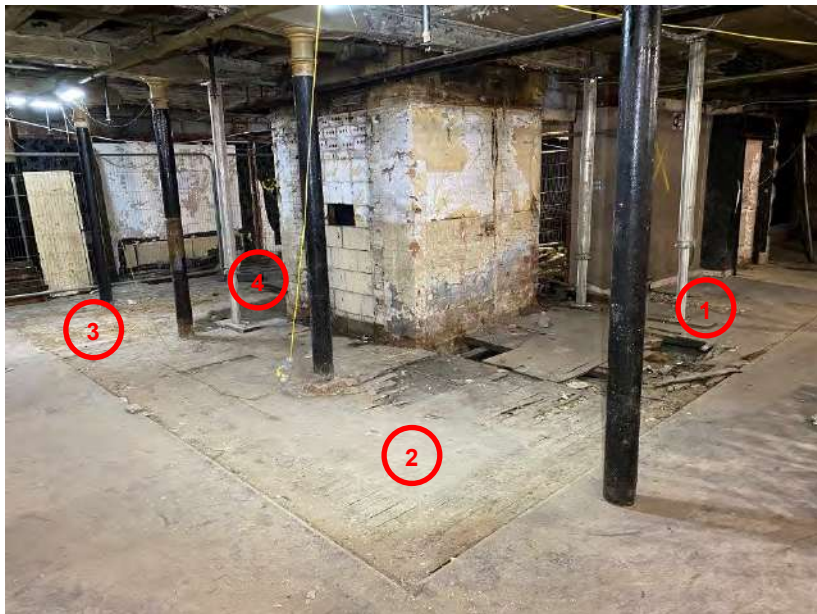
**Fig 1:**

Lower ground floor; showing a general view of the suspended timber floor around the central goods lift. The floor comprised 4 no. areas each with different forms of construction

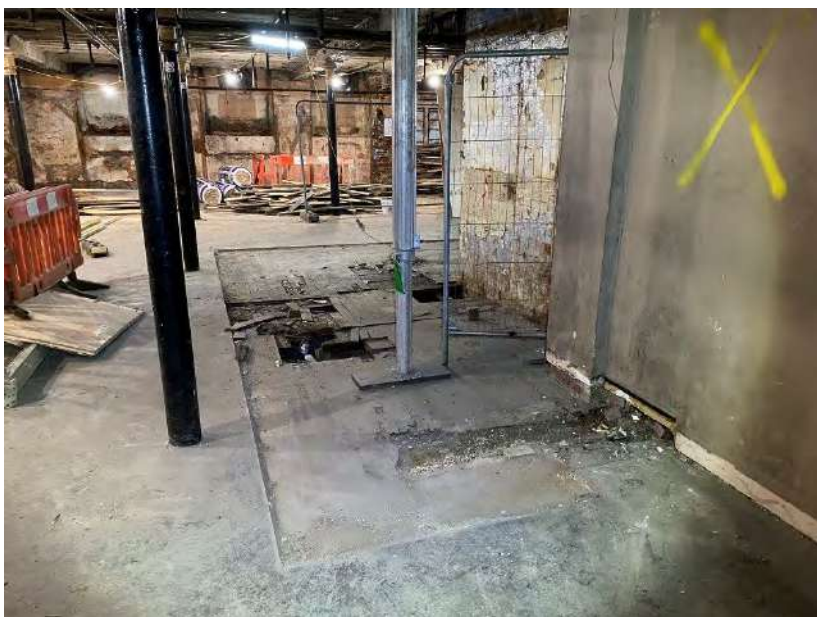
**Fig 2:**

Lower ground floor, Floor 1; showing a general view of the floor timbers which were bounded by a solid concrete floor

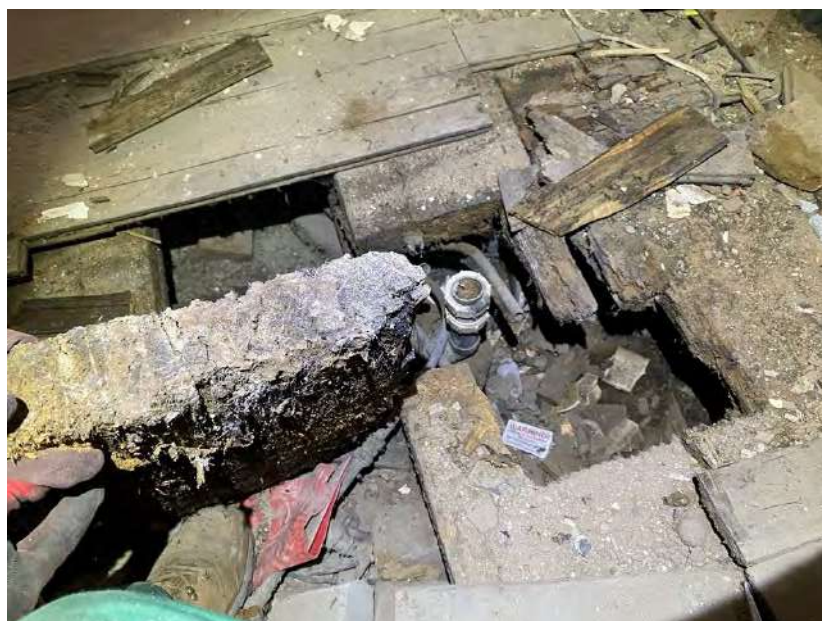
**Fig 4:**

Lower ground floor, Floor 1; showing a close-up of the heavily decayed timbers in the location of a former plumbing leak

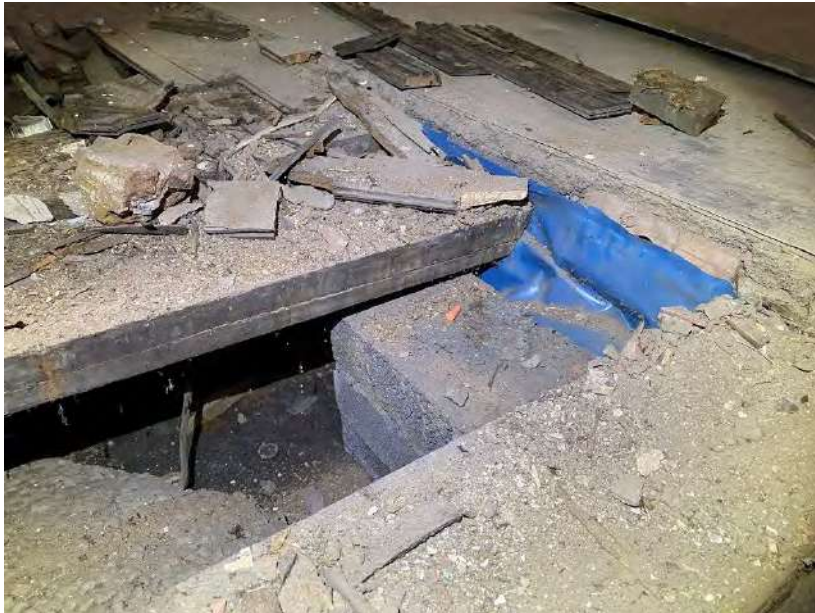
**Fig 5:**

Lower ground floor, Floor 1; showing exposure of the void beneath the millboards. The millboards were supported atop stacks of concrete blocks in many locations

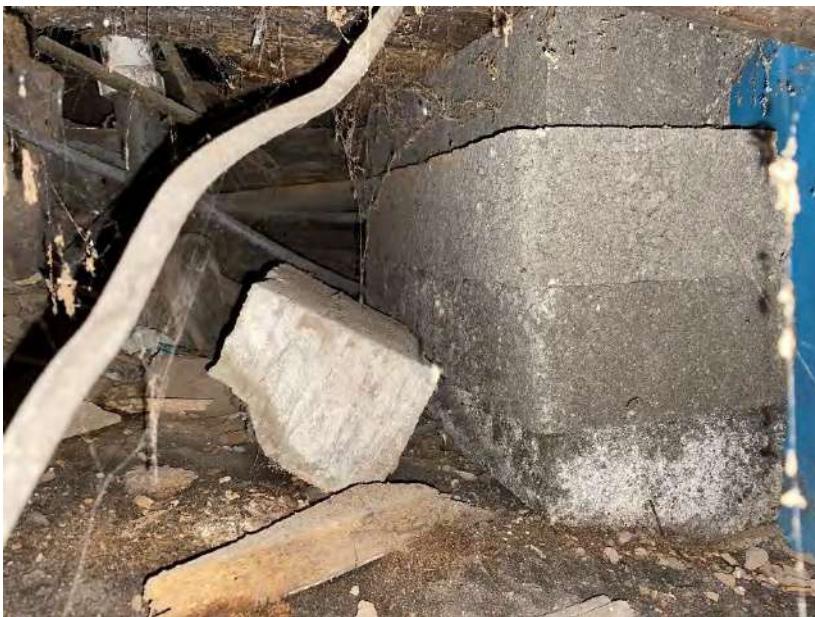
**Fig 6:**

Lower ground floor, Floor 1; showing a view of the concrete blocks from within the floor void. The blocks were stacked from a concrete slab

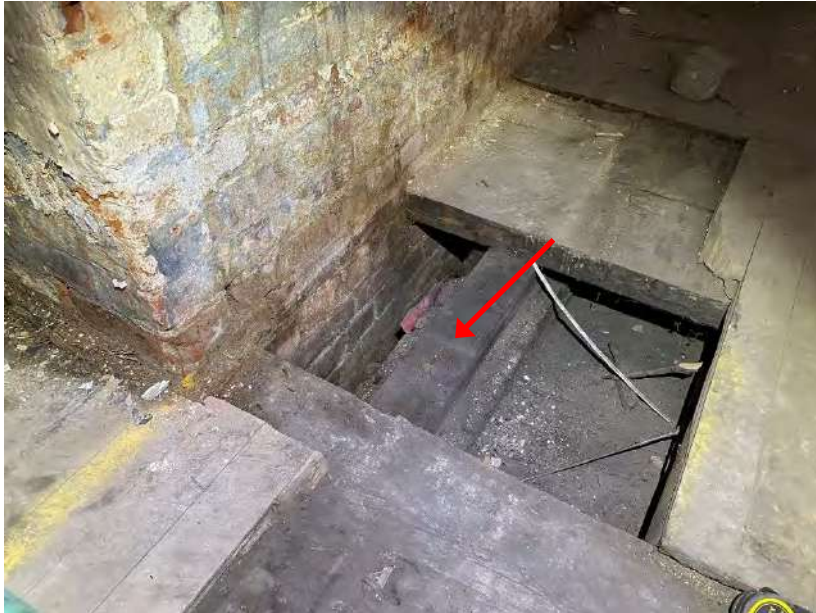
**Fig 7:**

Lower ground floor, Floor 2; showing the millboards bearing on a timber wall plate over a sleeper wall around the central goods lift

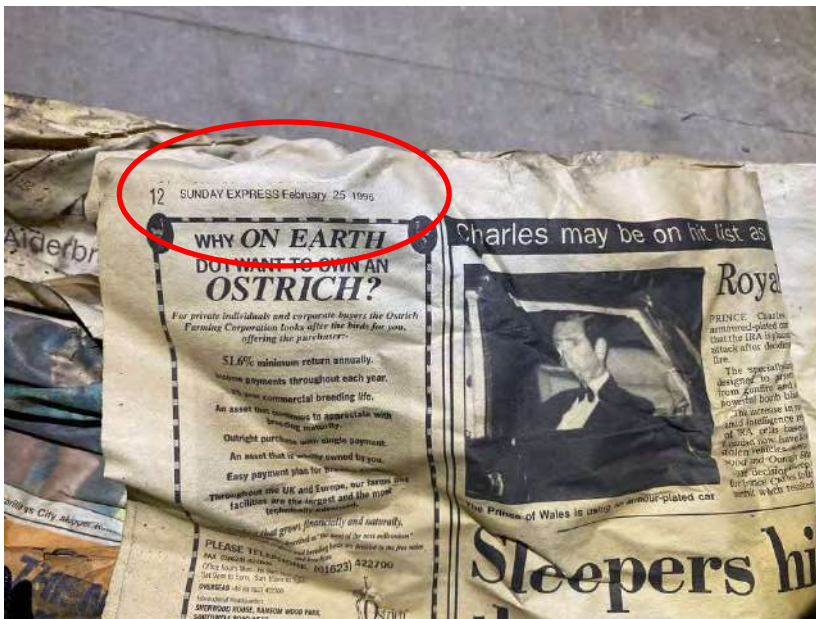
**Fig 8:**

Lower ground floor, Floor 2; showing the date of a newspaper found beneath the floor. This probably dates from the period of alteration to this floor structure

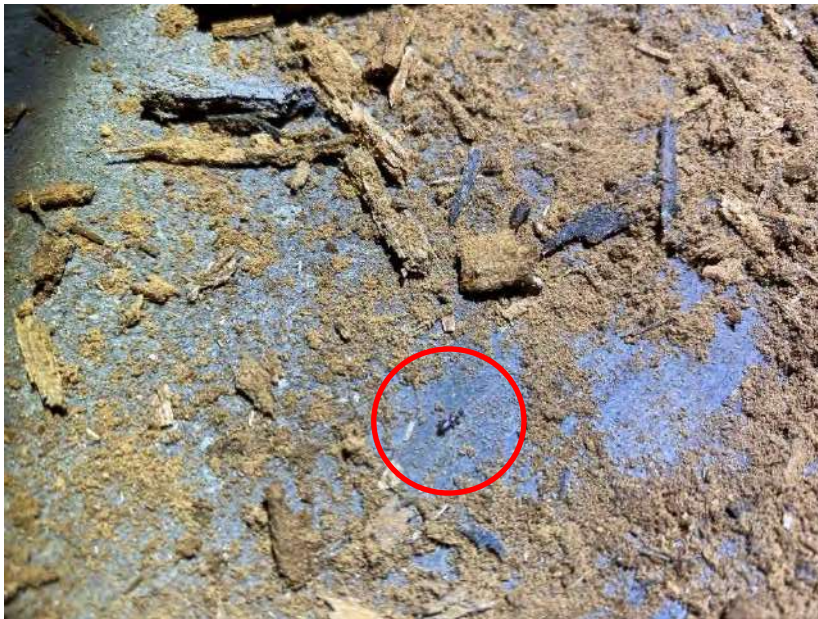
**Fig 10:**

Lower ground floor, Floor 2; showing an example of a live wood-boring weevil

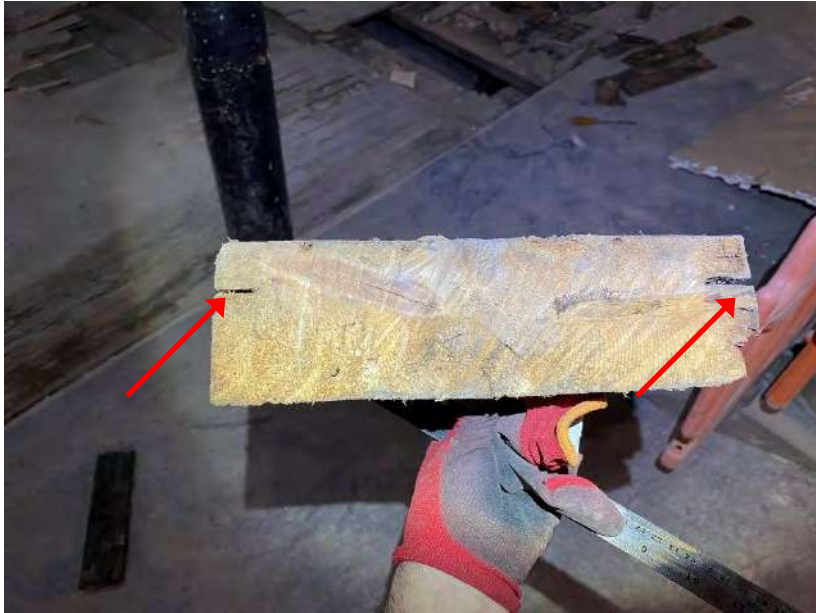
**Fig 11:**

Lower ground floor, Floor 2; showing a length of millboard that was removed for inspection. Note the milled grooves in the upper 1/3rd of the boards

- 2 Salvageability: The millboards and floorboards could be carefully raised and transported to a timber yard for de-nailing and re-milling. If desired, the reinstated millboards could receive new loose tongues or be secret nailed through the groove for fixing purposes. The t&g hardwood floorboards could also be secret nailed. The upper surface of the millboards and floorboards should be cleaned and although they could also be planed or sanded, this process would remove the historic patina

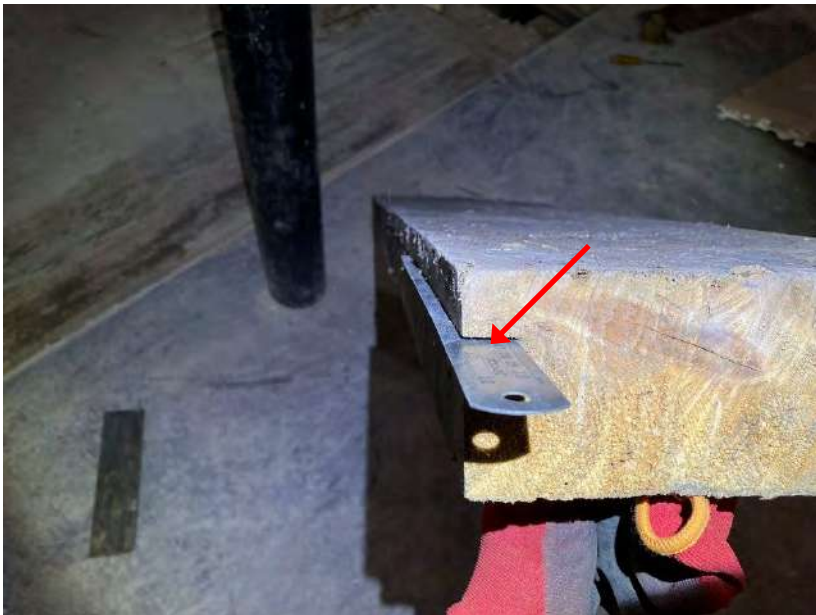
**Fig 12:**

Lower ground floor, Floor 2; showing a ruler placed in the groove. This is representative of a loose metal tongue

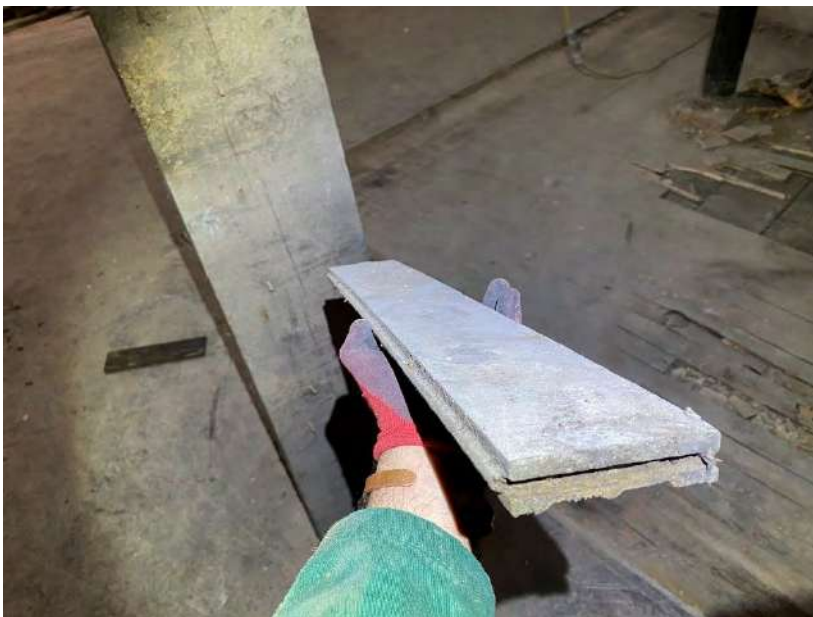
**Fig 14:**

Lower ground floor, Floor 2; showing a section of removed hardwood t&g flooring. There was no decay in this floorboard

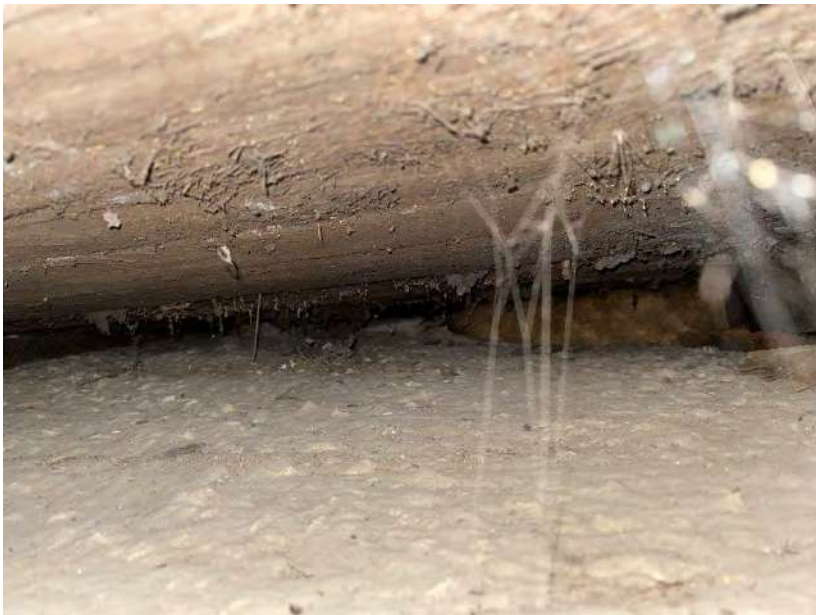
**Fig 16:**

Lower ground floor, Floor 2; showing a view of the concrete slab beneath the millboards. Note that there was no evidence of decay or wood-boring weevil or beetle infestation to the underside of the millboards

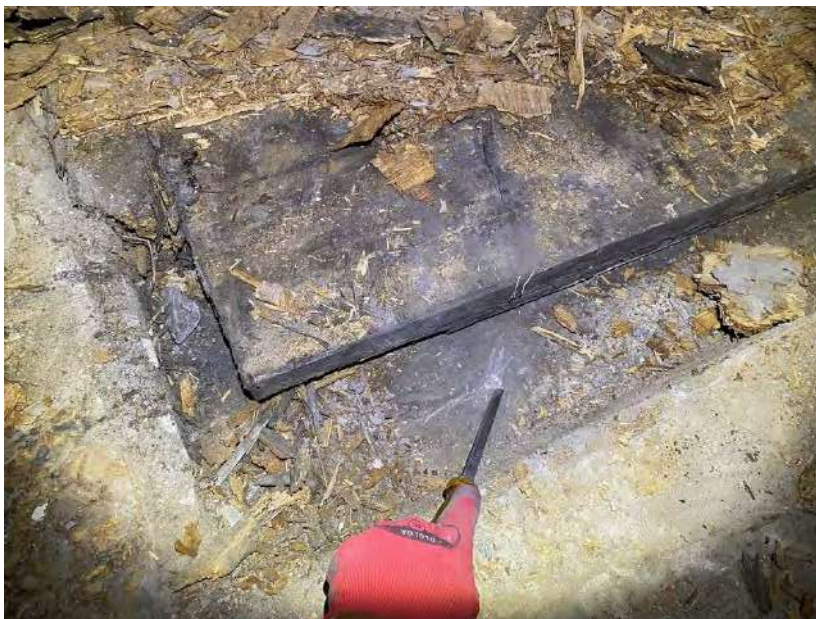
**Fig 18:**

Lower ground floor, Floor 3; showing millboards exposed beneath the OSB floor covering. Note the millboards were laid directly onto concrete and were heavily decayed by wood-boring weevil in this location

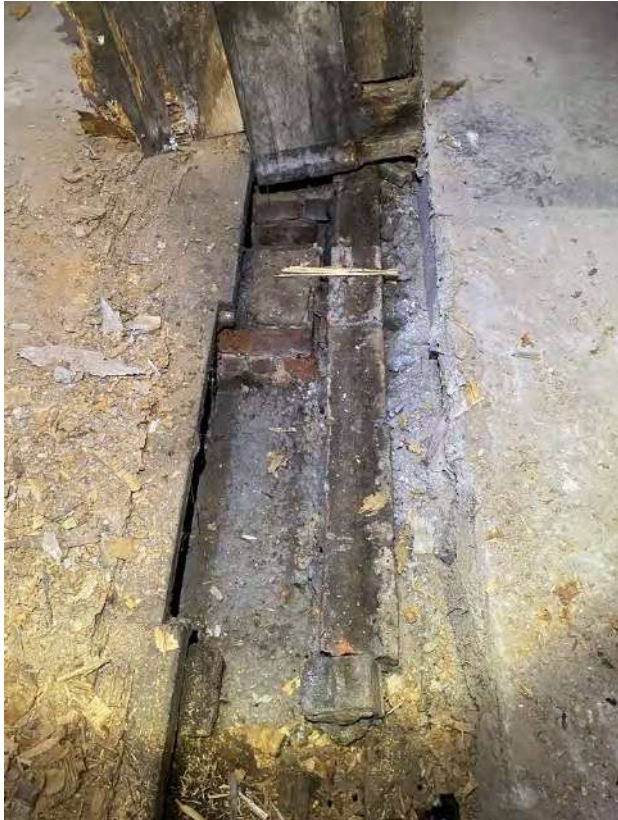
**Fig 19:**

Lower ground floor, Floor 3; showing millboards spanning between brick sleeper walls

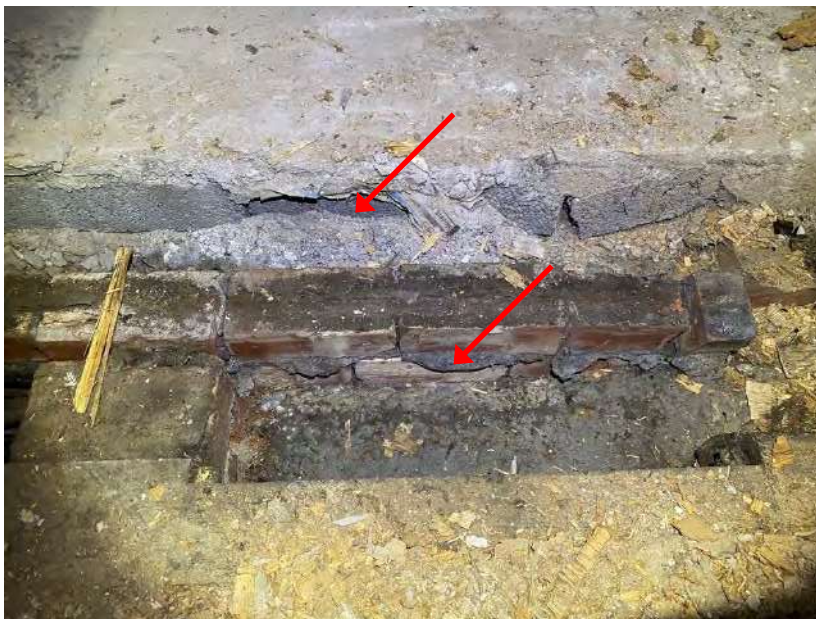
**Fig 20:**

Lower ground floor, Floor 3; showing brick sleeper wall to the perimeter of the area of timber floor. Note that the concrete floor was applied over loose concrete blocks

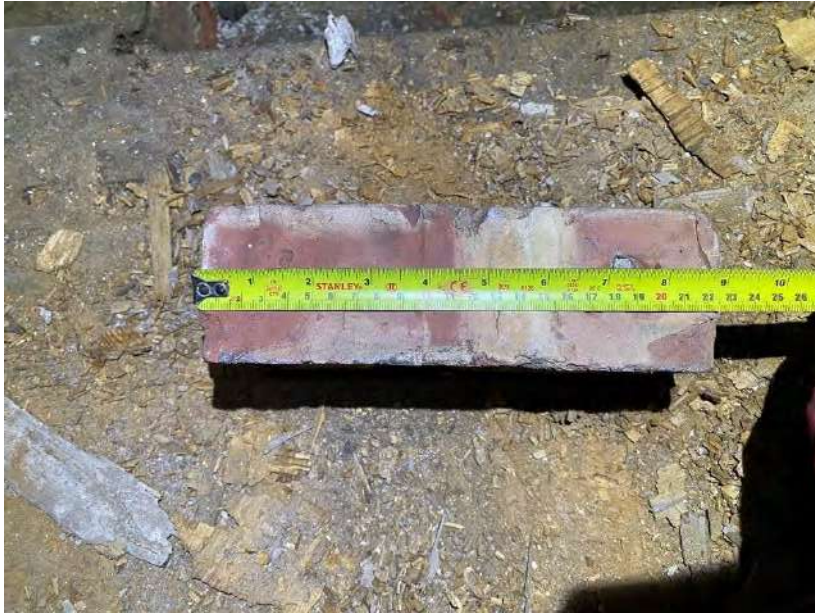
**Fig 21:**

Lower ground floor, Floor 3; showing a removed brick that was of metric dimension (post 1965). The sleeper wall appears to have been built during the late 20th Century

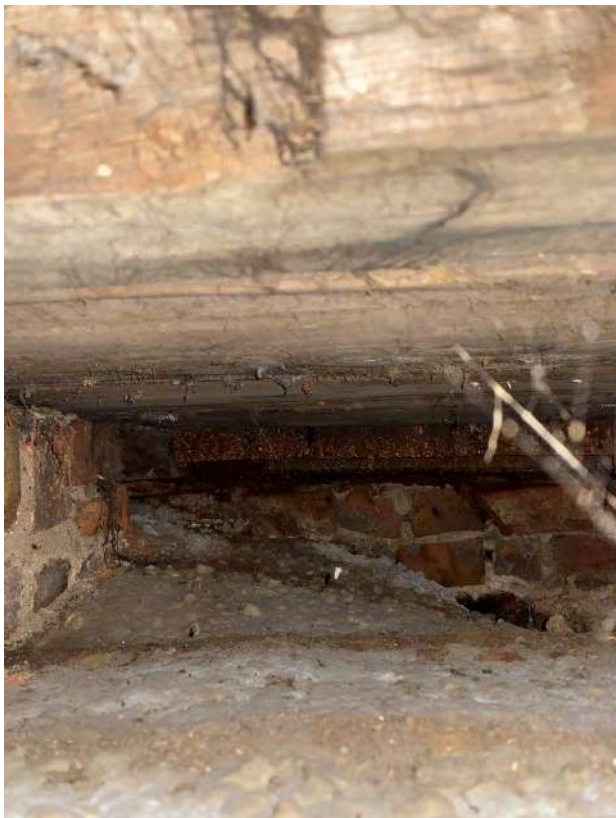
**Fig 22:**

Lower ground floor, Floor 3; showing a view of the concrete slab beneath the millboards. Note that there was no evidence of decay or wood-boring weevil or beetle infestation to the underside of the millboards here

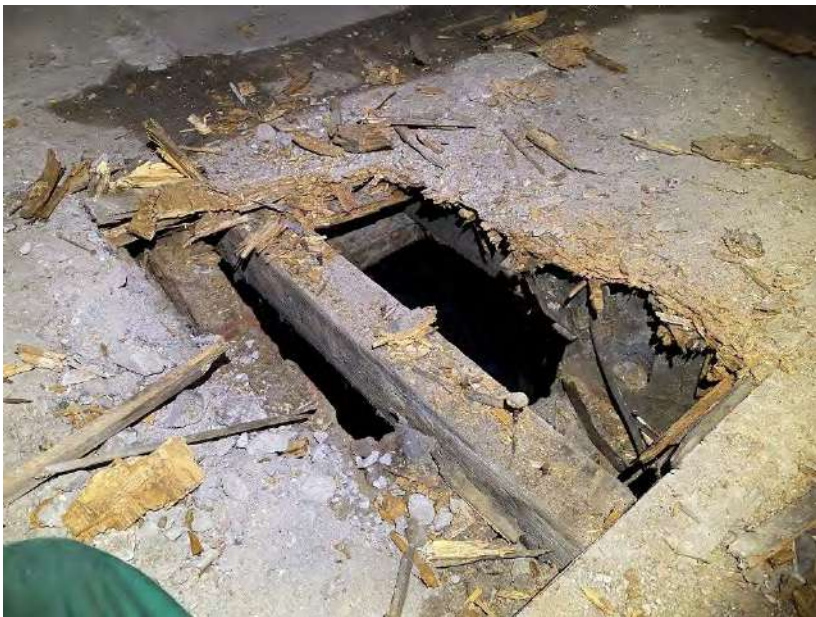
**Fig 24:**

- 7 Timber decay: All sheets of OSB and the floorboards and joists to Floor 4 were heavily decayed and beyond salvage. All timbers abutting the central goods lift were also heavily decayed and beyond salvage. There was evidence of a historical plumbing leak to the centre of Floor 1 and a proportion of the grooved millboards and t&g hardwood flooring in this area were heavily decayed. However, outside of these areas, a significant proportion of the grooved millboards were free from significant timber decay. Similarly, a proportion of the t&g hardwood flooring was also salvageable but this was to a lesser degree due to mechanical damage and warping attributed to fluctuating moisture contents and internal humidity

Lower ground floor, Floor 4; showing softwood joists and tongue and groove floorboards beneath the OSB. The joists spanned a small basement

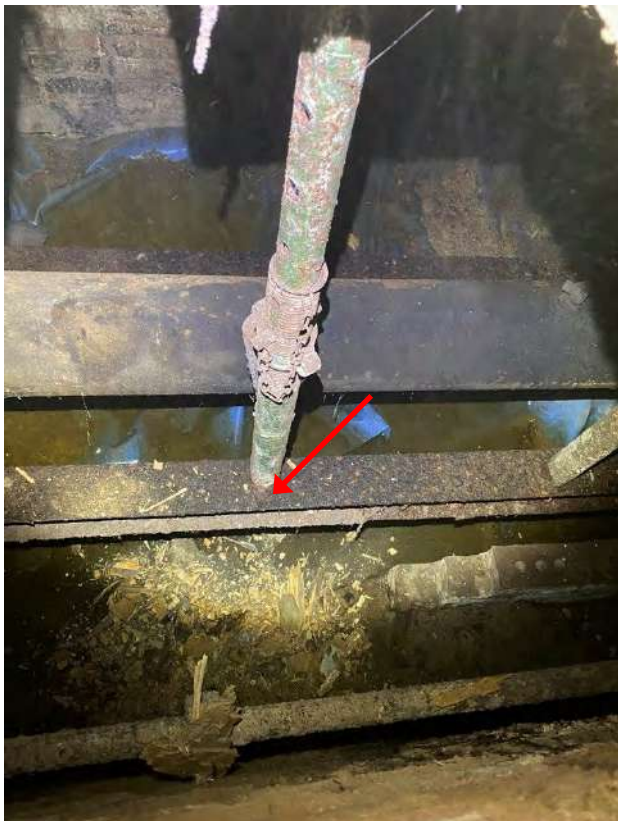
**Fig 26:**

Lower ground floor; showing the Acrow props supported from an RSJ to the floor of the basement
